Engineering Reconnaissance of the 24 August 2016 Central Italy Earthquake. Version 2

Geotechnical Extreme Events Reconnaissance Association

Report No. GEER-050

22 November 2016

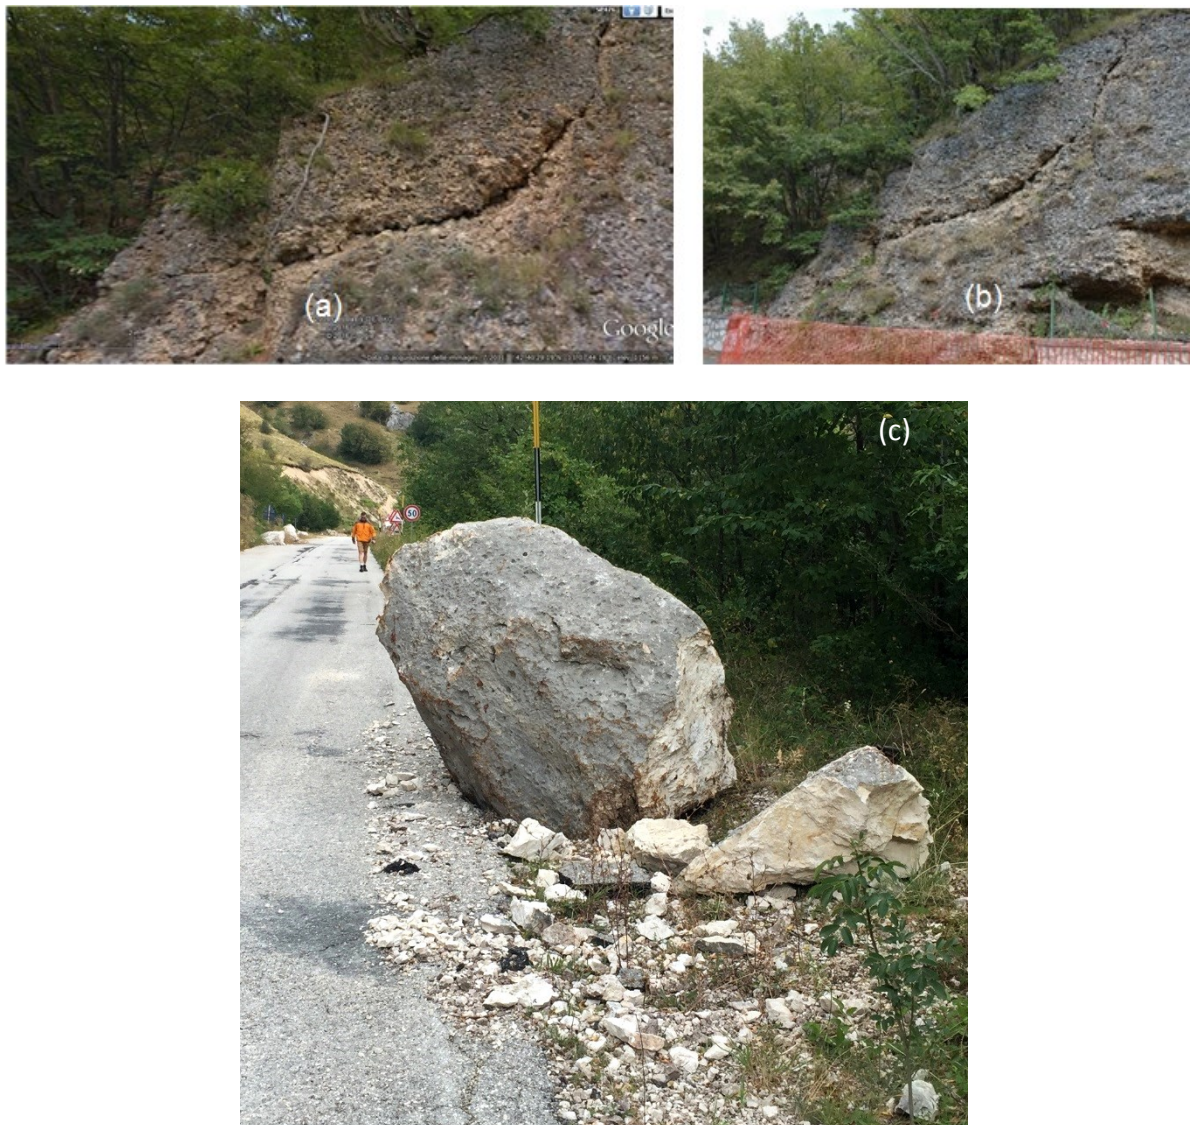
Figure 4.17. Large block of breccia (a) before the earthquake (image courtesy of Google 2016), (b) after the earthquake, and (c) example of rock fall below the Plano Grande on SP477. A large 2-m block of limestone crossed the road came to rest on the downslope side of the roadbed below a prominent outcrop of limestone (42.76729 N 13.16983 E).

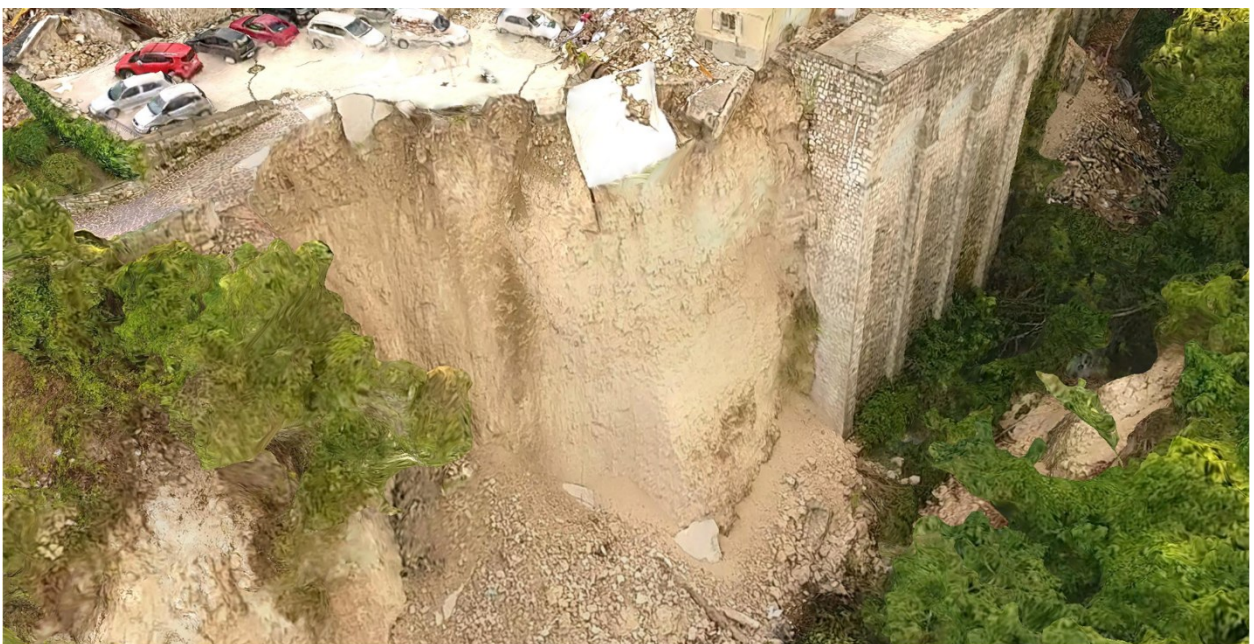
Figure 4.31. Model image of slope failure and possible retaining wall collapse (42.75109 N 13.27208 E).

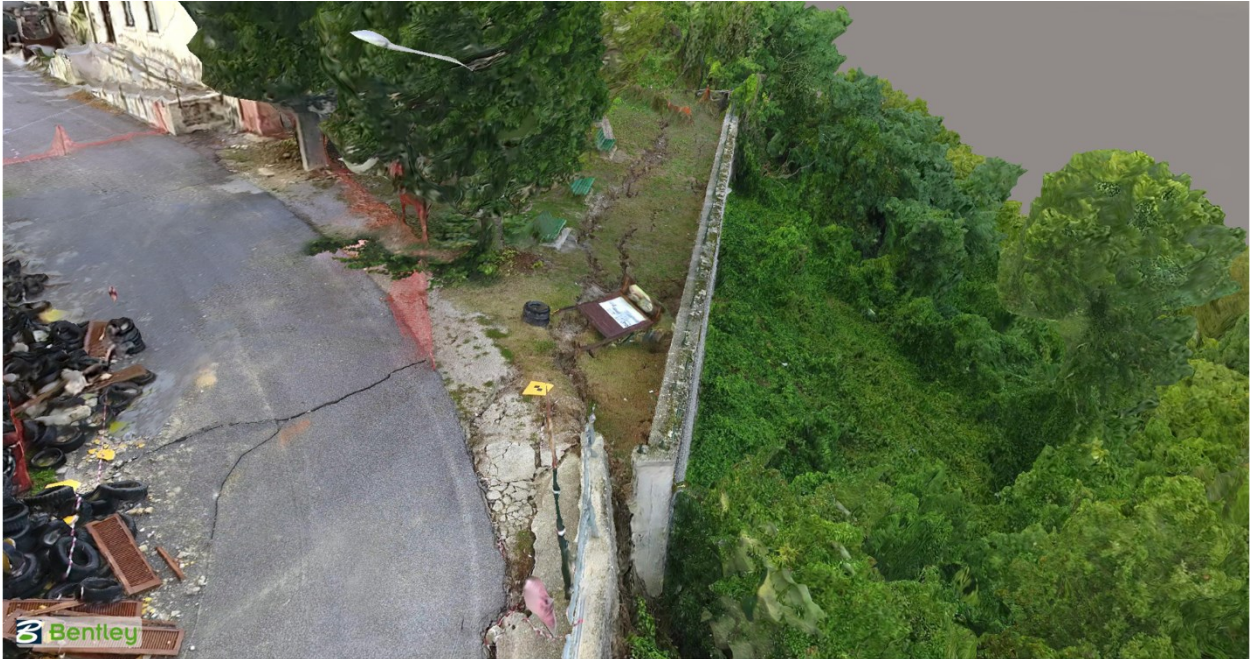
Figure 4.43. Rotated retaining wall and subsequent graben behind the wall. Soil settlement between 45-50 cm behind the wall, and formed cracks up to 45 cm in width (42.69446 N 13.24980 E).

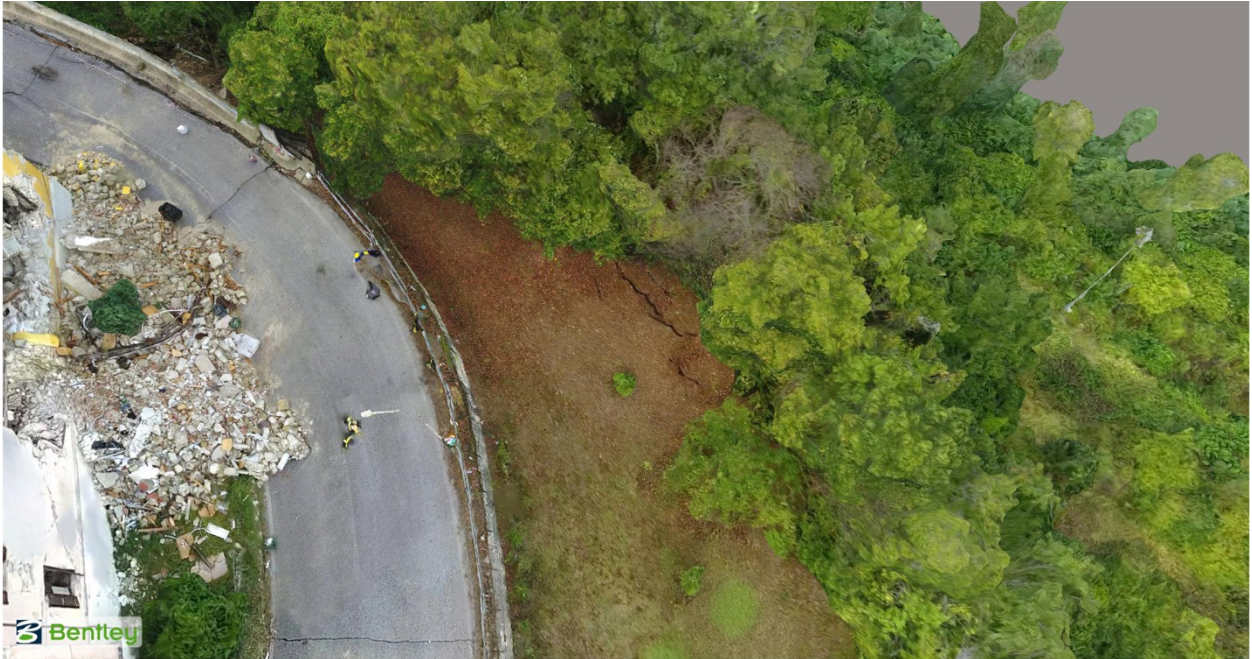
Figure 4.45. Model image of the cracks found in the silty-sandy fillslope located adjacent to the eastern walls of Accumoli. Crack widths range from 5 to 14 cm (42.69406 N 13.25019 E).

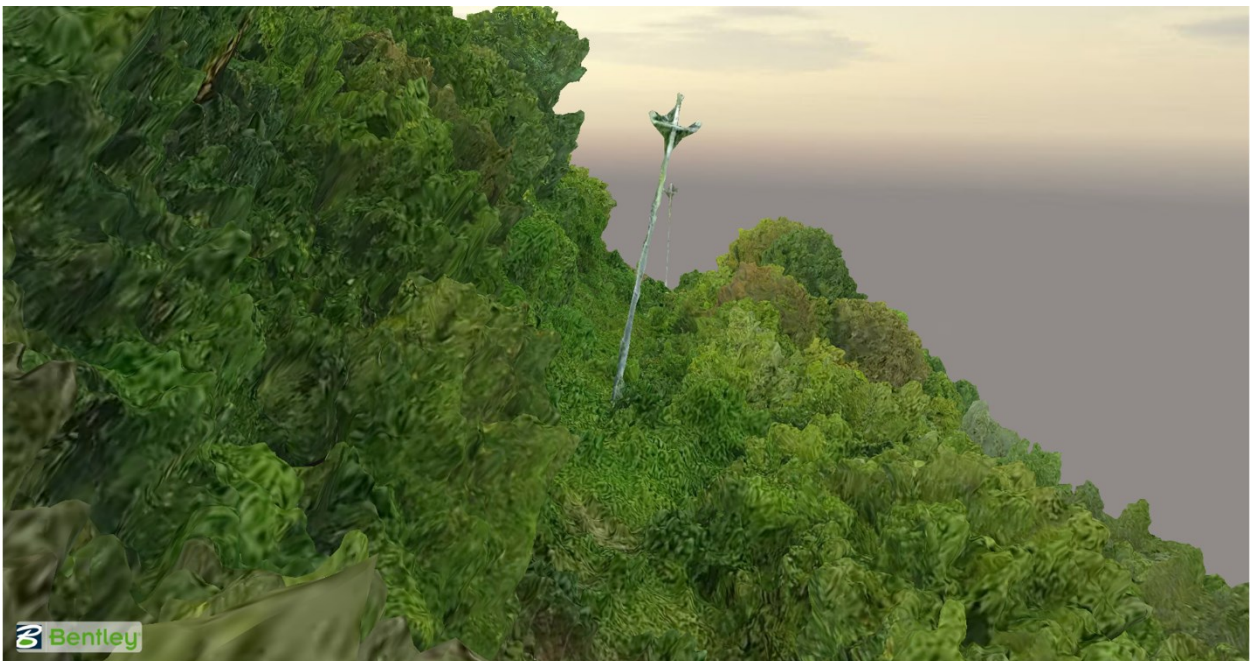
Figure 4.46. 3D model image of a rotated telephone pole in the slope below the cracks. The telephone pole is rotated 13 degrees from vertical, while the other telephone poles are approximately vertical.

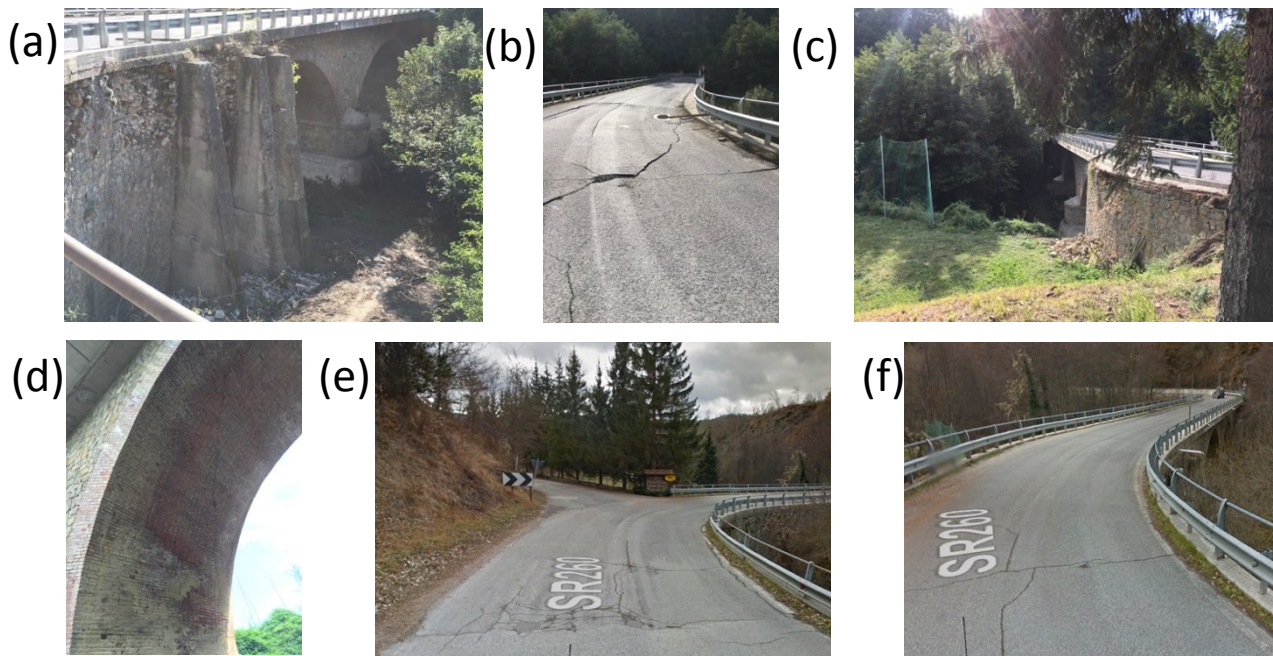
Figure 6.9. Ponte a Tre Occhi - Masonry bridge along the SR260 in Amatrice (42.620668 deg, 13.290176 deg): partial collapse of two side of the bridge (a, c), road settlement (b), cracks on the arch (d), pre-event cracks along the SR260 (e) and bridge-abutment connection (f) (source (e) and (f): Google maps).

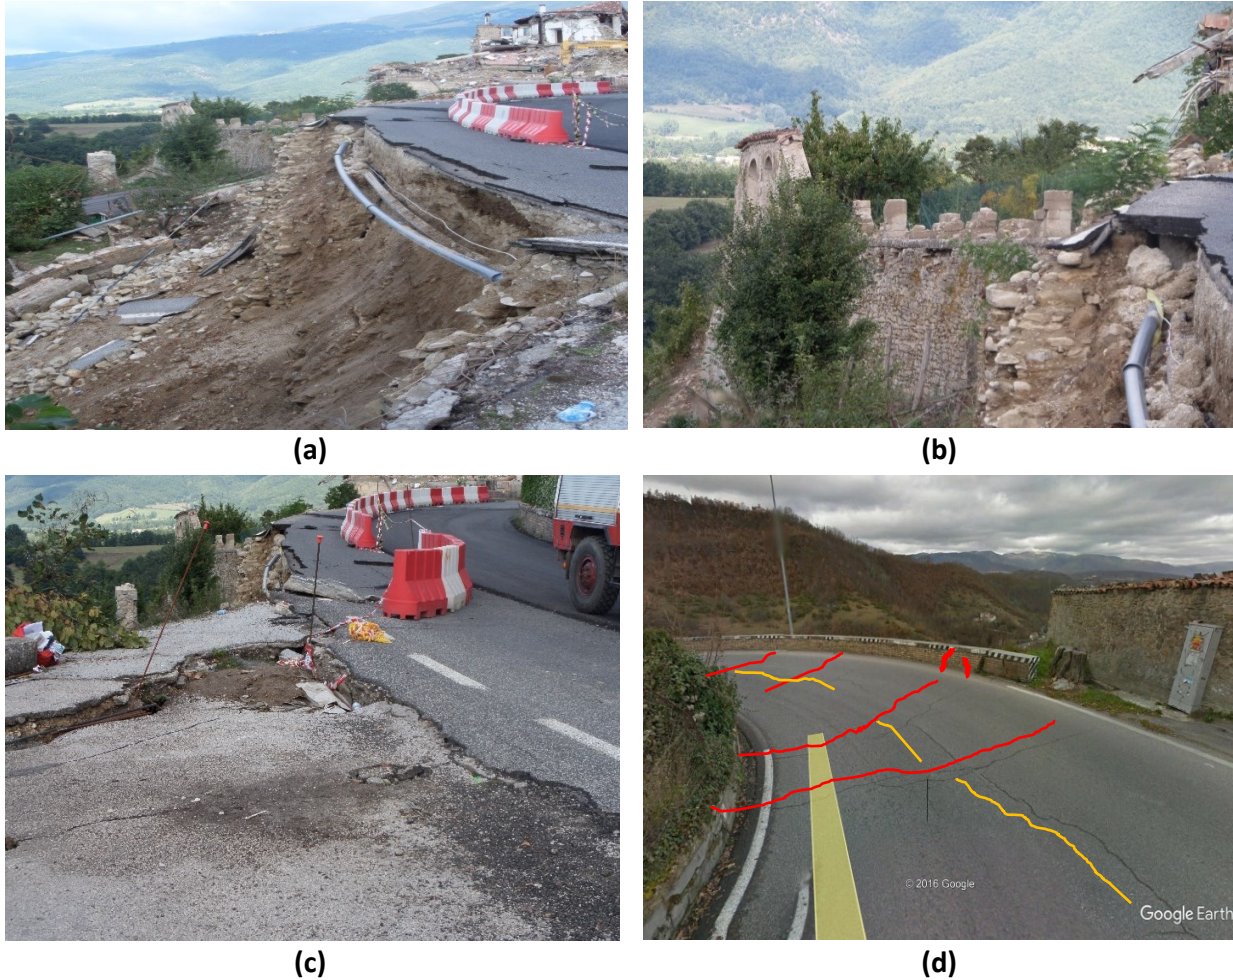
Figure 7.2. Retaining wall along the SS260 road close to Amatrice urban area (42.629533N, 13.286448E): (a) collapse of the wall, (b) detail of the stone masonry texture, (c) cracks along the unpaved portion of the road, (d) Google Earth (July 2011) view of the SS260 road before the earthquake, with evidences of diffuse cracks along the asphalt.

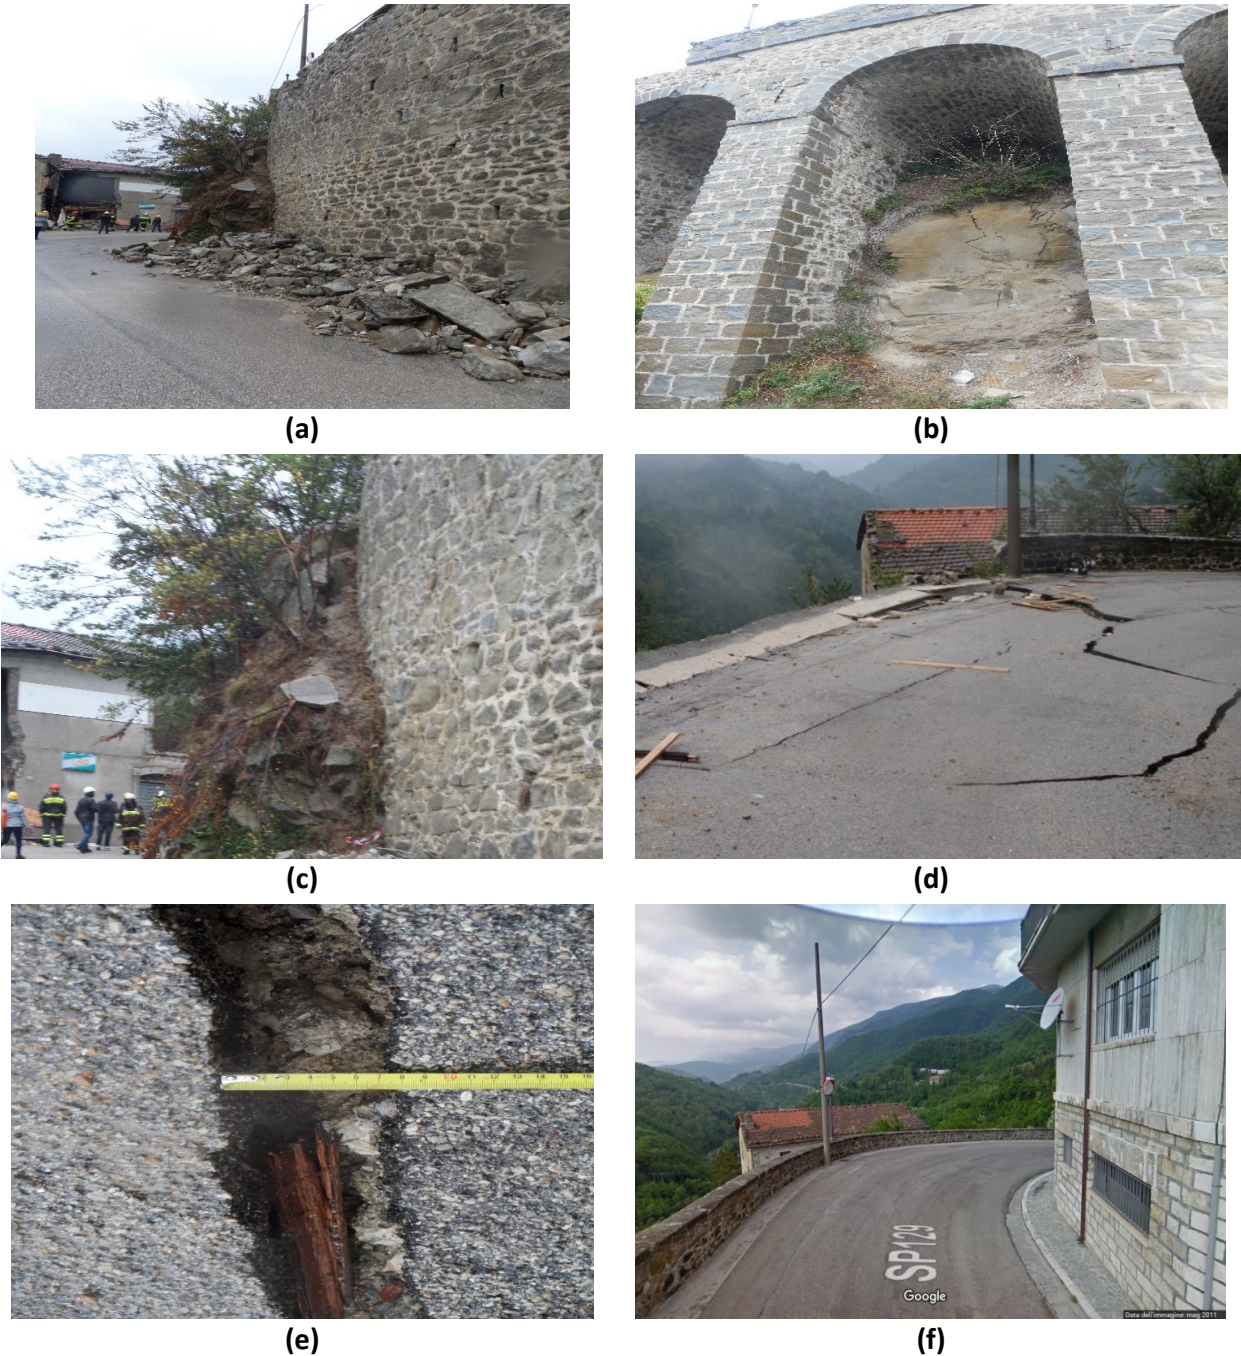
Figure 7.4. Masonry retaining wall in Arquata del Tronto (42.771898N, 13.296715E): (a) partial collapse of the wall parapet, (b) arch masonry structure, (c) marl blocks along the SP129 road, (d) road instability at the top of the wall, (e) opening of the cracks developing along the direction parallel to the road axis, (f) Google Earth view of the site (dated May 2011).
