**Italian Joint Reconnaissance Mission**

# Türkiye

**Daily Report**  
**May 10<sup>th</sup> 2023**

## Daily report, May 10th 2023

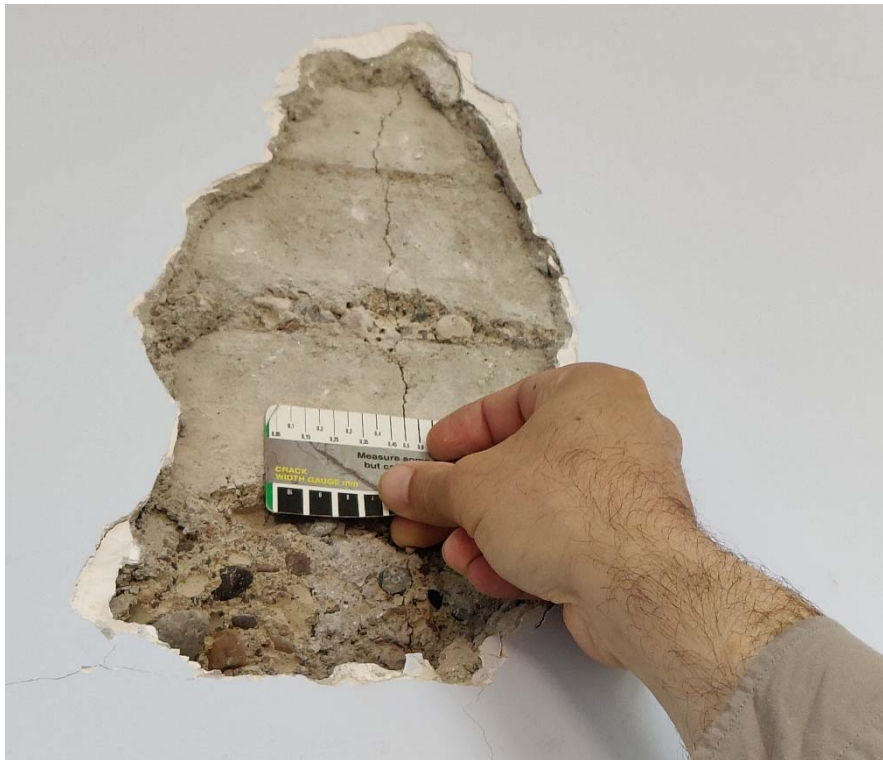
The building was classified as moderately damaged, and was temporarily closed to scholastic activities, due to flexural cracks observed on beams of the frames in the longitudinal direction, such as the one shown in Fig. 3 with a crack width of 0.5 millimeters. The building avails of a strengthening system composed by additional RC shear walls, placed near the central part and spanning the entire height of the building

Fig. 3. - Position on a flexural crack on a beam.

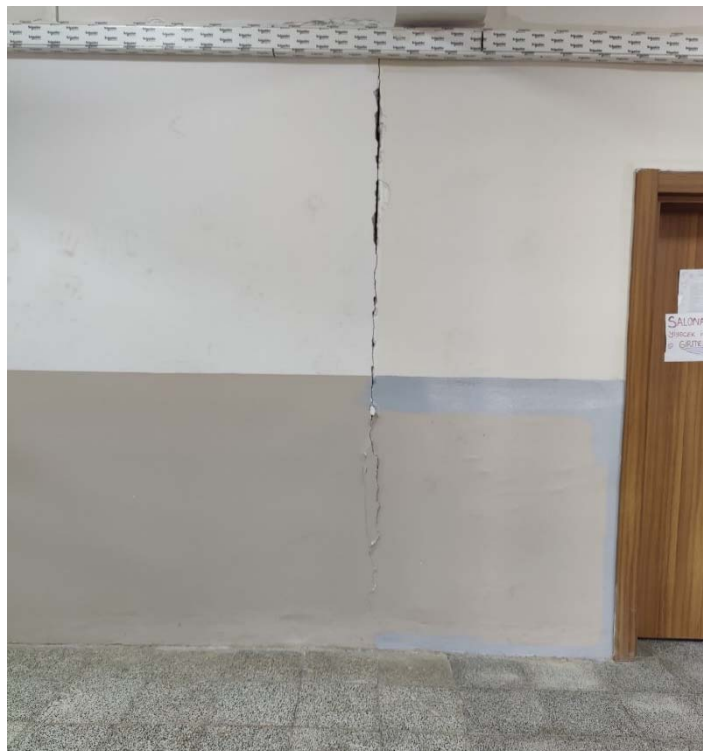
This building does not exhibit earthquake damage. All that can be observed is some separation of the masonry infill around the gym area, that was probably cause by some existing case of foundation settlement, as shown in Fig. 5. The building exhibits a strengthening system consisting of RCC shear walls spanning the entire height of the building

Fig. 5 – Separation of the masonry infill.

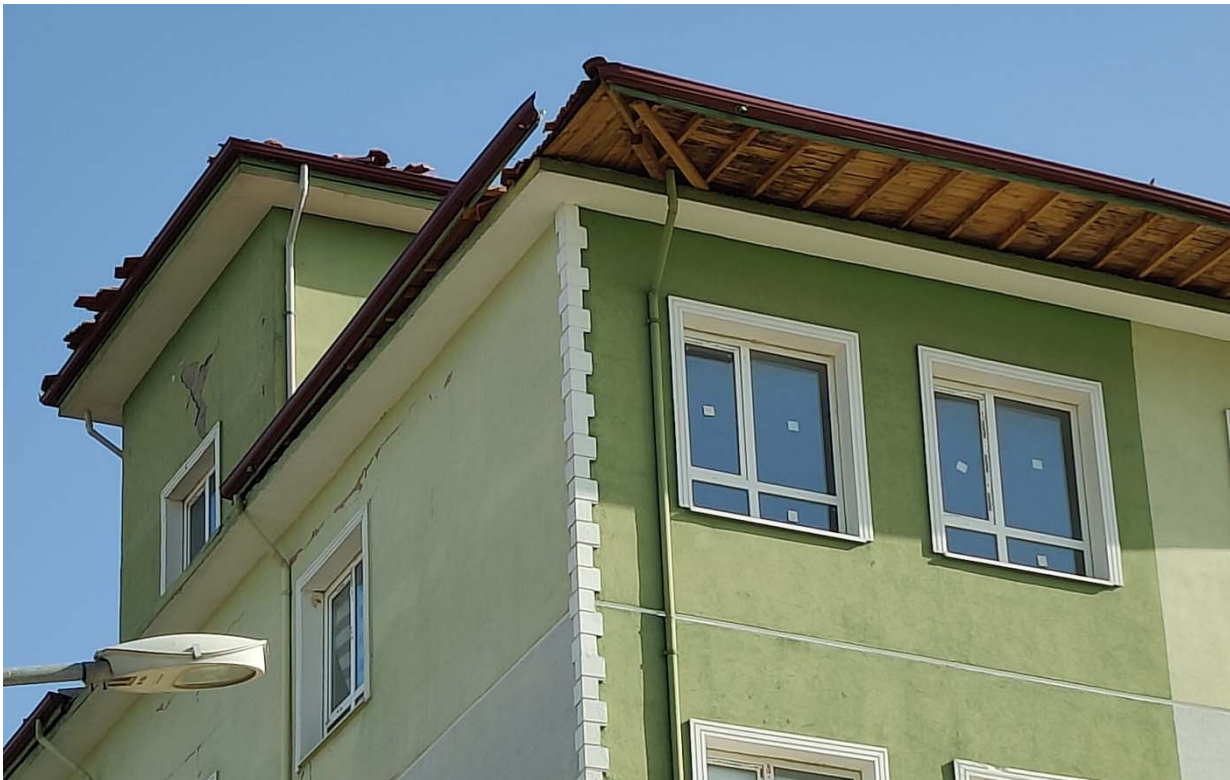
Fig. 7 – Partial collapse of the roof cover.

This building was closed to scholastic activities. It exhibits ubiquitous cracks on all sides, that only seem to concern the finishing mortar. The roof cover has evident damage, with part of it on the front side being displaced with some the roof tiles falling over.

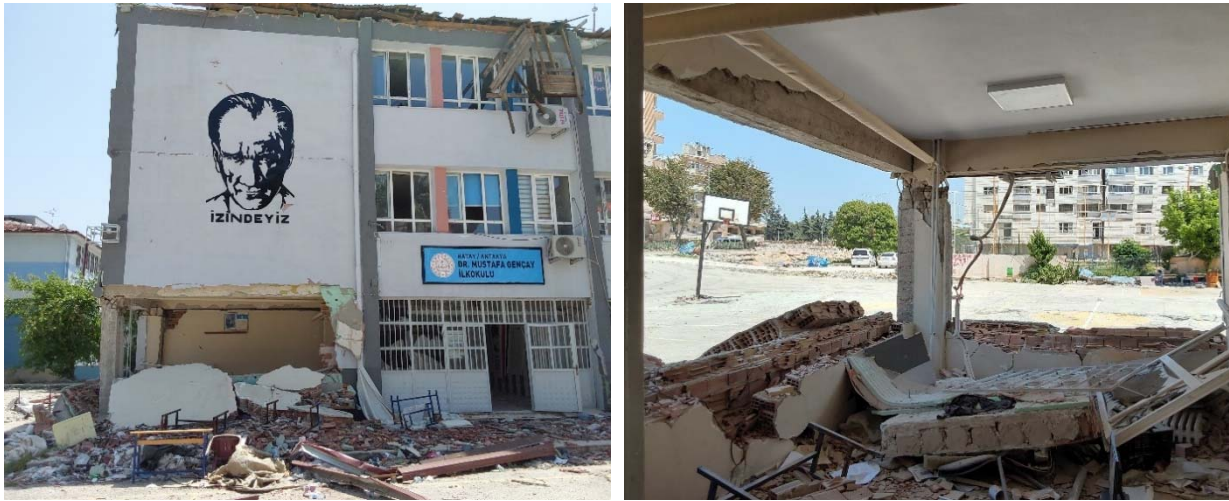
Fig. 8 Left panel: front view; right panel: view from the inside, collapsed external infill masonry walls and plastic hinging of the adjacent columns with clear disorganization of the concrete nucleus due to lack of adequate passive confinement

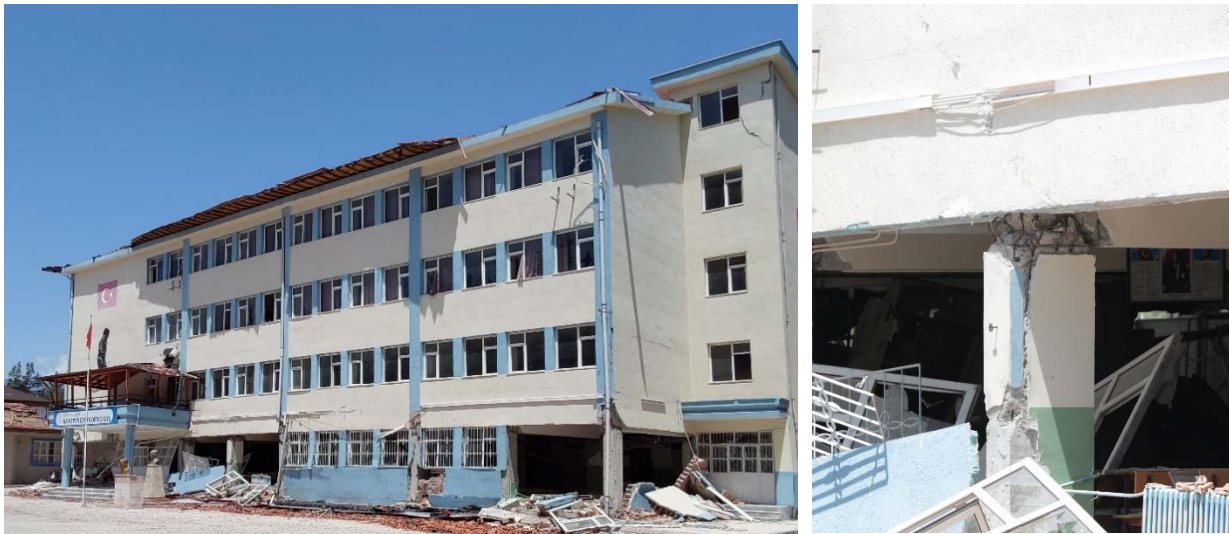
Fig. 9. Soft storey effect due to partial collapse of the front infill walls; plastic hinging of the columns.

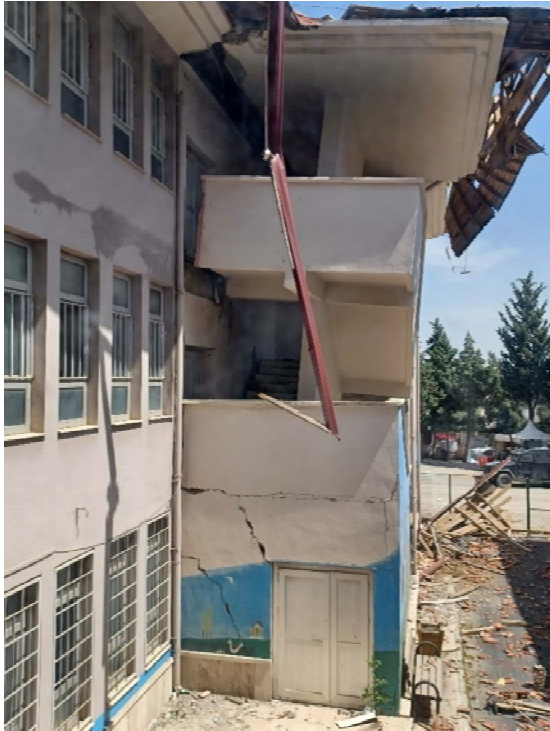
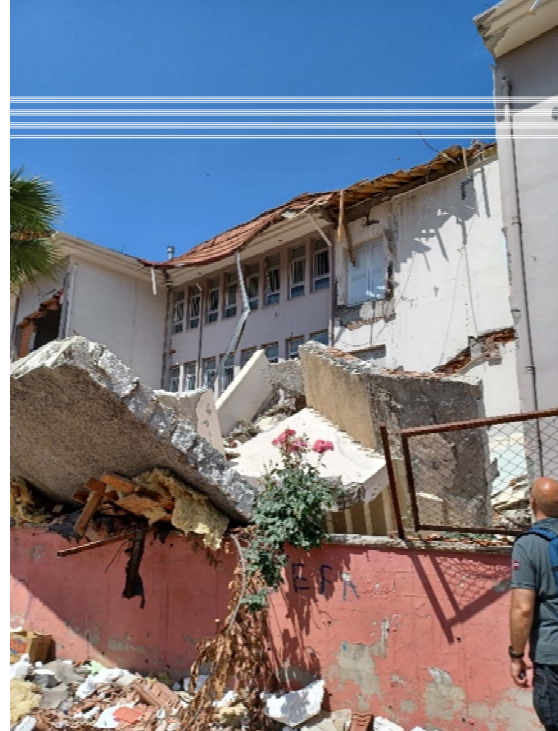
Fig. 10 Incipient (left) and total collapse (right) of the external structures bearing the emergency evacuation stairwells.

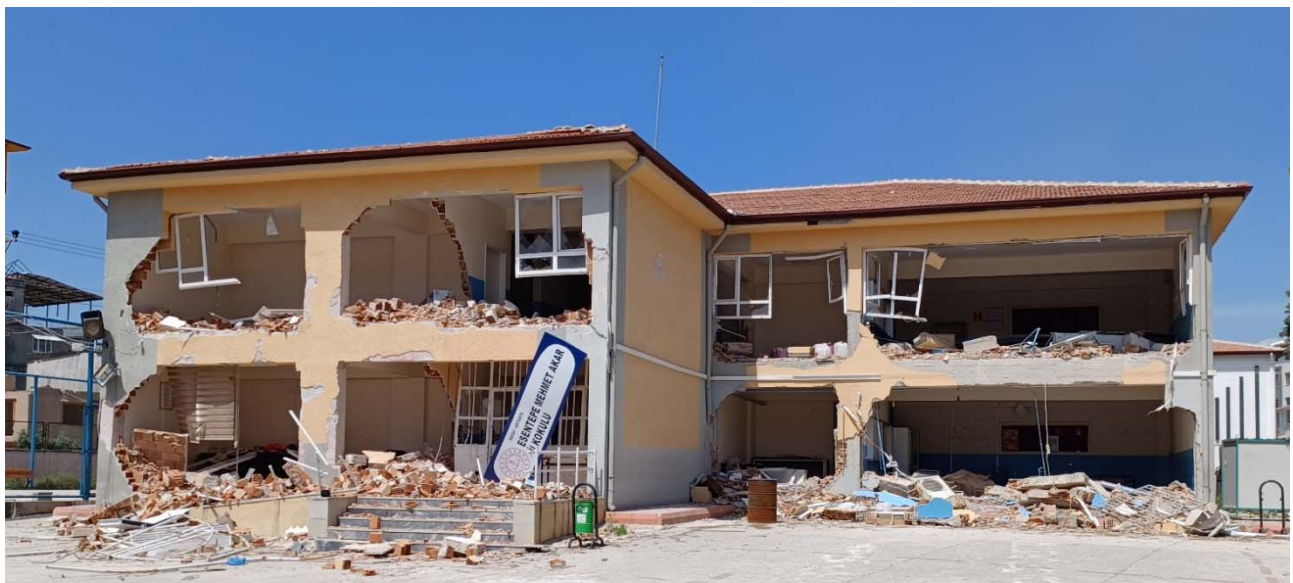
Fig. 11. Out of plane collapse of the infill walls on both floors.

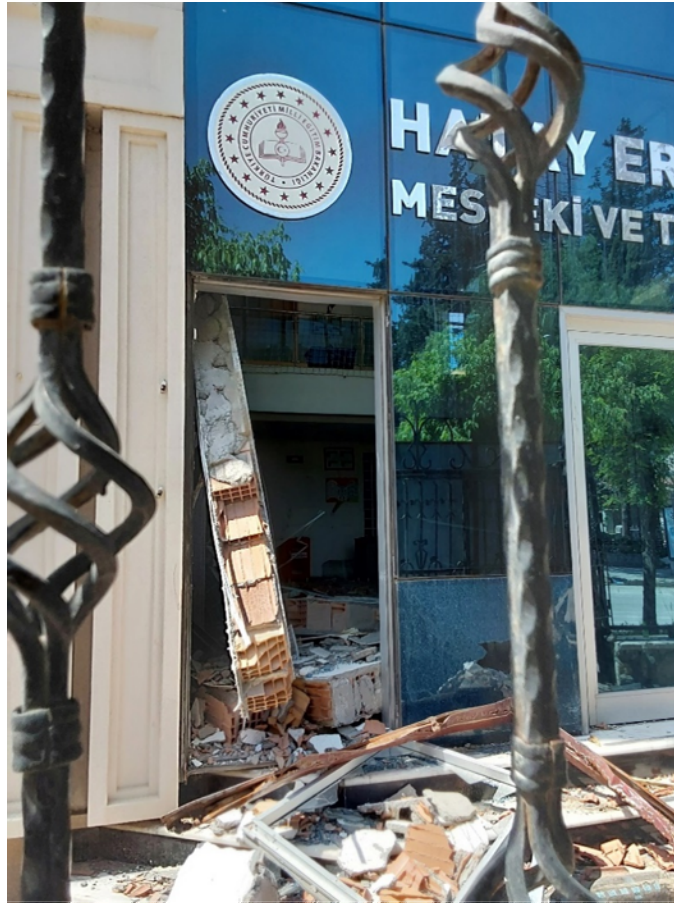
Fig. 12. Overturning of internal masonry separation walls

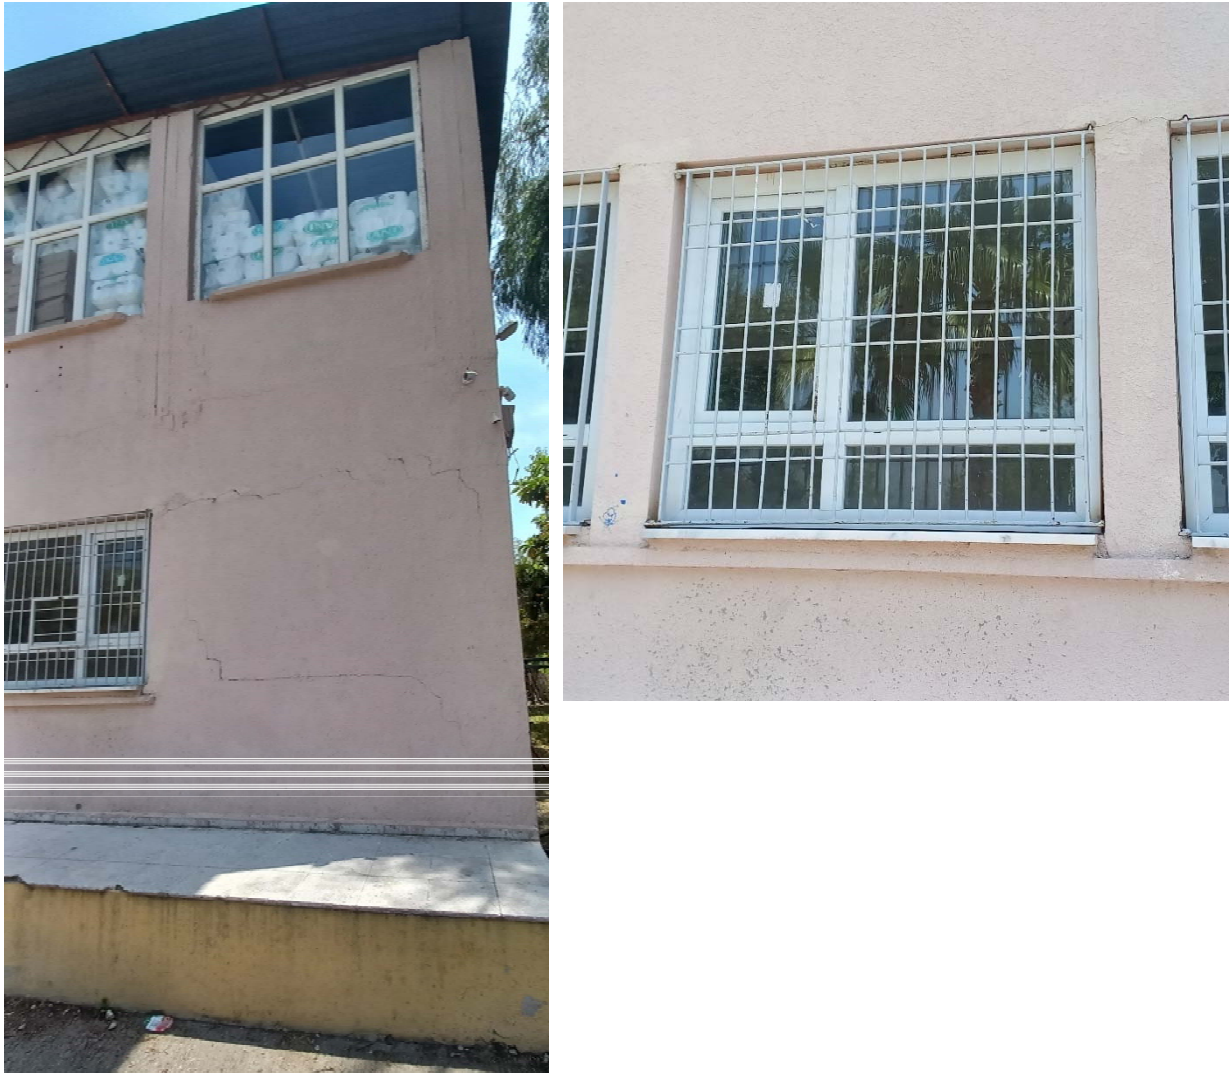
The load-bearing structures were not significantly damaged: only mild cracking was observed.

Fig. 13: Light damage at the interface of the infill walls

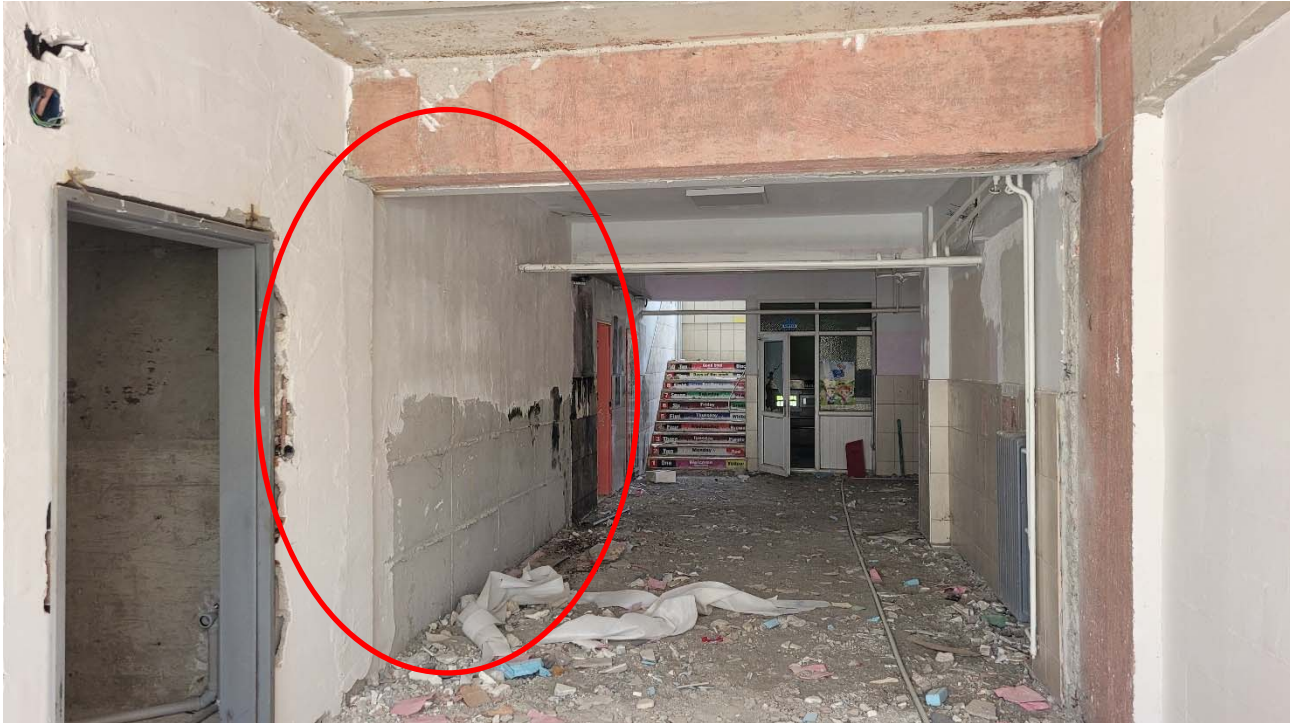
Ongoing retrofit operations that were not completed by the time of the earthquake.

Fig. 14: Additional RC shear wall.

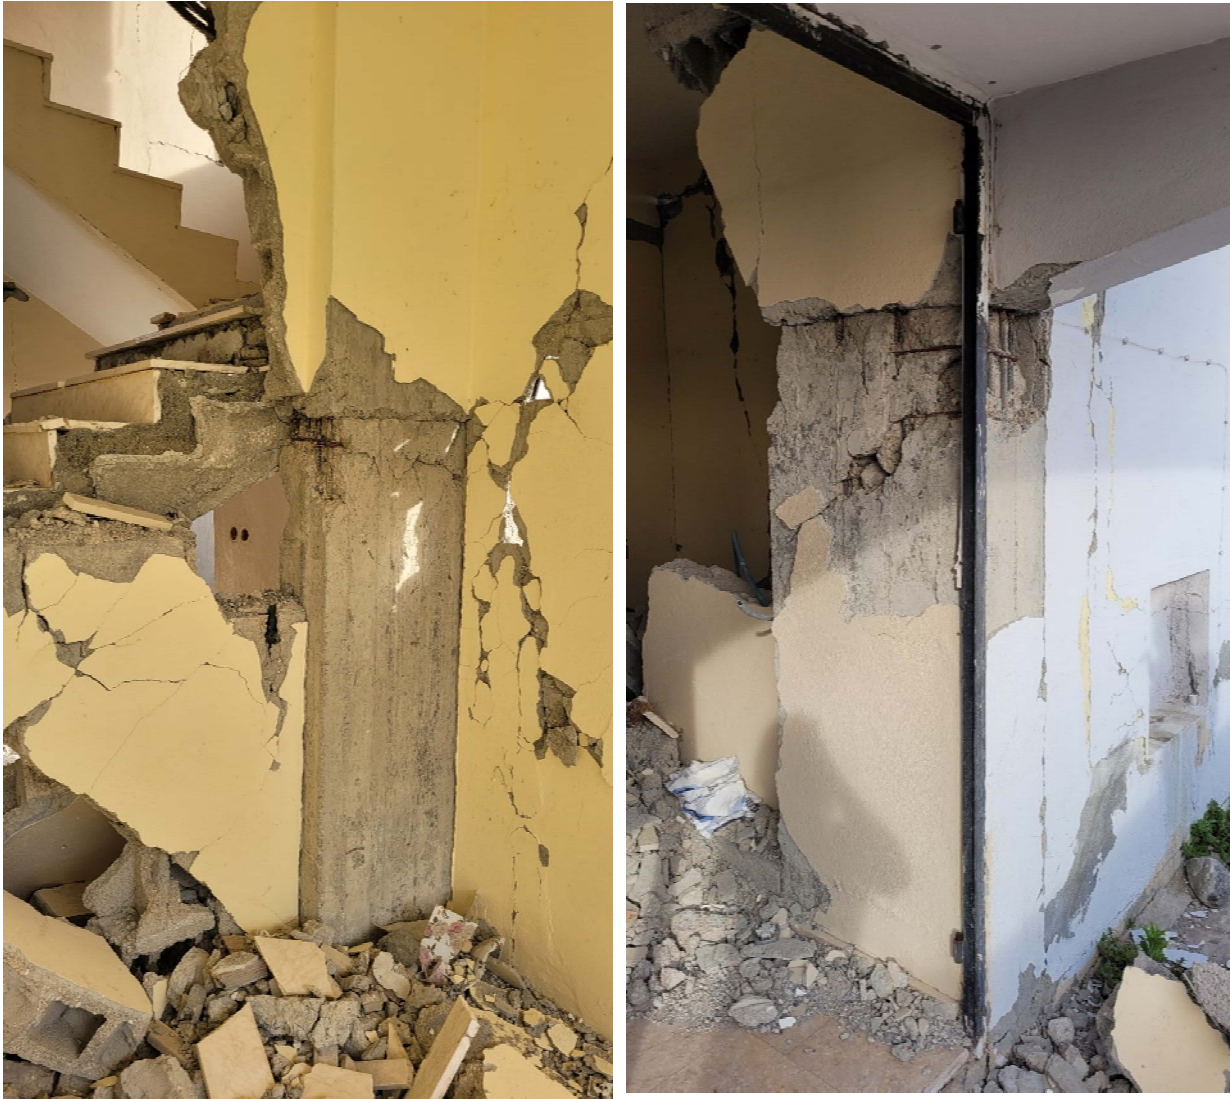
In the city of Erzin some column damage was observed near the staircase of an RC terrace.

Fig. 15: Column damage

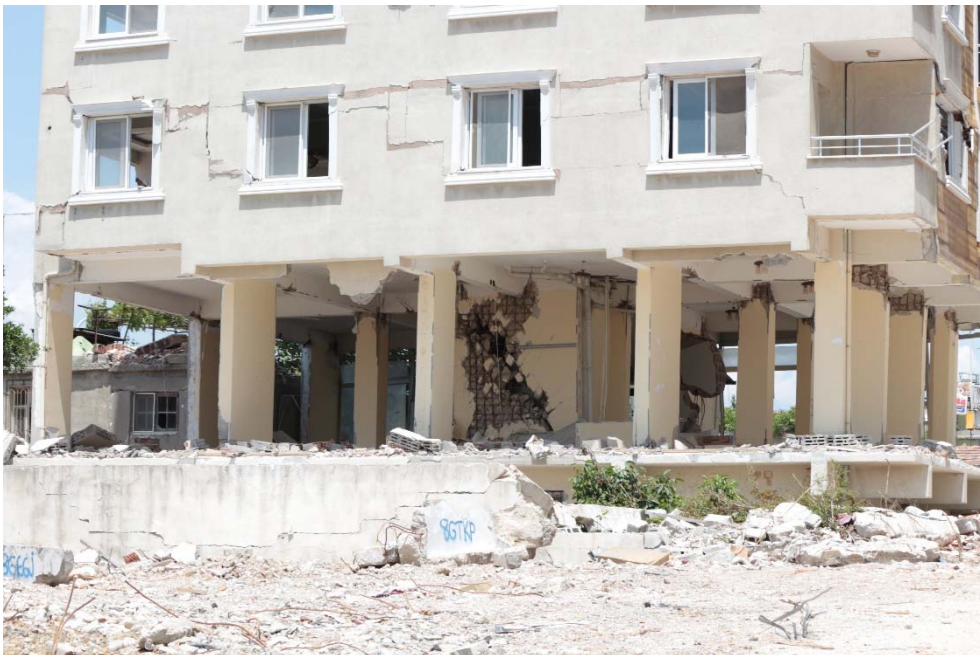
Fig. 16. Shear failure of an RC shear wall and plastic hinging at the top of the ground floor columns.

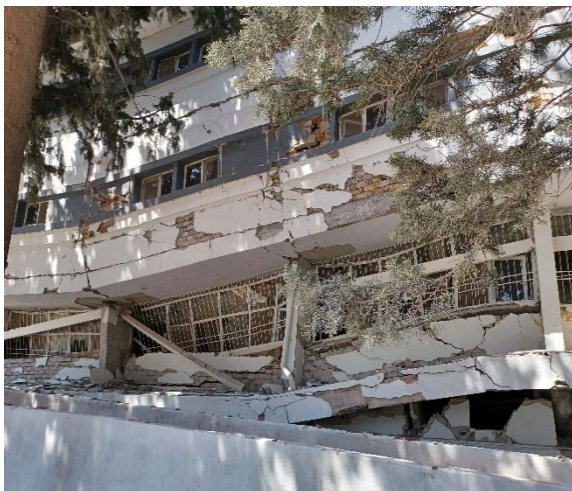
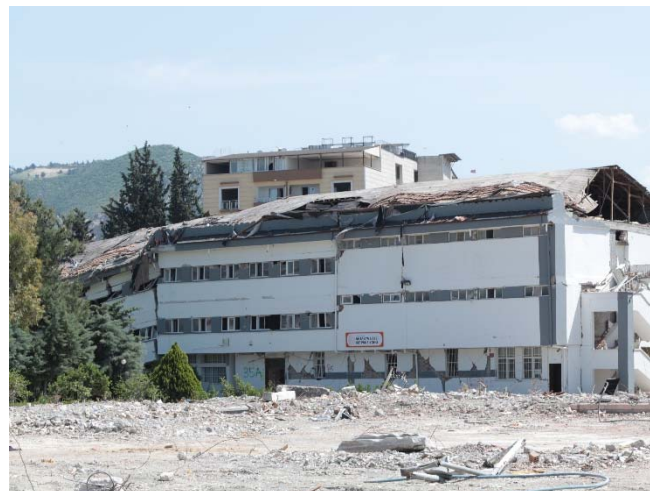
Fig. 17. Partial collapse of a large portion of a dormitory building, due to heavy damage of several consecutive columns at the ground floor.

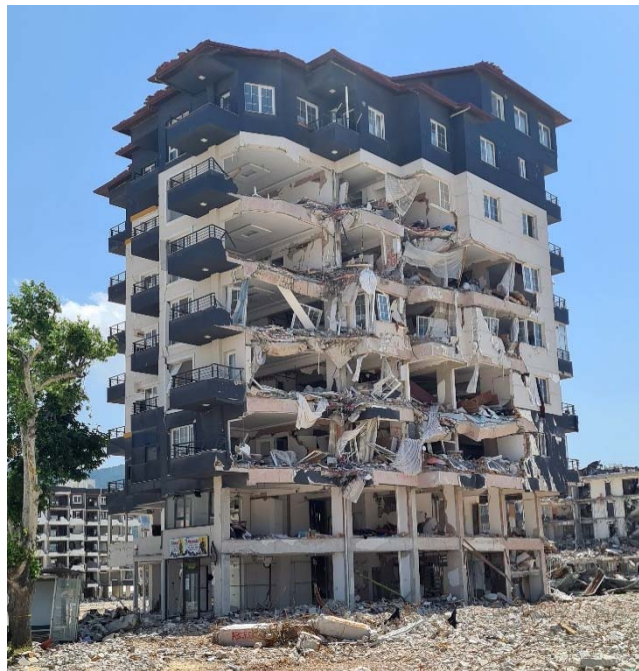
Fig. 18 Collapse of the external infill walls and damage to the perimeter beams lacking direct column support.

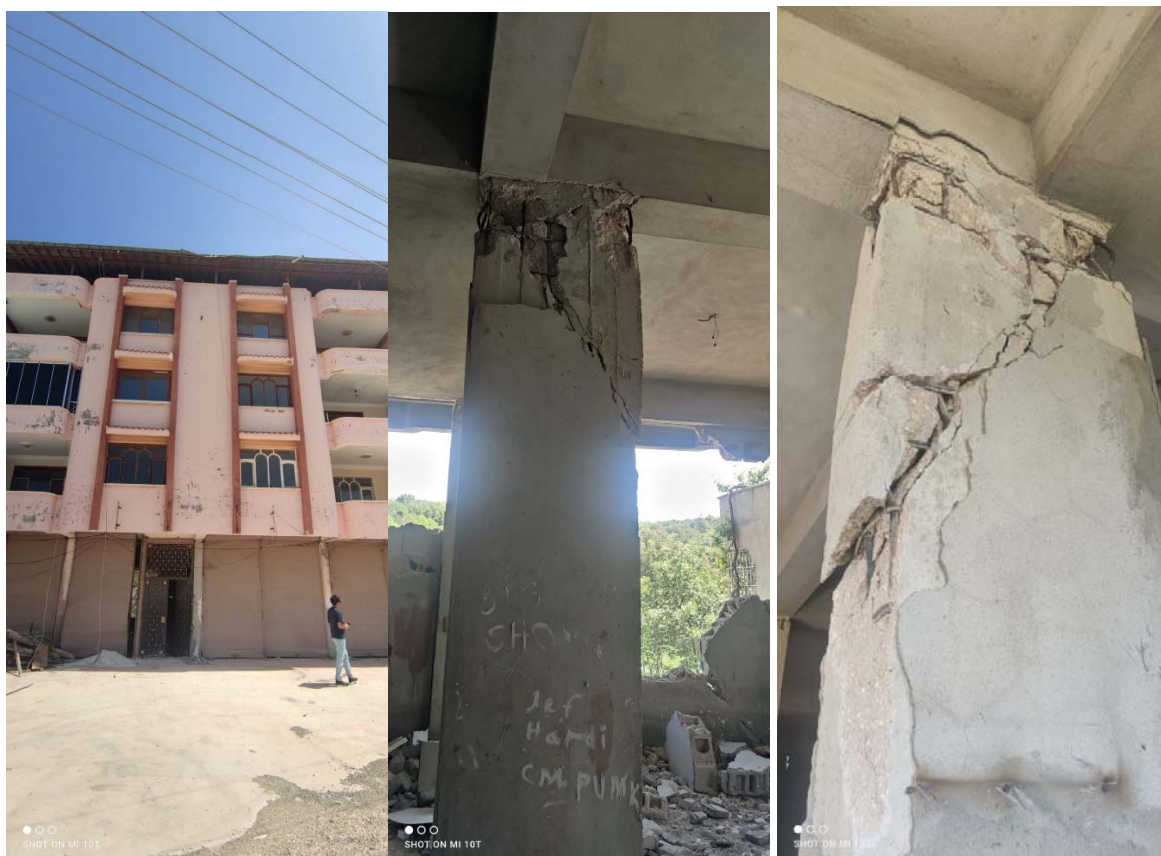
In the city of Atakoy, shear failure was observed in many RC columns in the vicinity of the stairwells

Fig. 19 Shear failure of several RC columns near the stairwells
