**Italian Joint Reconnaissance Mission**

# Türkiye

**Daily Report**  
**May 11<sup>th</sup> 2023**

## Report and photographic material: earthquake damage on the case study school buildings

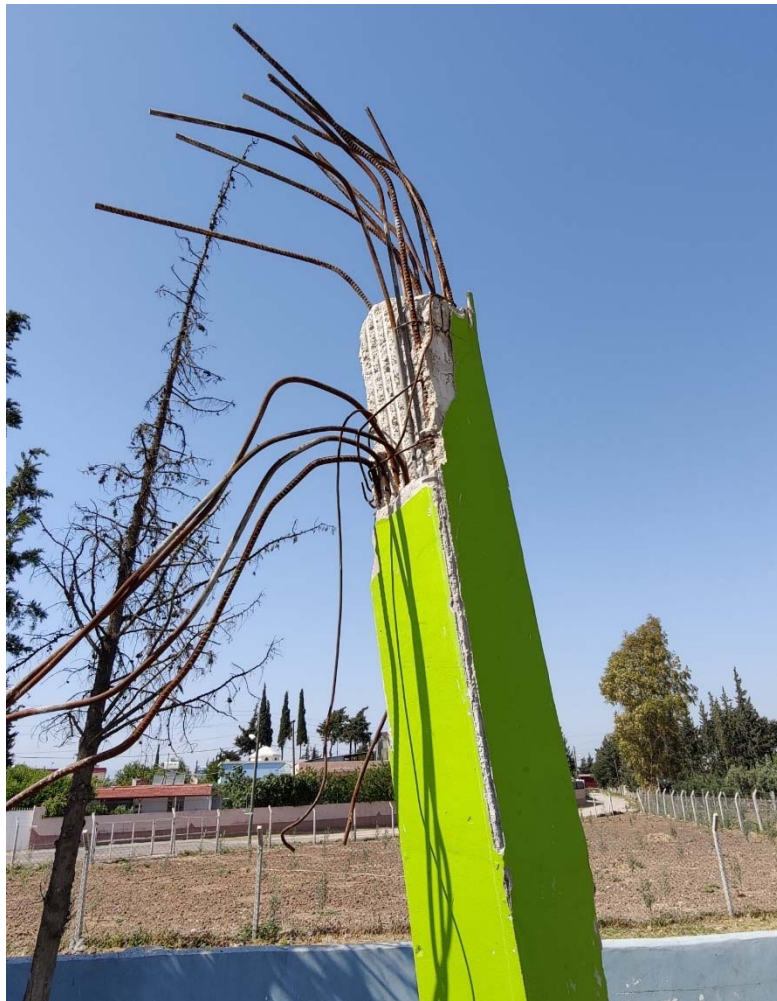
- **KARAHÜYÜK İLKOKULU**

The building was demolished after the earthquake and there is no information on either its retrofit or the damage state.

Fig. 2 – Remains of a column.

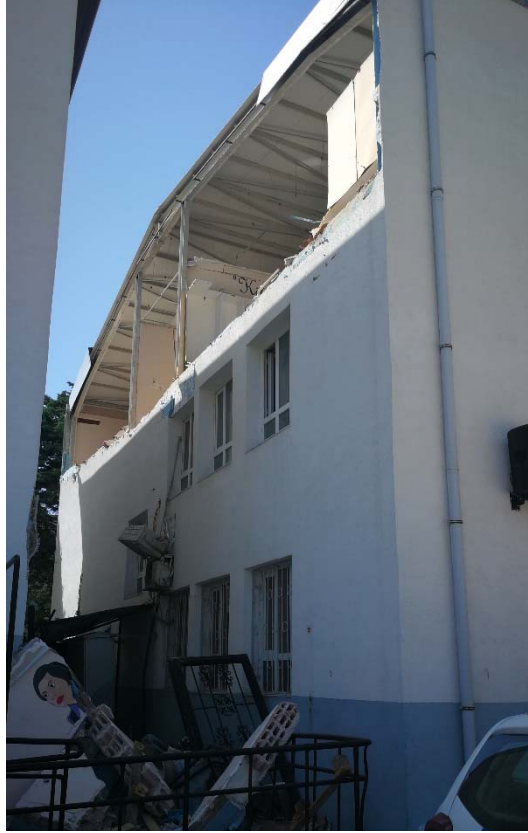
- **DR. MUSTAFA GENÇAY ANADOLU LİSESİ A BLOK**

Fig. 3 Raised floor constructed with structural steel and truss-beam roof cover, insufficiently connected to the masonry wall parapets.

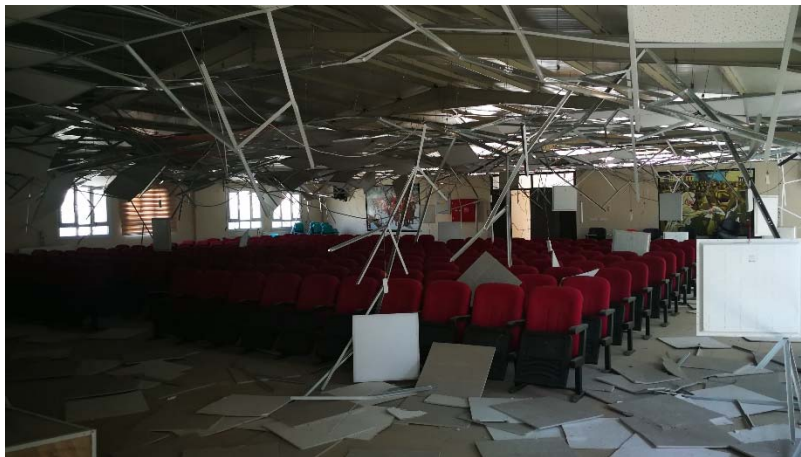
Fig. 4 Auditorium in raised floor with widespread damage of the false (suspended) ceiling.

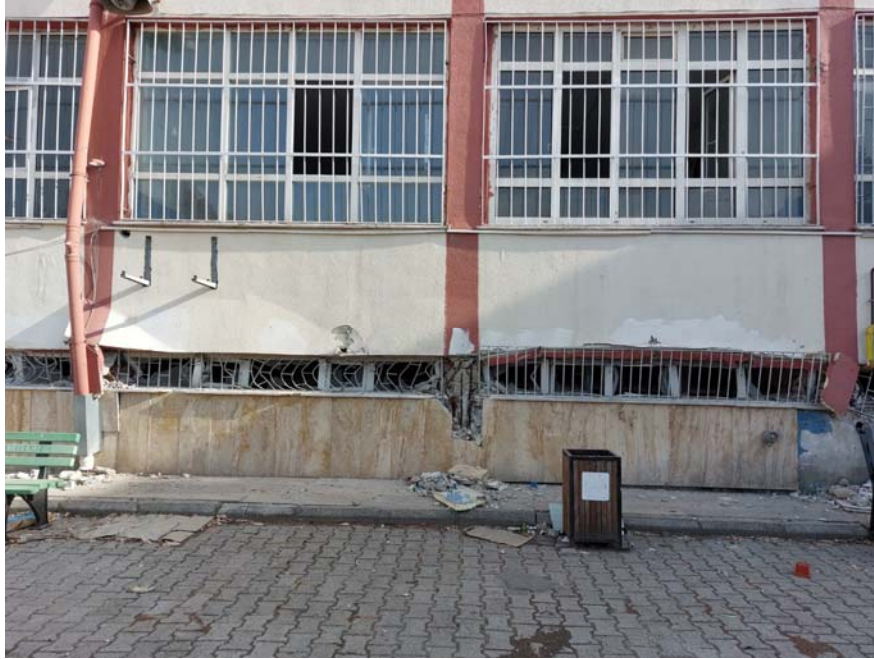
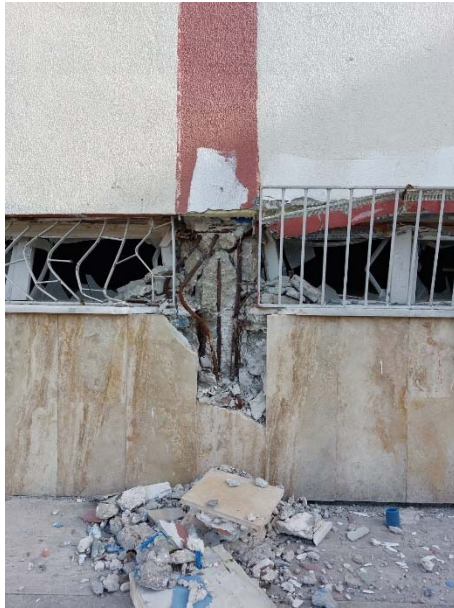
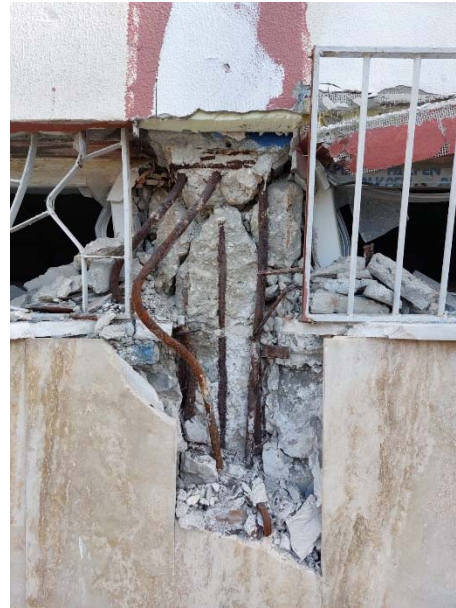
- HÜSEYİN ÖZBUĞDAY LİSESİ OKUL+SPOR SALONU

Fig. 5 Typical short-column type of damage, induced by continuous belt of low-height windows.

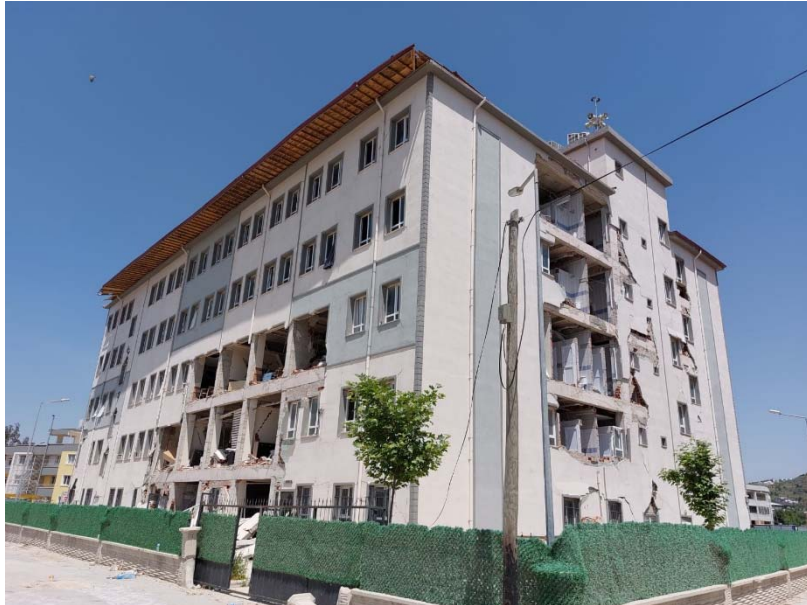
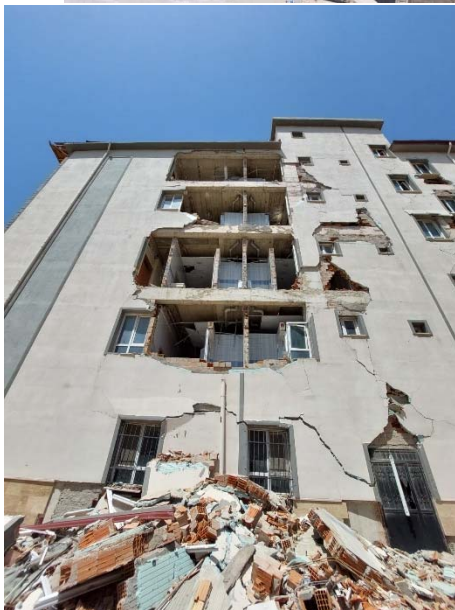
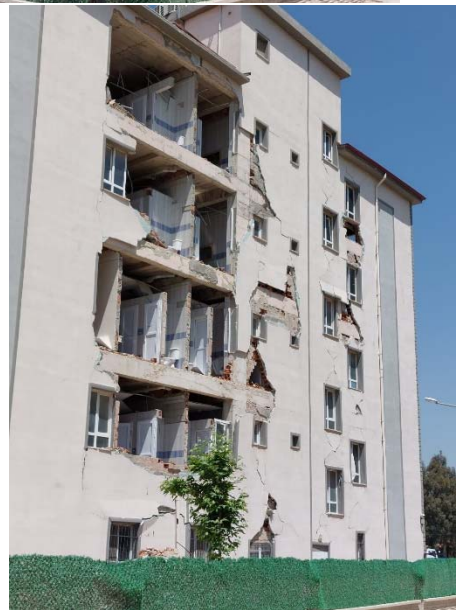
- **HACI BEKTRAS VELI ANADOLU LİSESİ**

Fig. 5 Heavy damage of masonry infills, with out-of-plane collapse, corresponding to the front and back perimeter frames. Damage to the wooden roof cover with dislocation of roof tiles.

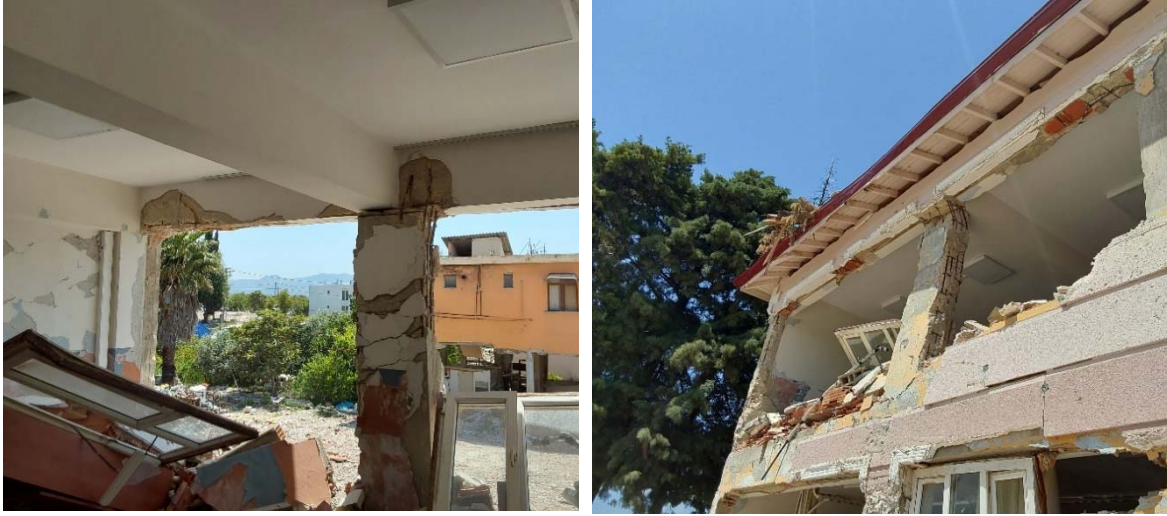
- **SUBAŞI MEHMET AKİF ORTAOKULU**

Fig. 6. Column top sheared-off at the construction joint, due to pounding from a (collapsed) adjacent structure: internal and external view (from left to right).

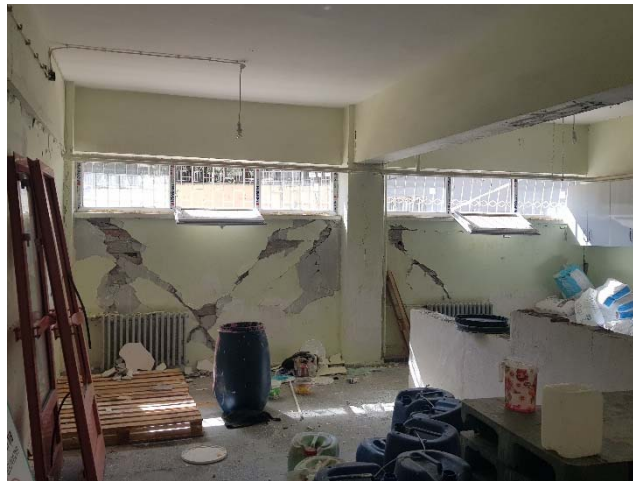
- **Anadolu Teknik Lisesi Ve E.M.L**

Fig. 7 Widespread diagonal cracking of infill and partition masonry walls.

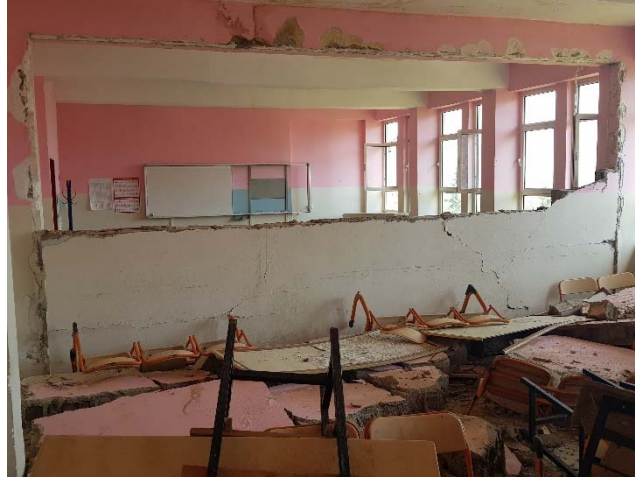
- Yil İlköğretim Okulu

Fig. 8: Out-of-plane failure of infill and partition walls, with overturning.

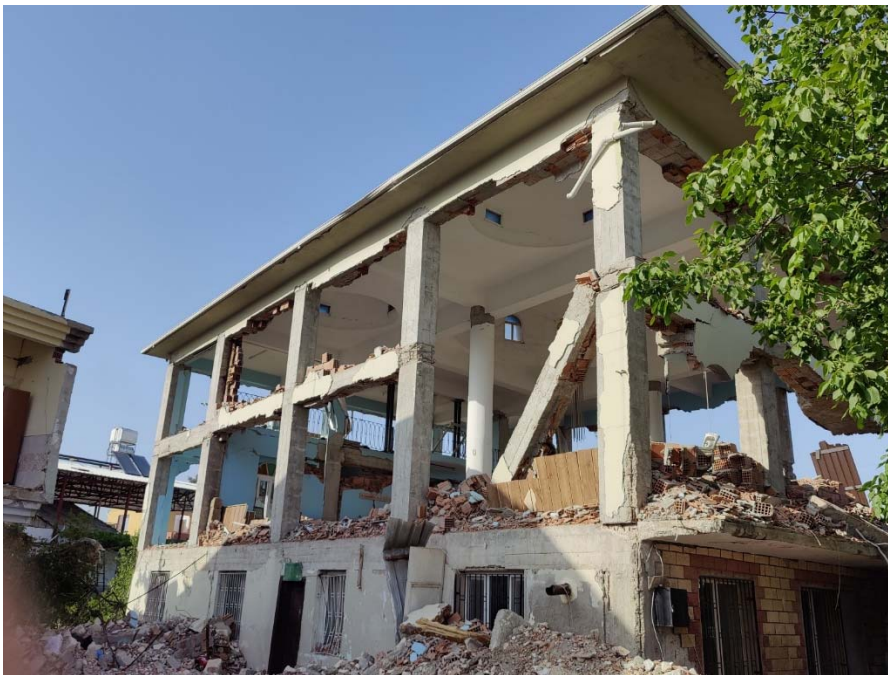
Fig. 8 Partial collapse of RC beam and floor slab.

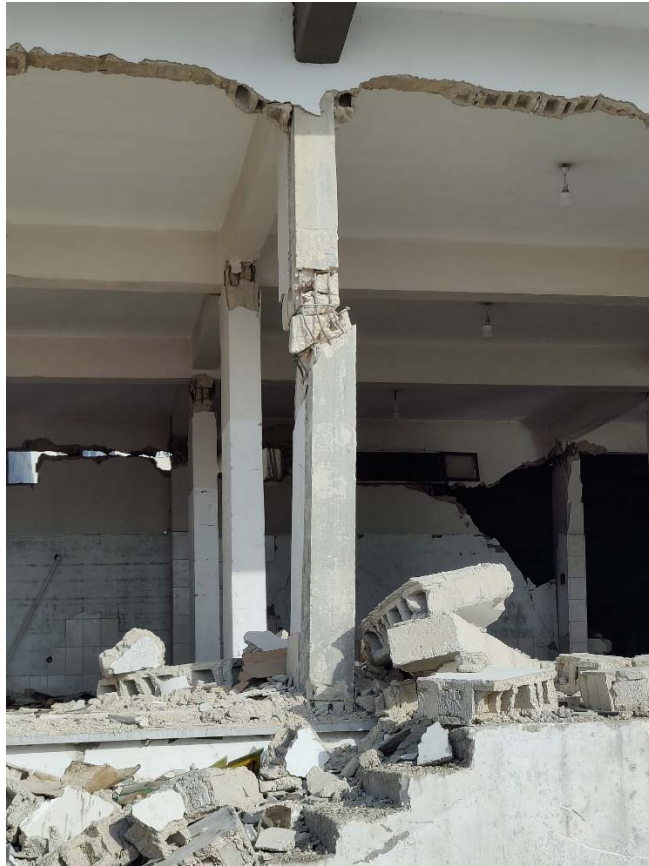
Fig. 9 Shear failure of an RC column.

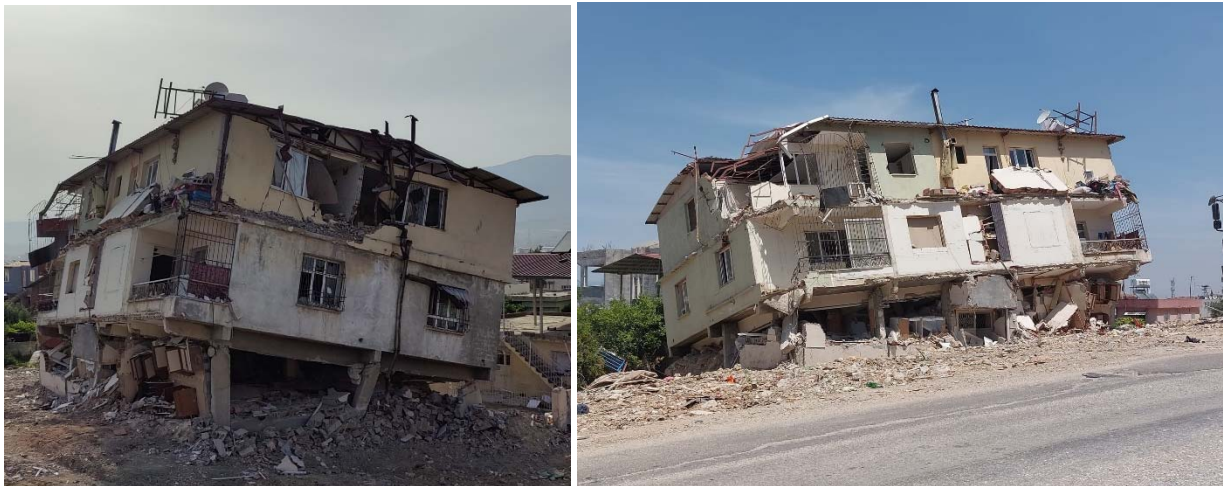
Fig. 10 RC building exhibiting soft-storey failure.

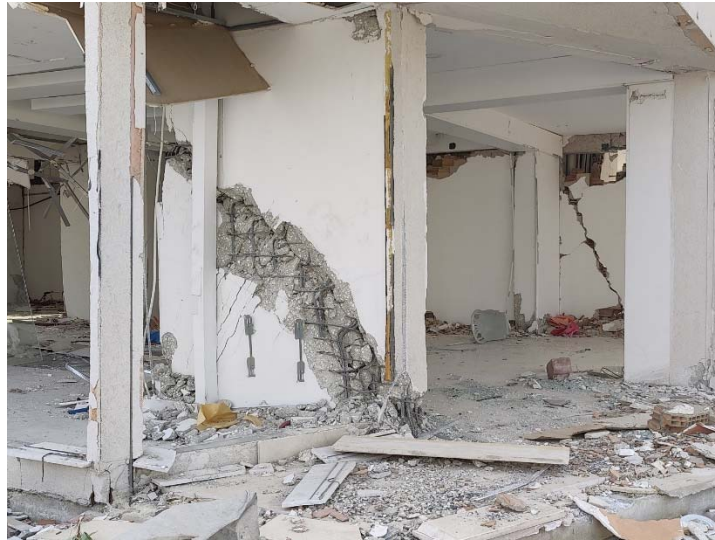
Fig. 11 Shear failure of an RC wall.

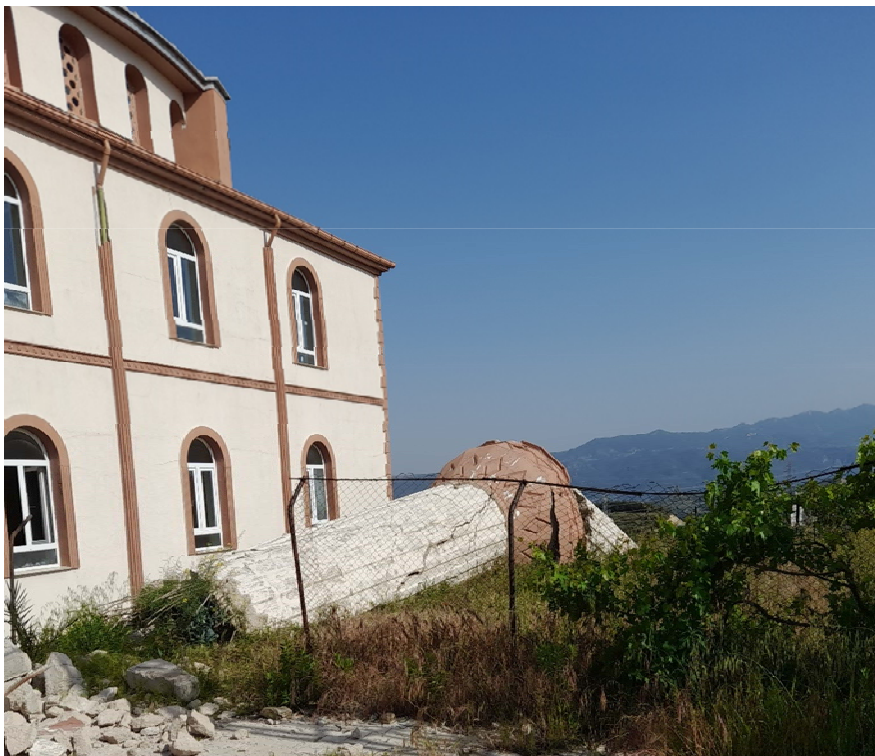
- **Città di Saman/aag**

Fig. 12 Overturning collapse of a mosque's minaret.

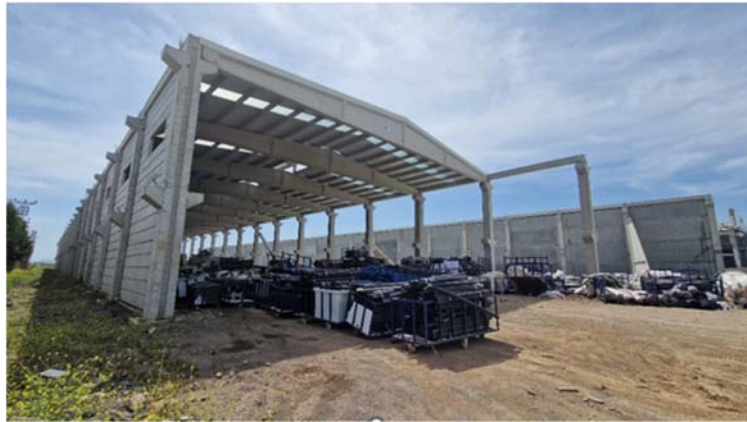
*Fig. 13 – Side-view of the structure.*

As shown in Fig.13 and 14, the earthquake-induced damage consists of a loss-of-support of the girders and consequent collapse of the roof cladding.

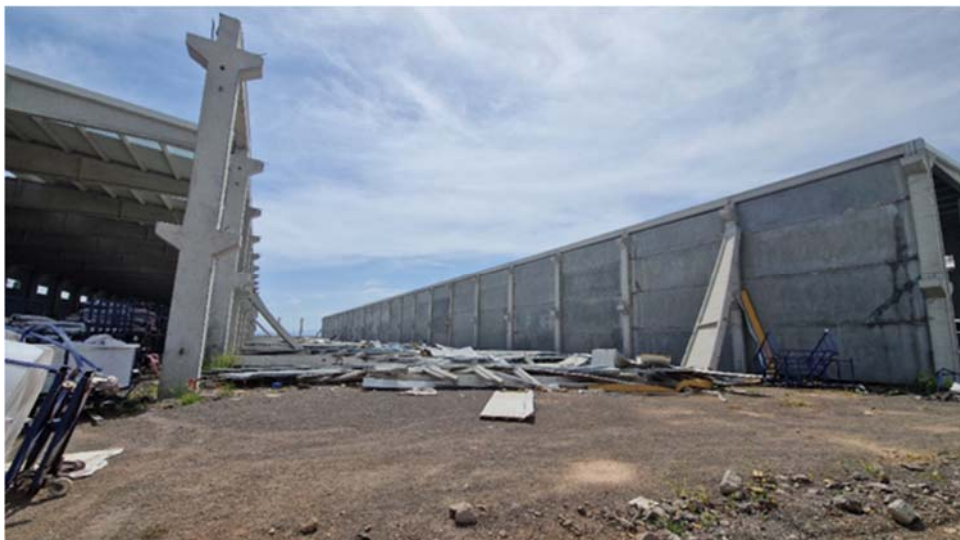
*Fig. 14 – Collapsed roof cladding elements.*
