**Italian Joint Reconnaissance Mission**

# Türkiye

May 8<sup>th</sup> – 13<sup>th</sup> 2023

**Final Report  
of the mission**

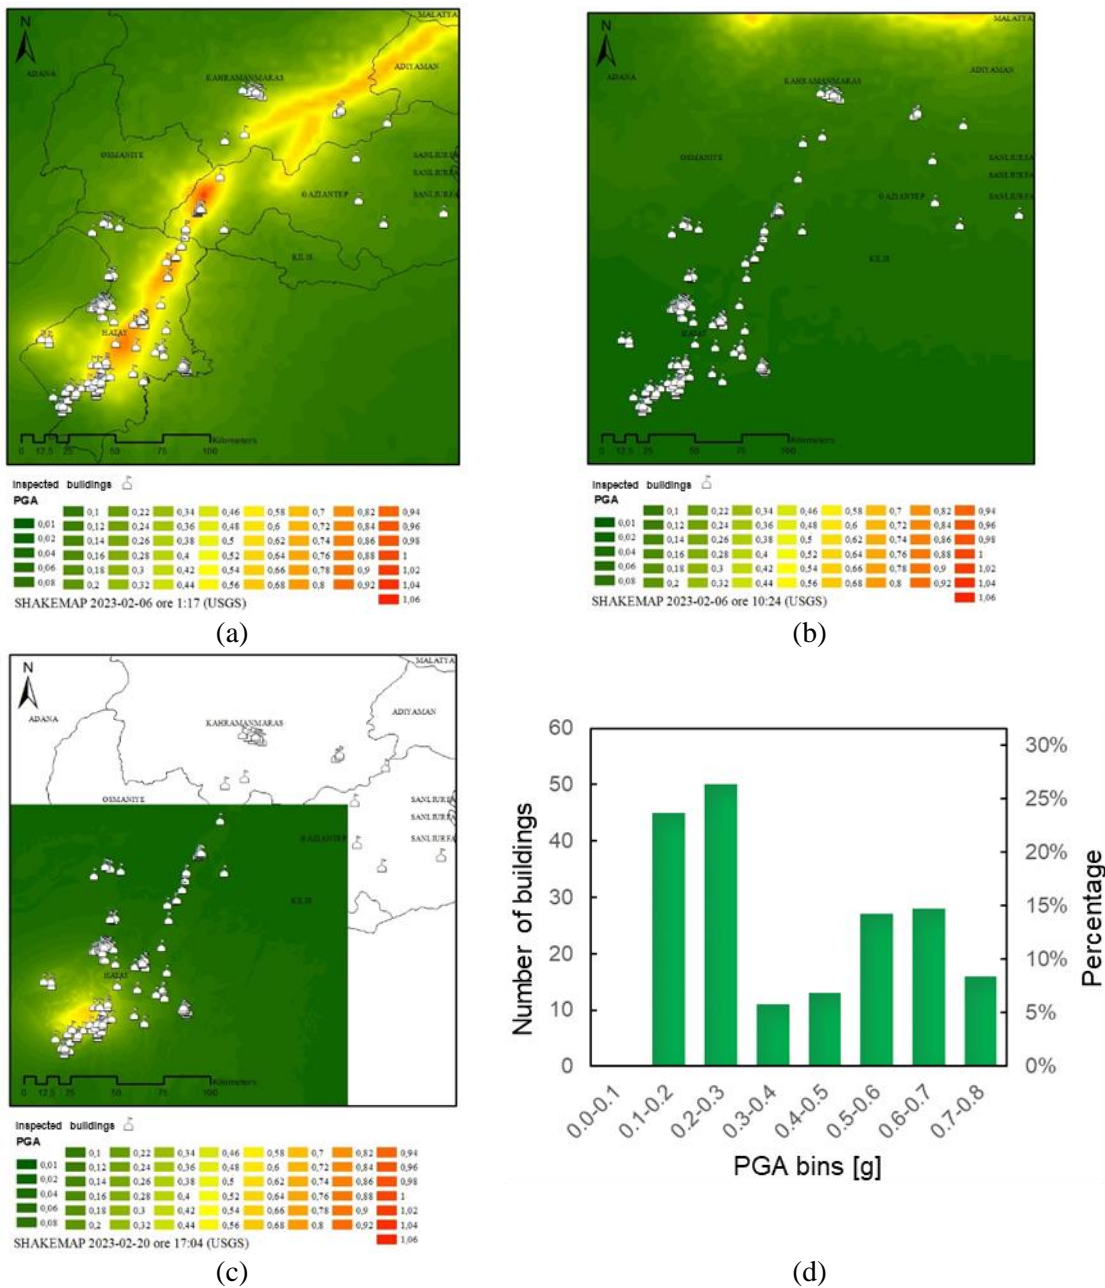
In Fig.1 shows the sample of buildings inspected on each day of the field mission and their positions. The positions are shown against the PGA shake maps published by the USGS, corresponding  $M_w$ 7.8 shock of February 6<sup>th</sup> 2023 at 01:17:34 (UTC) (Fig.1a), the  $M_w$ 7.5 shock of February 6<sup>th</sup> at 10:24:48 (Fig.1b) and the  $M_w$ 6.3 shock of February 20<sup>th</sup> at 17:04:29 (Fig.1c). Fig.1d shows the breakdown of the inspected buildings into eight 0.1g-wide PGA intervals, in terms of both number of buildings and percentage of the entire sample. This figure was plotted by assigning to each building the maximum PGA value that the site experienced among the three events cited above. It should be noted that, for the vast majority of the school buildings, the maximum PGA corresponds the February 6<sup>th</sup>  $M_w$ 7.8 shock, as clearly emerges from Fig. 1; the maximum PGA corresponds to the February 20<sup>th</sup>  $M_w$ 6.3 event in just 18 cases, while the  $M_w$ 7.5 event, despite its large magnitude, ruptured a portion of the fault to the north of Gaziantep, further away from the positions of the examined buildings than the other two events.

Fig.1d shows that around 50% of the buildings were subjected to PGA values, as estimated by the shake maps, falling within the 0.1g-0.3g interval, 13% in the 0.3g - 0.5g interval, and the remaining 37% experienced  $PGA > 0.5g$ .

Fig. 1 – Positions of the inspected school buildings plotted against the PGA shake map of the  $M_w$ 7.8 February 6<sup>th</sup> 2023 shock (a); the  $M_w$ 7.5 February 6<sup>th</sup> shock (b); the  $M_w$ 6.3 February 20<sup>th</sup> shock (c); number and percentage of buildings falling under each PGA interval (d).

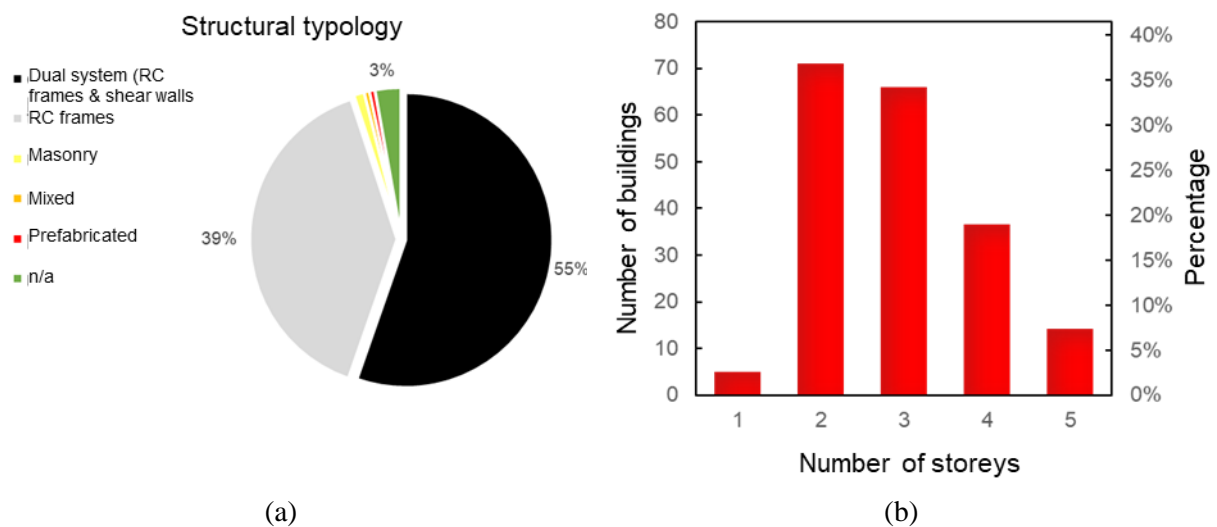
The pie-chart in Fig.2a provides the building percentage belonging to each structural typology, for the entire sample of inspected schools. The figure shows a prevalence of *dual systems*, that is RC structures with moment-resisting frames that incorporate shear walls (55%), while the percentage of buildings with just cast in-situ moment-resisting frames in both directions is 39%. Masonry, mixed masonry-RC and precast RC buildings constitute a measly 2% of the entire sample.

Regarding the number of above-ground storeys, it was possible to observe a clear preponderance of two- and three-storey buildings (constituting 37% e 34% of the sample, respectively). A significant portion of the examined buildings, 19% of the sample, exhibited four above-ground storeys.

Fig. 2 – Structural typology (a) and number of storeys (b) breakdown of the school buildings inspected.

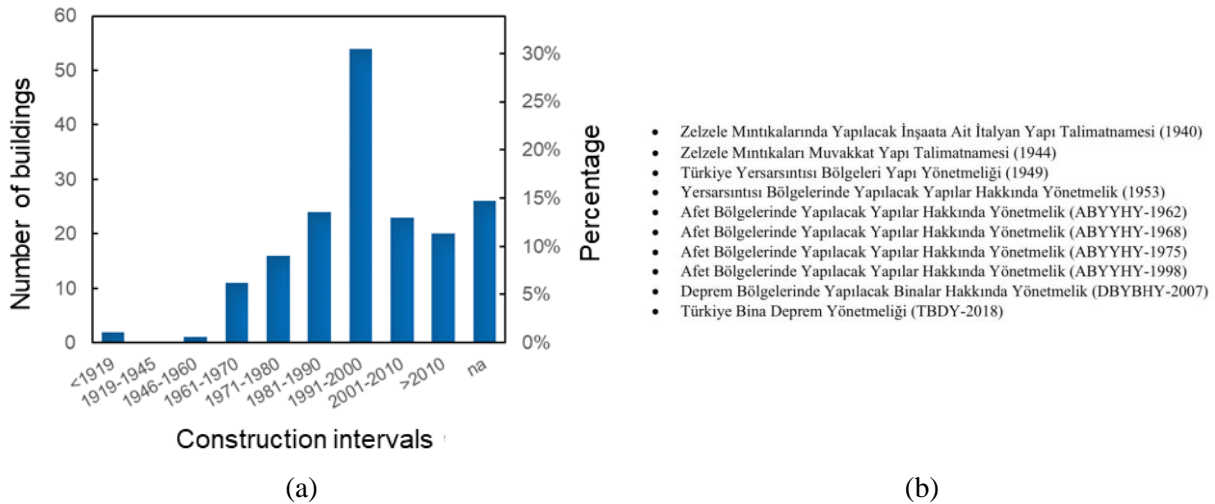
The building distribution in terms of construction period, shown in Fig. 3a, reveals that 31% of the buildings were erected prior to the 90's, 30% between 1991 and 2000, 24% post-2000, leaving a 15% for

which the construction year could not be ascertained. Comparing this against the temporal evolution of seismic design codes in Türkiye, which is shown in Fig. 3b, one can see that less than 20% of the buildings were designed according to the 2007 prescriptions and even fewer according to the latest update of the code, which came into effect in 2018.

Fig. 3 – Construction period (a) and temporal evolution of seismic design codes in Türkiye (b).

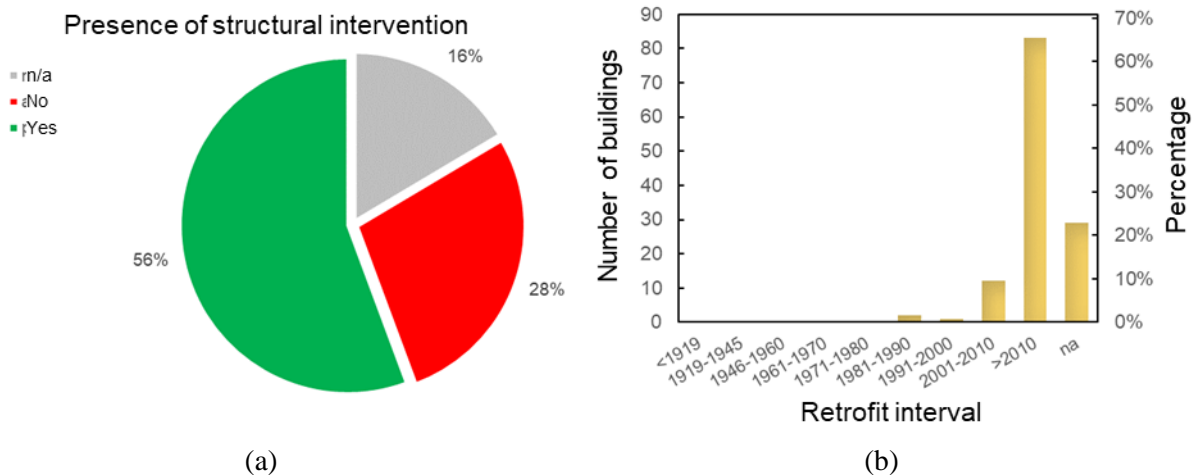
During the inspection visits, interaction with school personnel that welcomed the technical groups provided a trove of preliminary information concerning retrofit operations that had possibly taken place in the buildings. As a matter of fact, a large part of the buildings had been due for structural retrofit (and other installation upgrades), which, however, had not always been completed by the time of the earthquake. More specifically, Fig. 4 shows that such retrofit operations had been completed for 48% of the cases examined (Fig. 4a), and that the majority of these were relatively recent with 61% seeing completion after 2010 (Fig. 4b).

Fig. 4 – Presence of structural retrofit (a) and retrofit period (b) for the school buildings inspected.

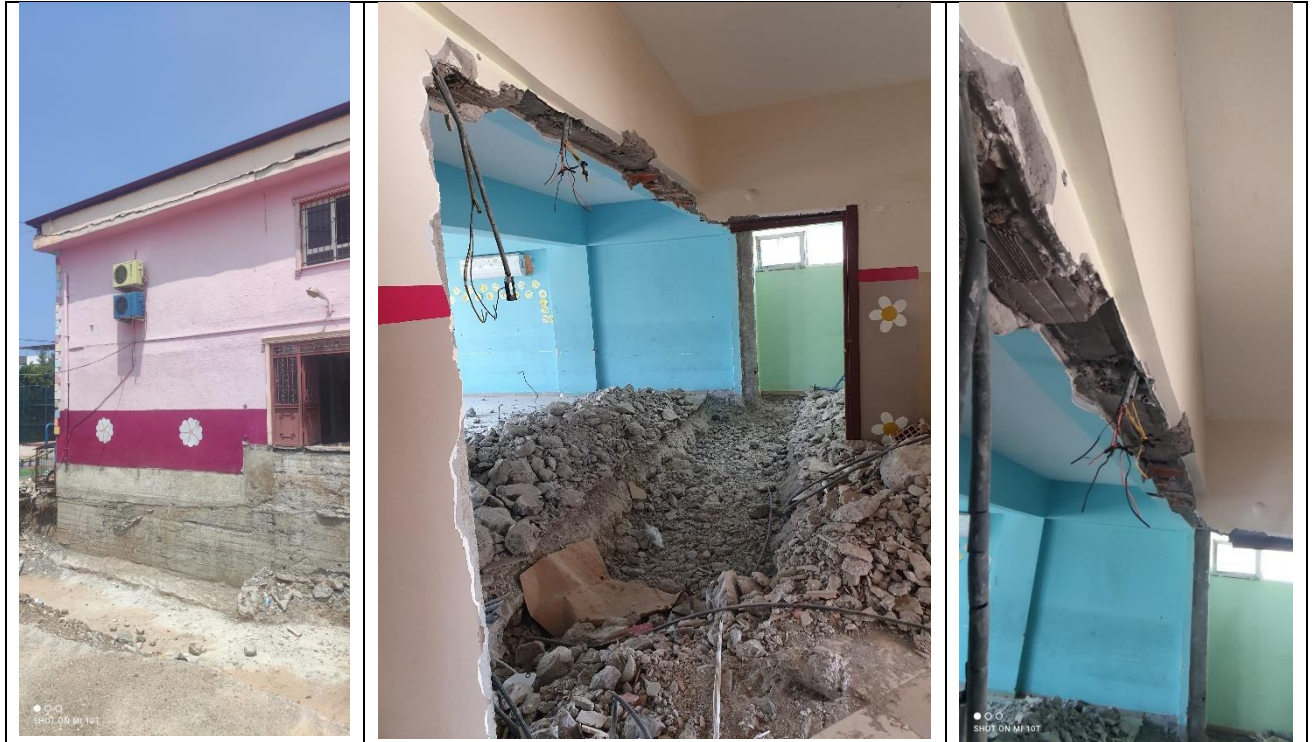
The data collected during the field mission revealed that the most ubiquitous type of seismic retrofit adopted had been incorporating additional RC shear walls within the existing lateral load-bearing system, usually oriented along both principal directions. These strengthening walls were installed by substituting masonry infill or partition walls with cast-in-situ concrete connected to the surrounding frame (Fig. 5 and Fig. 6).

Such retrofit measures, apparently require a consequent upgrade of the underlying foundation, in order for the increased seismic loads that the new shear walls will be called-upon to sustain. It was further observed that, in many cases, these retrofit operations were performed in parallel with the construction of a small building-block addendum, separated by the existing structure via expansion joint (Fig. 7). The role of this addition was to house an additional staircase, serving as an emergency fire escape.

Fig. 5 – Retrofit works, still in progress just before the seismic event hit: excavation to foundation level for the needed upgrade in bearing capacity (a), removal of masonry partition in preparation for the addition of an RC wall and its integration into the surrounding frame (b, c).

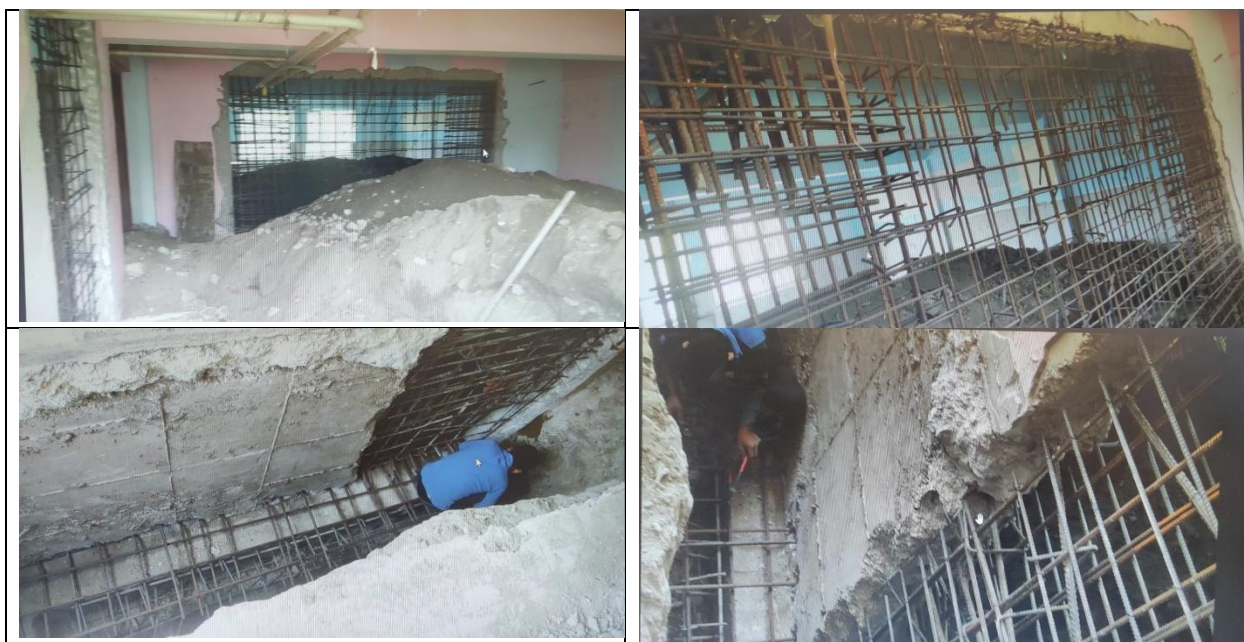
Fig. 6 – Archive photos, provided by the school administration, depicting construction phases during the insertion of the additional RC shear walls as part of the seismic retrofit: removal of infills and reinforcement detailing for the RC wall and its connection to the surrounding frame (a,b), excavation to foundation level in preparation for enlarging the footings (c), close-up of the old-new concrete interface and detailing of steel reinforcement (d).

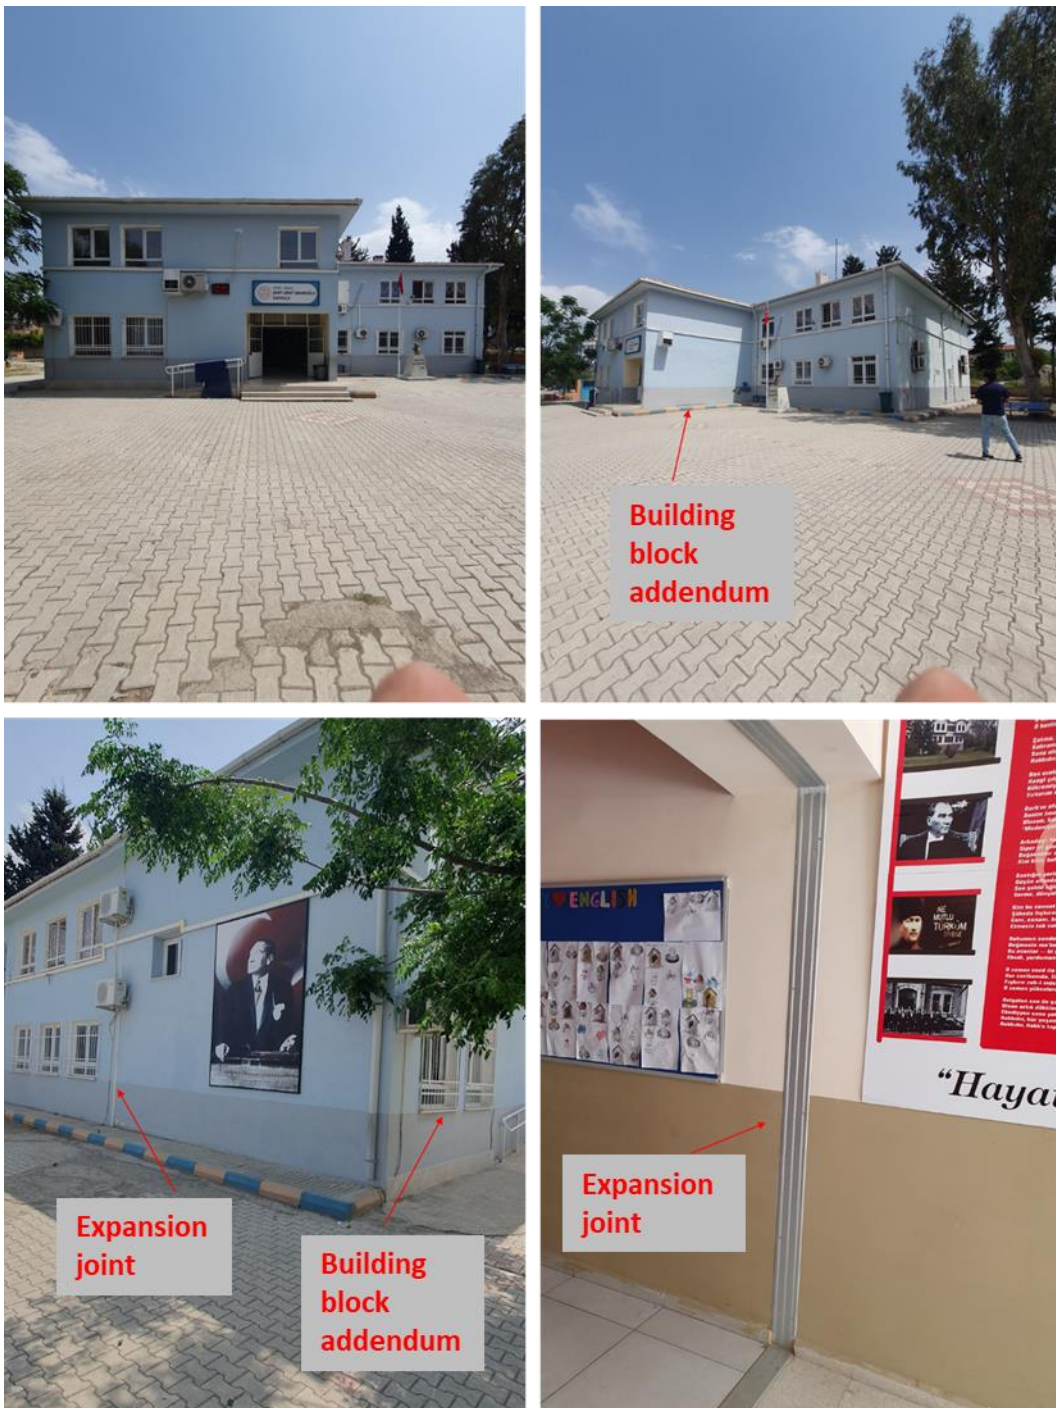
Fig. 7 – Photos that highlight the newly added building block next to the existing school structure (a, b, c) and location of expansion joint between new and existing structure (d).

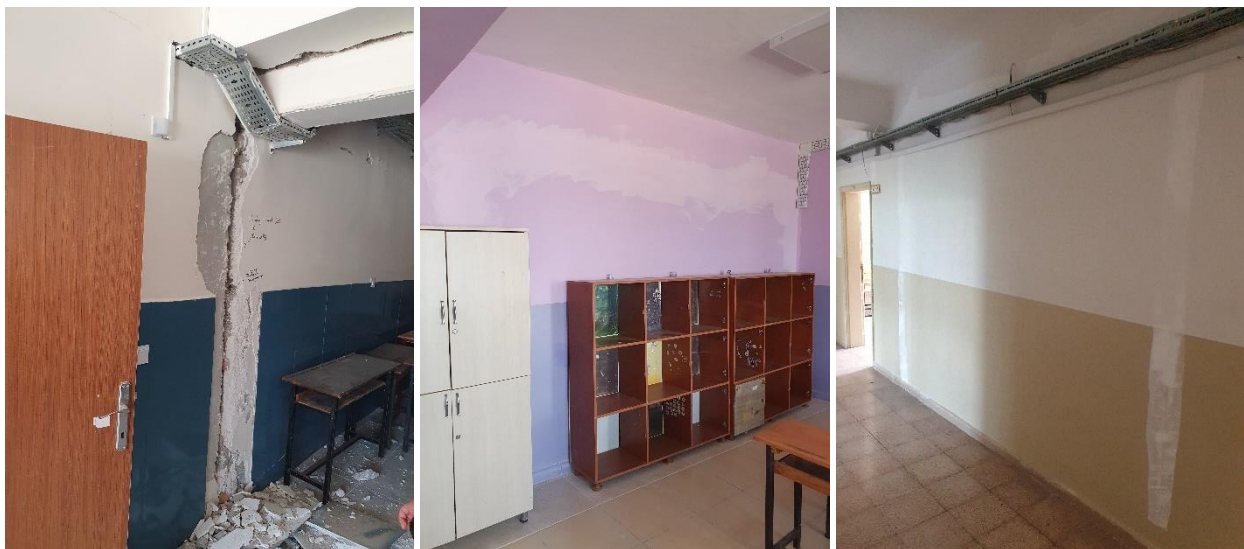
The buildings that had been seismically retrofitted, and were subjected to more detailed scrutiny, for the most part exhibited modest levels of global damage. In fact, visible damage in those cases was typically concentrated along the expansion joint between the existing structure and the new segment and was mainly due to pounding between the two (Fig. 8a). For the most part, the load-bearing structural elements in these buildings did not suffer significant damage, while there were often observed cracks running along the interface between retrofit wall and original RC frame (Fig. 8b,c), a possible testimony of non-optimal connection of the former to the latter.

Fig. 8 – Visible damage due to pounding between the different structural units across the expansion joint (a), and cracks along the interface between original RC frame and additional shear wall adopted as retrofit measure (b, c).
