Task 5.4 Interventi di miglioramento ed adeguamento di ponti esistenti Study of the mechanical behavior of half-joints in reinforced concrete bridges: from the assessment to the optimization of the strengthening techniques

Giuseppe Santarsiero, Valentina Picciano & Angelo Masi (Università degli Studi della Basilicata)

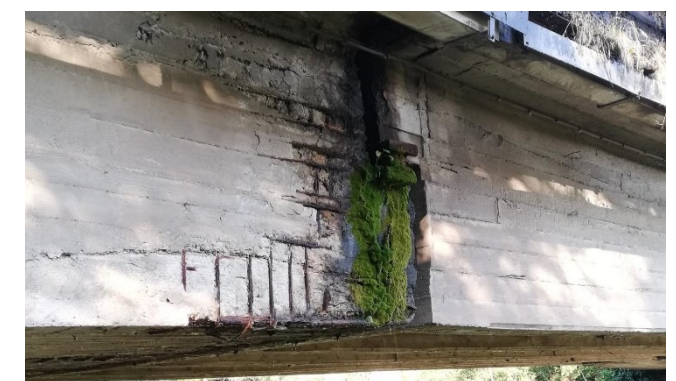
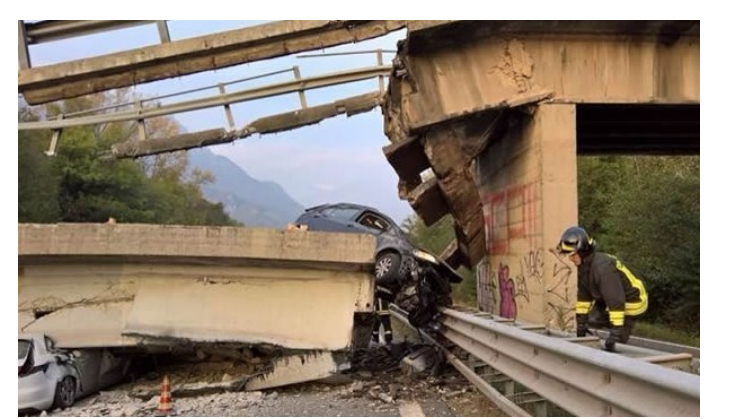
A frequent problem related to this kind of bridge is the malfunctioning of drains, which causes seepage across expansion joints. In particular environmental conditions, the presence of chloride ions may enhance the degradation phenomena leading to reinforcement corrosion and consequent cracking and spalling of concrete.

In the literature, there are cases of bridge collapses related to the half-joint failure. One is related to the Gerber bridge overpass in Annone Brianza (Italy), which collapsed in 2016 following the passage of a 108-ton truck. In that case, the deterioration of the half-joints and damage already present on the bridge coupled with some design and construction flaws were responsible for the collapse.

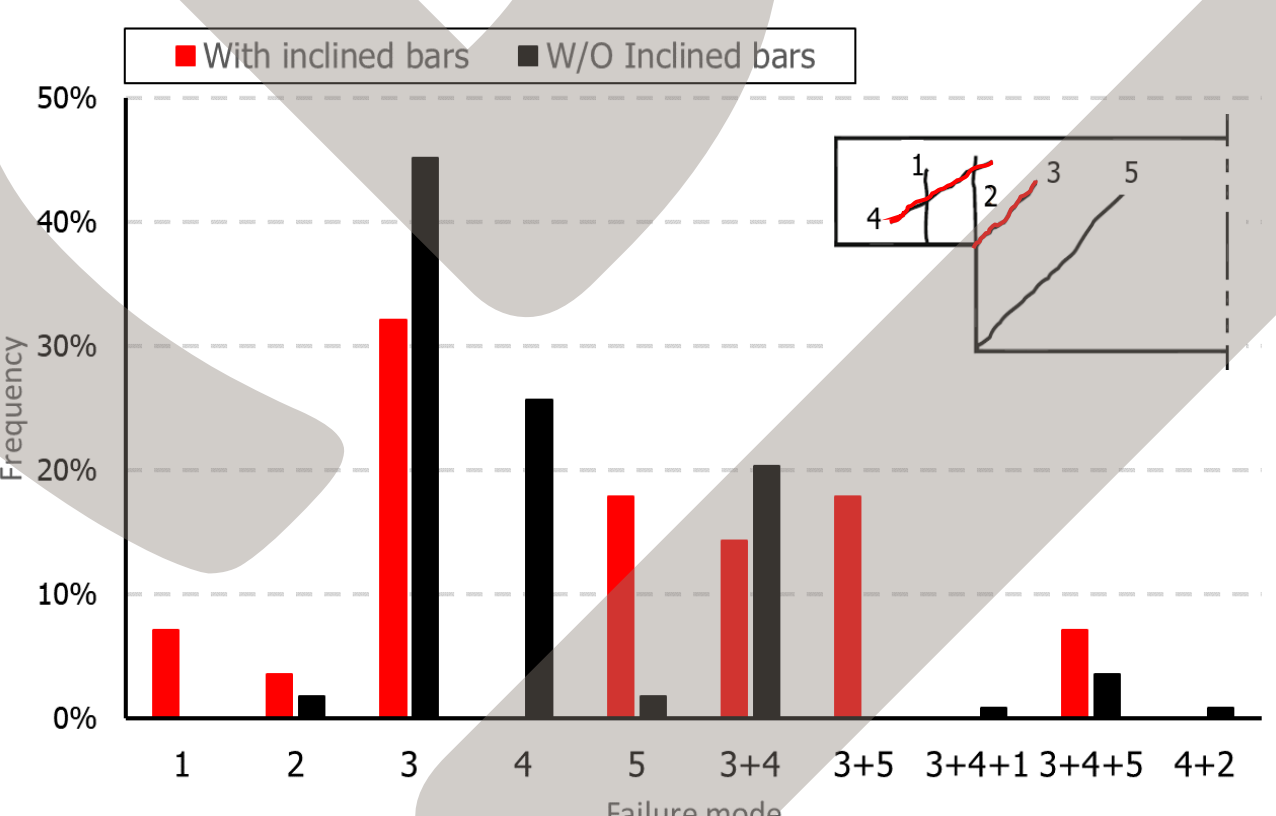
Regarding the ultimate behaviour, it is worth emphasizing that there can be different collapse modes depending on the adopted reinforcement layout. A review of experimental research on half-joints has been conducted, which allowed the collection of 210 experimental tests on dapped-end beams. Regarding the failure mode, it was possible to attribute the collapse to one of the five types indicated in the PCI Design Handbook (2010) or a combination of them.

In the presence of inclined rebars, the most frequent failure mode is associated with a combination of modes 3 and 4, while pure mode 4 is almost absent. In the absence of inclined reinforcements, the tested dapped-ends mostly failed through modes 3 and 4 or a combination of them. Therefore, the presence of inclined reinforcements seems to prevent failure mode 4 related to shear stresses in the nib.

Due to their geometry, half-joints represent a discontinuity zone from the perspective of stress distribution. Moreover, regarding the construction detail, the arrangement of reinforcements necessary for external load absorption can vary. The most commonly used reinforcement layouts are two: the first is mainly related to building structures, where only vertical and horizontal rebars are used, and the second also involves the presence of inclined reinforcements, which are widely used within the Gerber saddles of existing bridges.

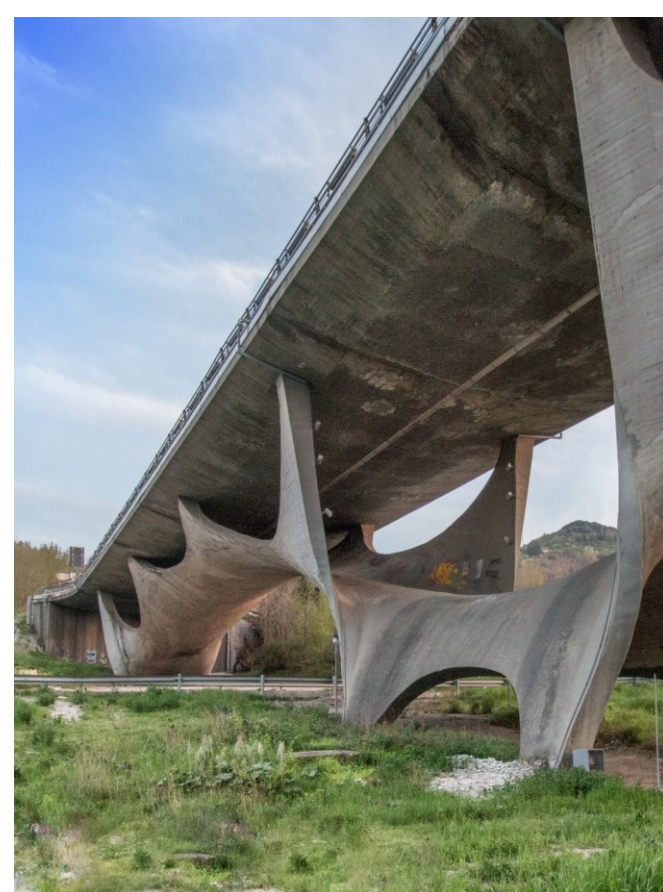
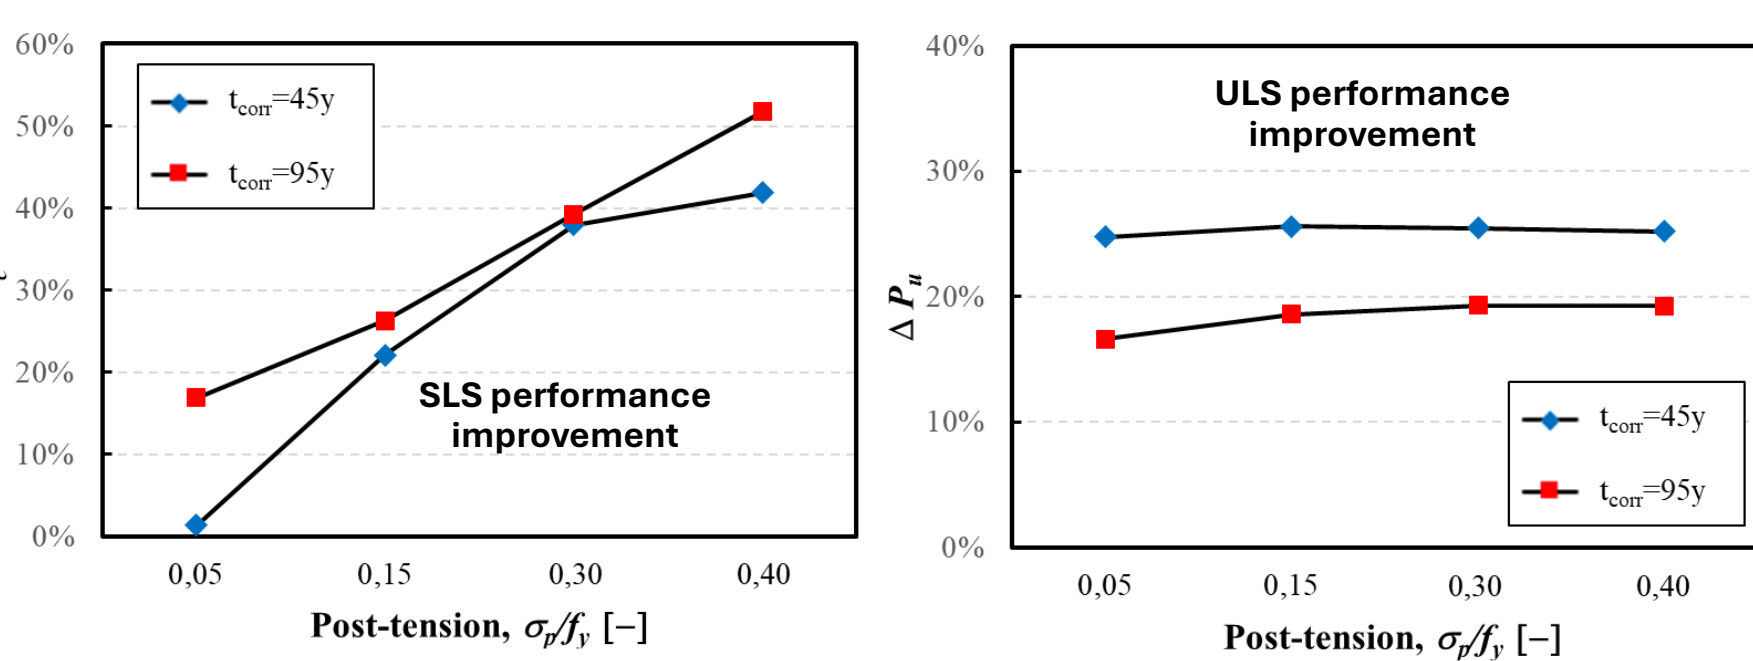
Further numerical analyses were conducted to assess the effectiveness of the intervention technique by simultaneously simulating degradation conditions caused by reinforcement corrosion induced by the presence of chlorides resulting from the use of de-icing salts. In this case, a representative model of one of the half-joints within the deck of the Musmeci Bridge located in Potenza was developed. In this particular bridge, the deck is supported by a double-curvature RC vault designed through a form-finding study devoted to optimising the stress flow and exploiting the concrete ability to support compression stress fields. In addition to considering degradation conditions for different periods, the presence of inclined reinforcements was also accounted for as an additional analysis parameter. In fact, the half-joints of the Musmeci Bridge were designed using inclined reinforcements, whereas in previous cases, the tested specimens were provided with only orthogonal bars. The results of these analyses showed that the intervention is most effective when implemented after 45 years of corrosion development, not only restoring the joint's load-bearing capacity to the as-built condition but also increasing it. Conversely, if the intervention is applied following 95 years of degradation, only the share of strength lost due to corrosion is recovered. Moreover, when the intervention is applied to half-joints designed with diagonal reinforcements, the increase in load-bearing capacity is lower under similar conditions compared to cases without them.
