Engineering Reconnaissance of the 24 August 2016 Central Italy Earthquake. Version 2

Geotechnical Extreme Events Reconnaissance Association

Report No. GEER-050

22 November 2016

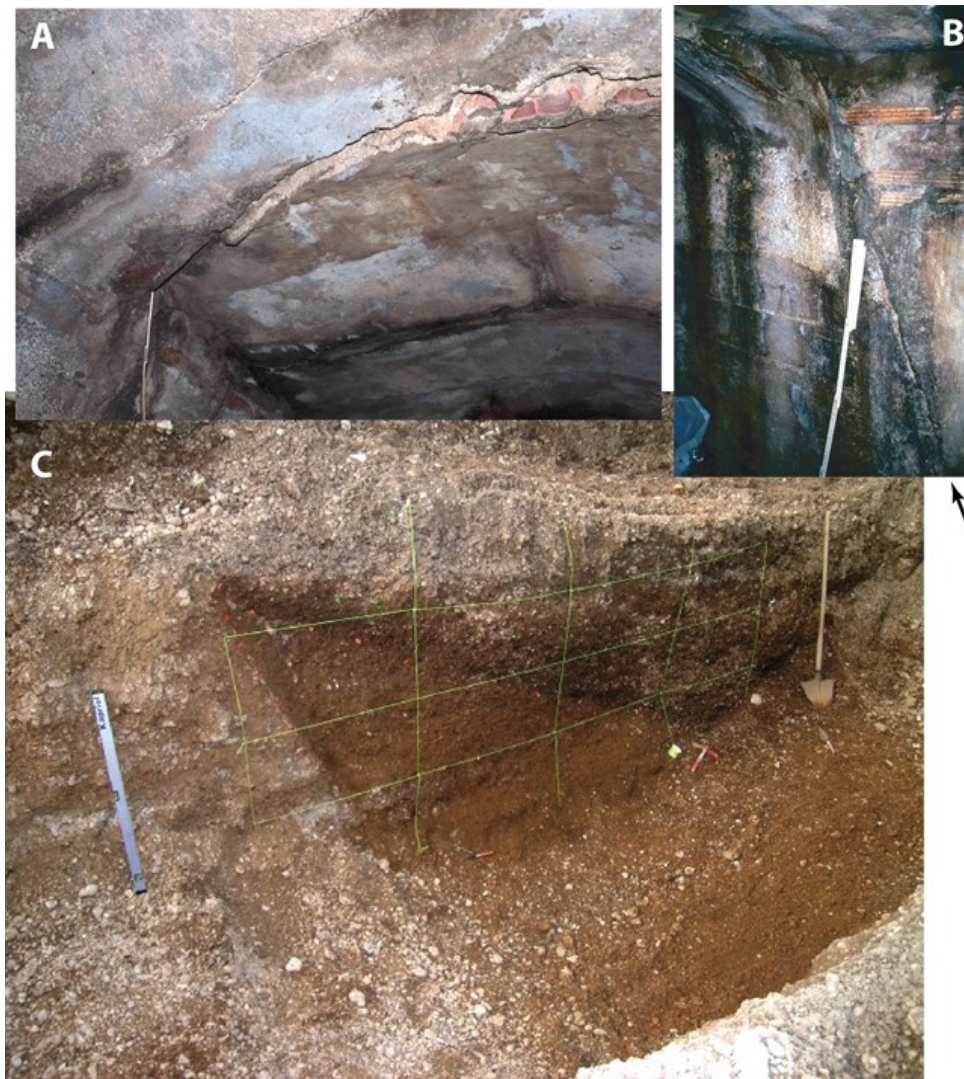
Recent displacements have also been related to minor fault sections within Norcia (Galli et al., 2005) (Figure 2.5). Paleoseismological investigations identified slip from the 1703 (14 January) earthquake and events between 6th-5th century BC and 3rd-1st BC (99 BC?). As a result, the recurrence interval for large **M** events can be estimated as 1,700-1,900 years (Galli et al., 2005).

Figure 2.5. Norcia fault: emergence of active fault splays in the settled area of Norcia: a, b) vault and walls of a cellar displaced by a fault which activated during the earthquake of 1979; c) panoramic view of the trenches excavated by Galli et al. (2005) in the suburbs of Norcia: the fault places Middle Pleistocene alluvial gravels in contact with colluvial units ranging in age from the Upper Pleistocene (i.e. the lowermost unit with the orange matrix in the hanging wall) to the 18th century AD.

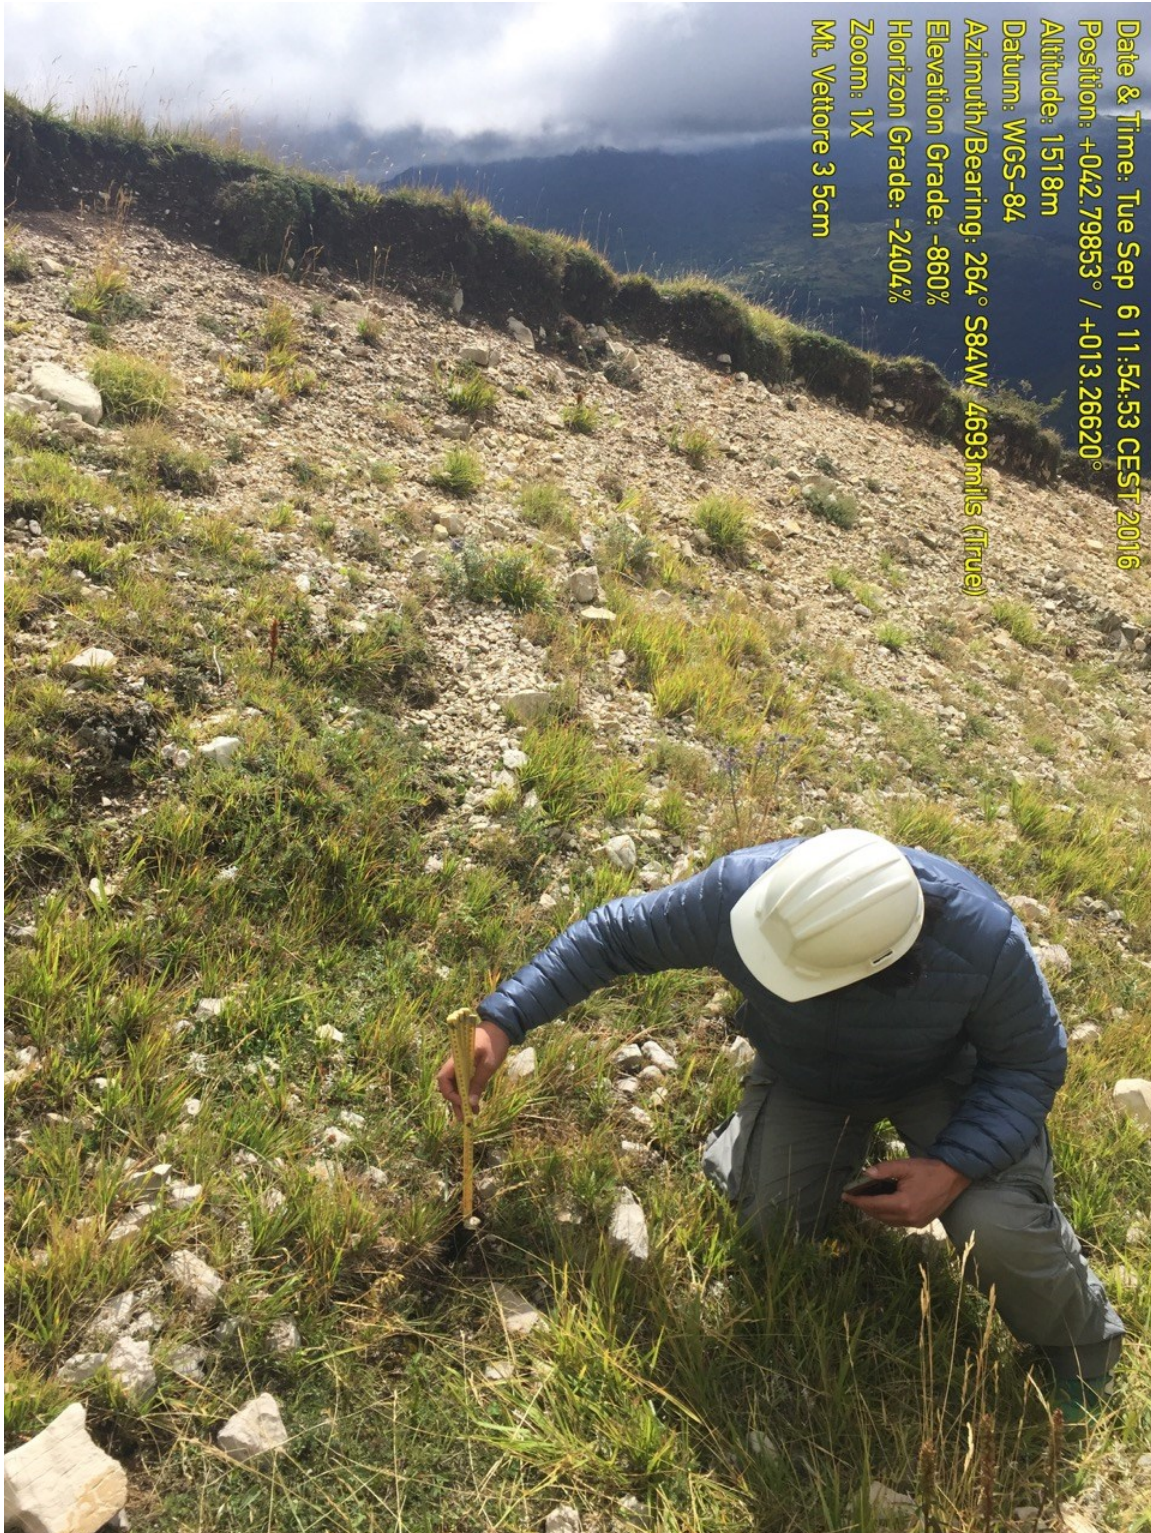
Figure 2.19e. Mt. Vettore fault Site 3 at a WGS84 ellipsoid elevation of 1518 m. The normal fault displacement at this site was 5 cm down toward the west (Latitude and Longitude are annotated on the image).

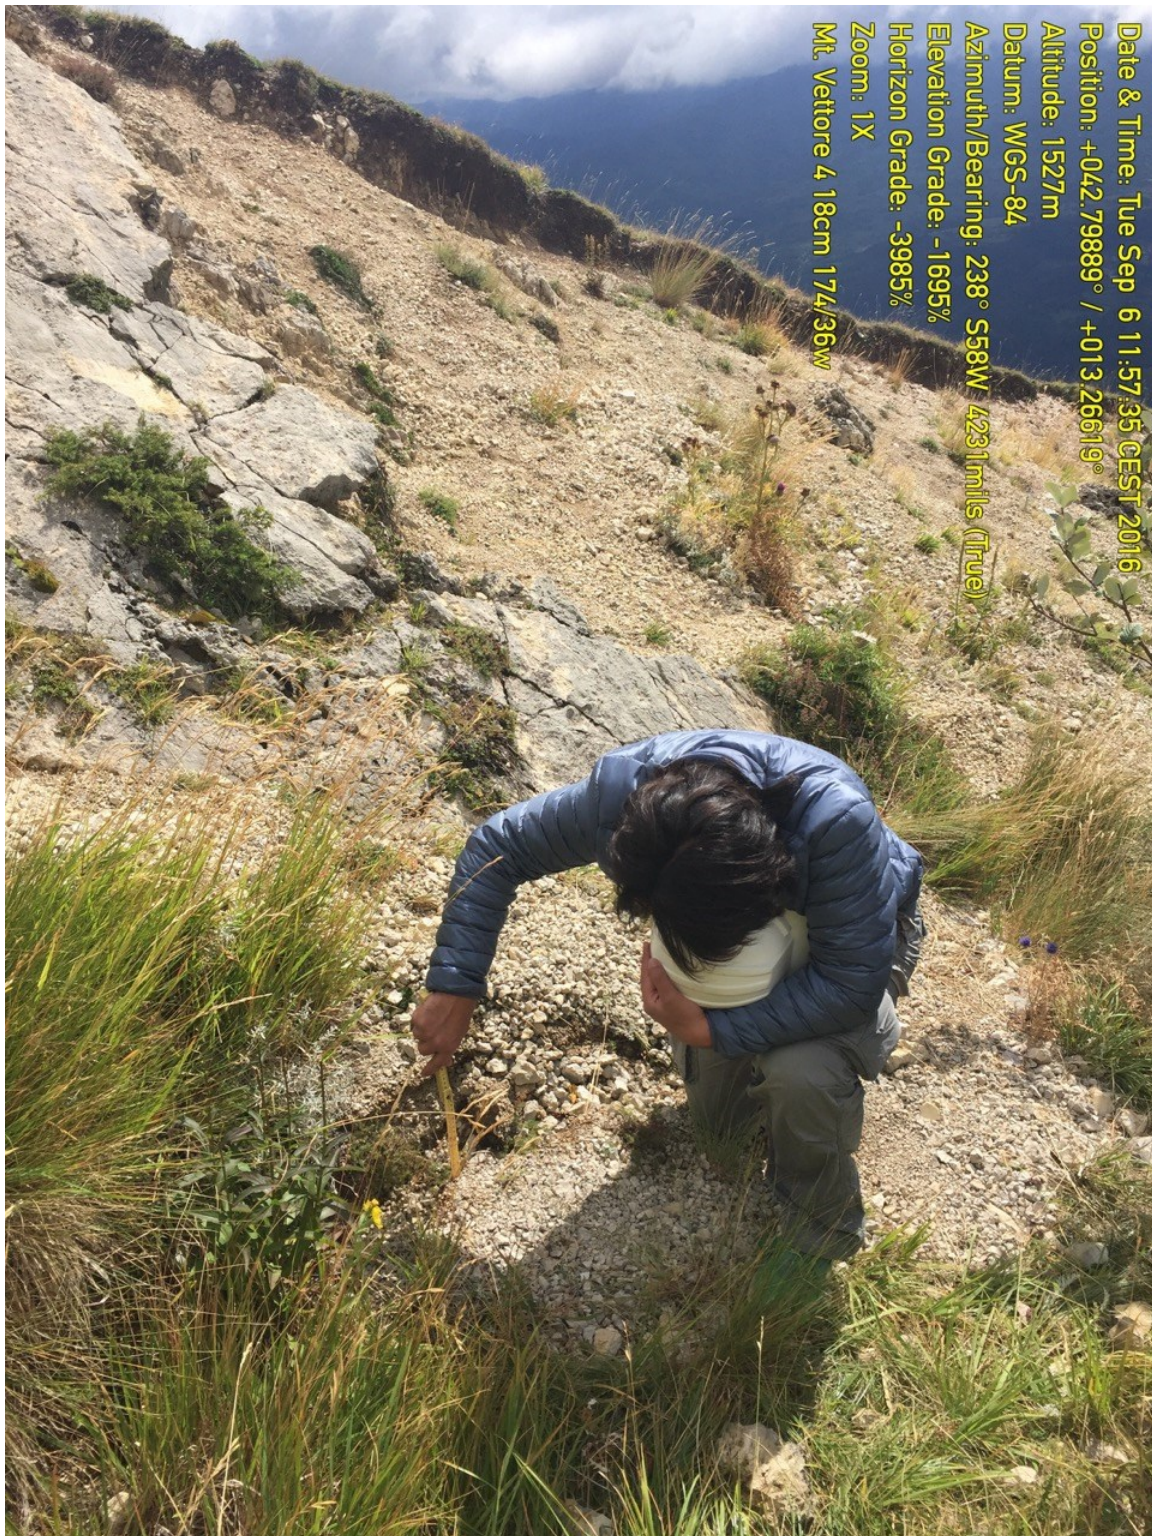
Figure 2.19f. Mt. Vettore fault Site 4 at a WGS84 ellipsoid elevation of 1527 m. The normal fault displacement at this site was 18 cm down toward the west, with a strike was 174° and dip of 36° west (Latitude and Longitude are annotated on the image).

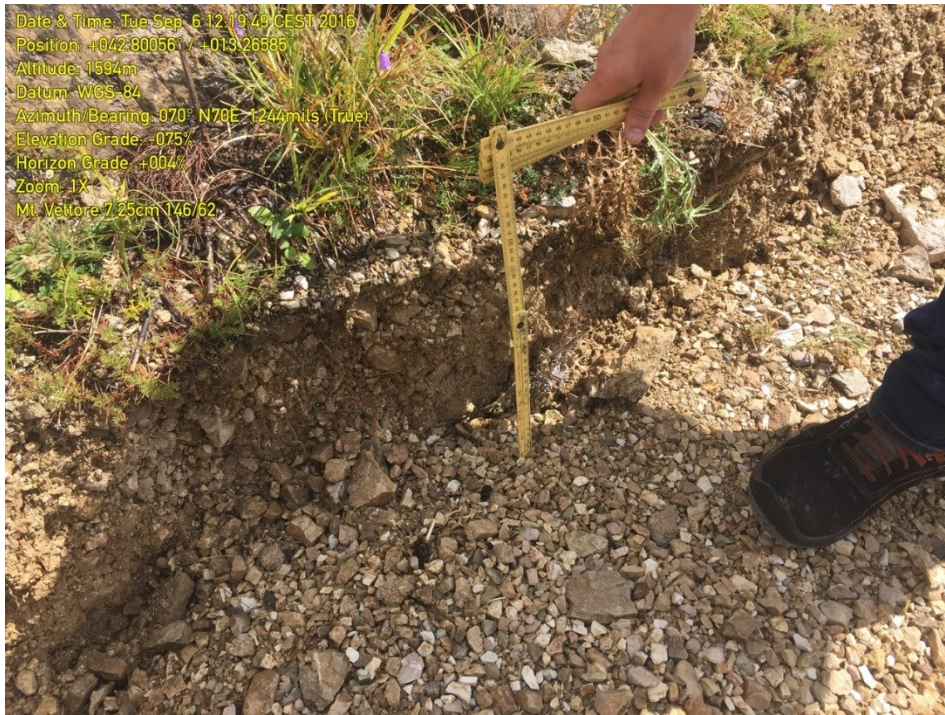
Figure 2.19i. Mt. Vettore fault Site 7 at a WGS84 ellipsoid elevation of 1594 m. The normal fault displacement at this site was 25 cm down toward the west. (Latitude and Longitude are annotated on the image).

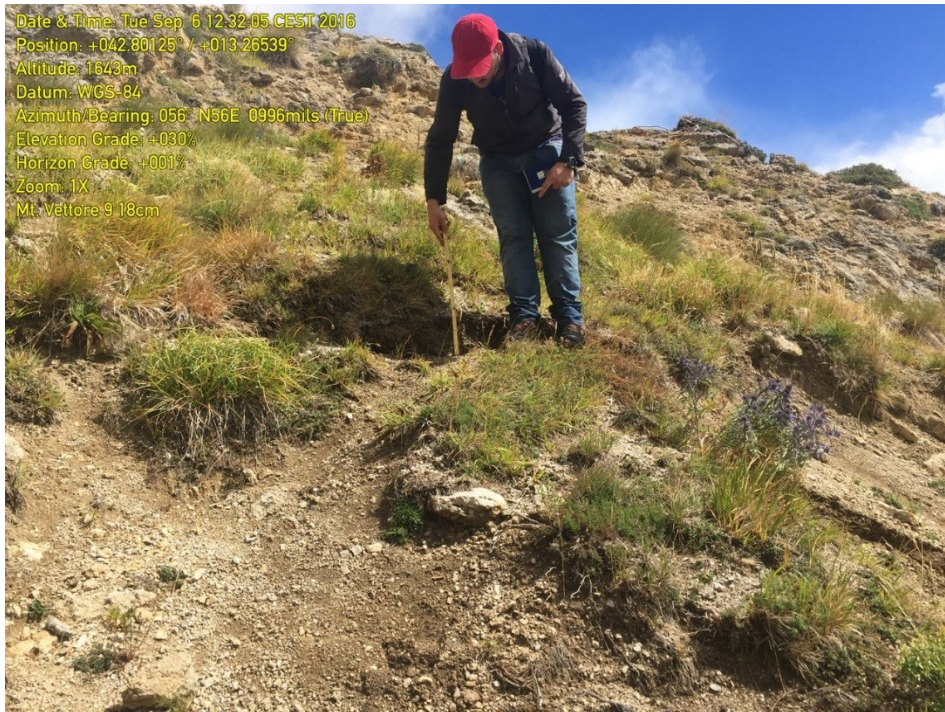
Figure 2.19l. Mt. Vettore fault Site 9 at a WGS84 ellipsoid elevation of 1643 m. The normal fault displacement at this site was 18 cm down toward the west (Latitude and Longitude are annotated on the image).

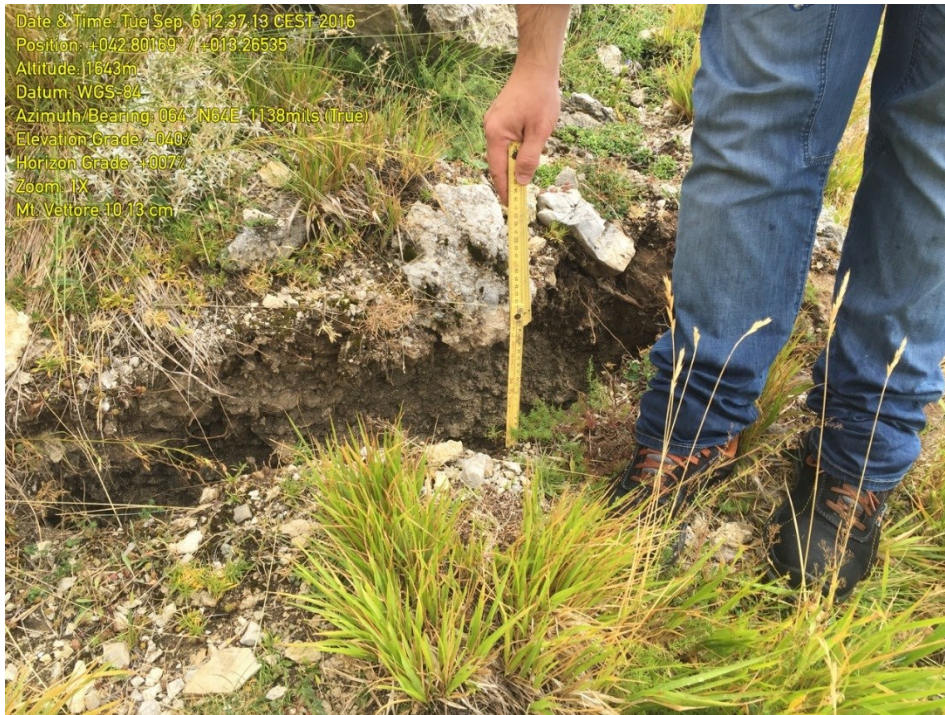
Figure 2.19m. Mt. Vettore fault Site 10 at a WGS84 ellipsoid elevation of 1643m.ch2. The normal fault displacement at this site was 13 cm down toward the west (Latitude and Longitude are annotated on the image).

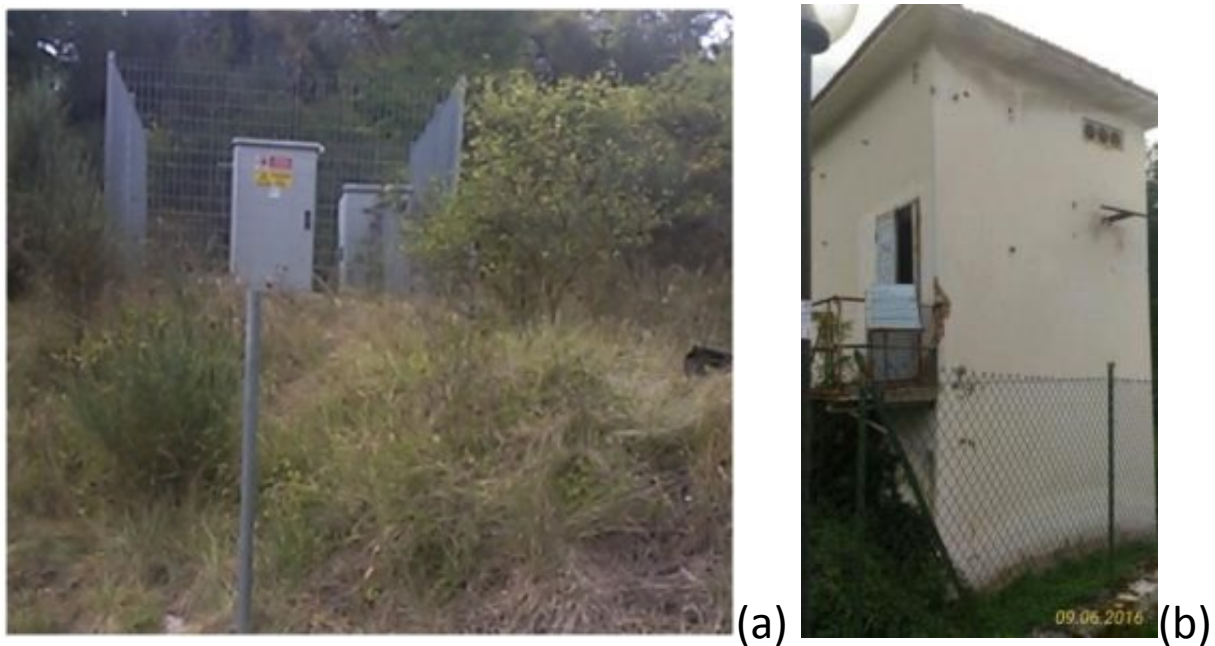
The GEER team inspected two recording station sites: (1) AMT in the town of Amatrice (Figure 3.2a; Lat: 42.632460 – Long: 13.286176), and (2) NRC in the town of Norcia (Figure 3.2b; Lat: 42.792543 – Long: 13.096475). Both stations are part of the RAN network, owned and operated by the Italian department of civil protection. AMT is a free-field station with a digital sensor protected by a fiberglass box, while the accelerometers at NRT are installed inside an ENEL electric transformer cabin. The AMT and NRC stations recorded the highest acceleration values during the M6.1 mainshock (0.43g and 0.36g, respectively) but the level of damage in Amatrice and Norcia was quite different as discussed in Chapter 5. As shown in Figure 3.2, we did not find ground failure features or earthquake-induced damage traces at these locations.

Figure 3.2. (a) AMT station; (b) NRC station.

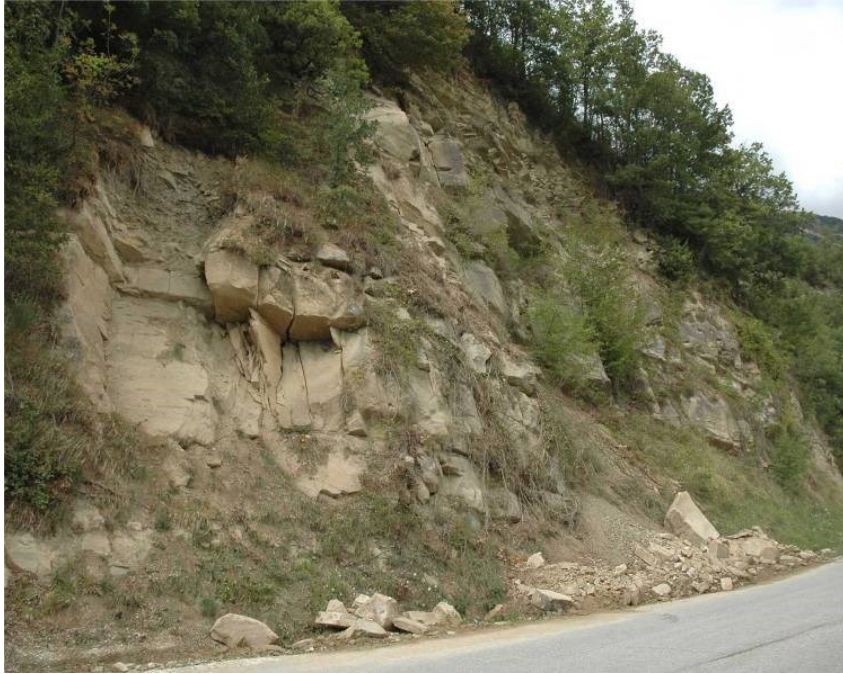
In the Central Italy event, strong ground motions triggered larger rock failures only where the flysch was regularly fractured and/or block interlocking was insufficient to keep the rocks in place due to relatively low confining stresses. Observed failures in the flysch most commonly occurred along highway cut slopes. Different mechanisms of rock failure were detected both by GEER and CERl investigators: detachment of sandstone slabs overlying marl layers (Figure 4.5), wedge sliding (Figure 4.6), or planar sliding along bedding joints and toppling.

Figure 4.6. Free-face wedge sliding that is governed by bedding joint attitude.

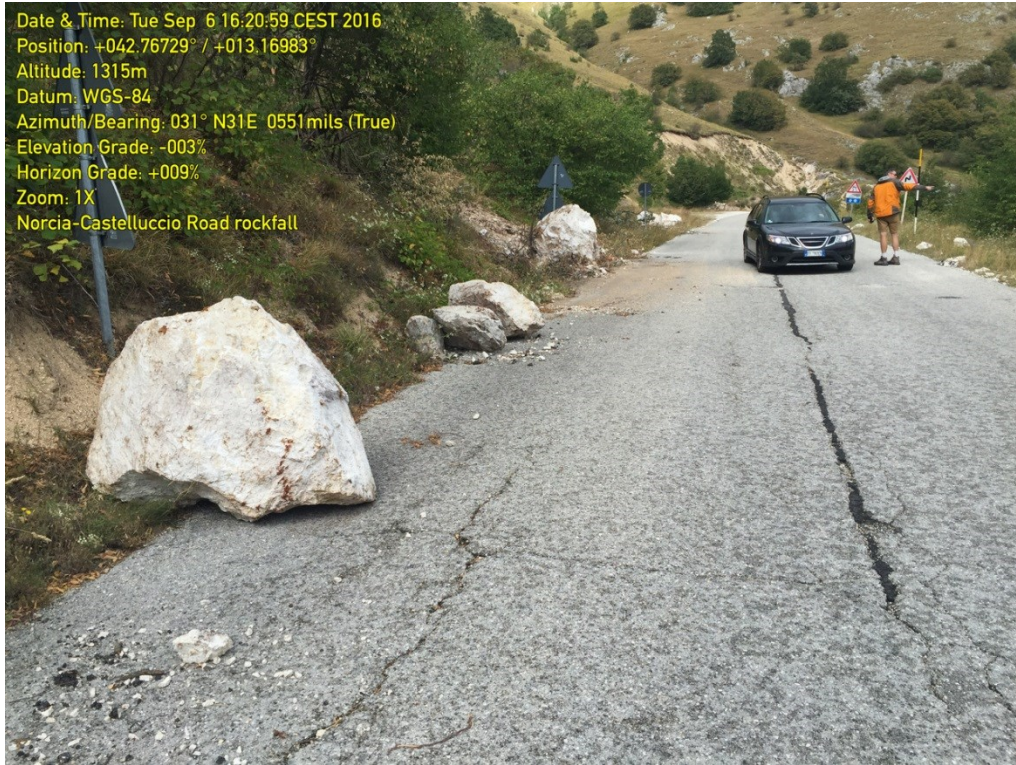
Figure 4.18. Example of rock fall below the Plano Grande on SP477. Blocks as large as 3 to 4 m across came to rest on the flat roadbed below a prominent outcrop of limestone (42.76729 N 13.16983 E).

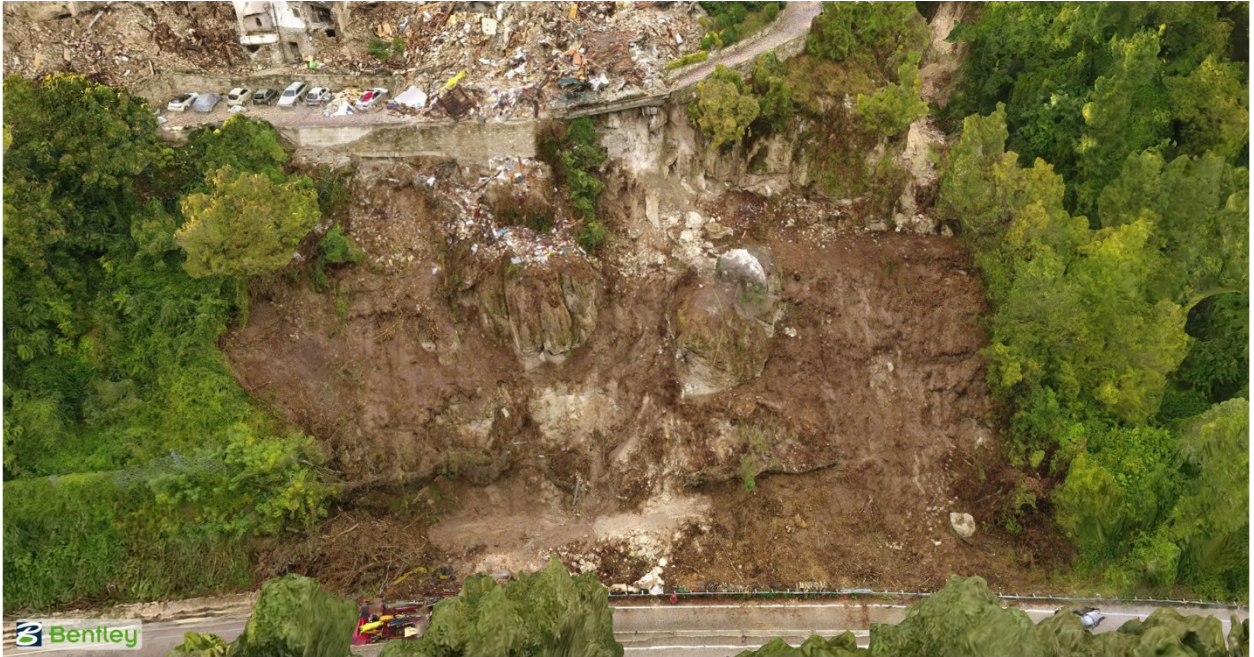
Investigation of the 3D model of Pescara del Tronto revealed numerous shallow earthquake-induced landslides and retaining wall failures. These landslide locations are summarized on a site vicinity map presented in Figure 4.24. The largest landslide occurred on the east slope below the city (42.75057 N 13.27223 E), directly above Highway SS4 (marked as #1 in Figure 4.24). A modeled image of this landslide is presented in Figure 4.25. At the time of the GEER reconnaissance, this landslide was approximately 75 meters wide by 30 meters high. The landslide itself was quite shallow, with only the upper meter or less of soil sliding downslope. The slope bedrock is formed by the flysch bedrock overlain by a layer of fluvio-lacustrine sediments and a slightly-to-moderately cemented travertine deposit. The landslide damaged and/or undercut retaining wall structures surrounding the city, leaving portions of the overlying city dangerously susceptible to collapse (Figure 4.26). Two large tilted travertine blocks remained exposed along the side slope (Figure 4.27), and it was not immediately clear whether those blocks were stable. Although there was no debris visible along Highway SS4 at the time of the GEER team visit, the road surface was discolored below the landslide, suggesting that the landslide most likely ran out onto the road and obstructed it until cleanup crews could remove the debris. An orthophoto of the landslide developed in *Pix4D* is presented in Figure 4.28.

Figure 4.25. 3D model image of the large landslide below Pescara del Tronto (42.75057 N 13.27223 E).

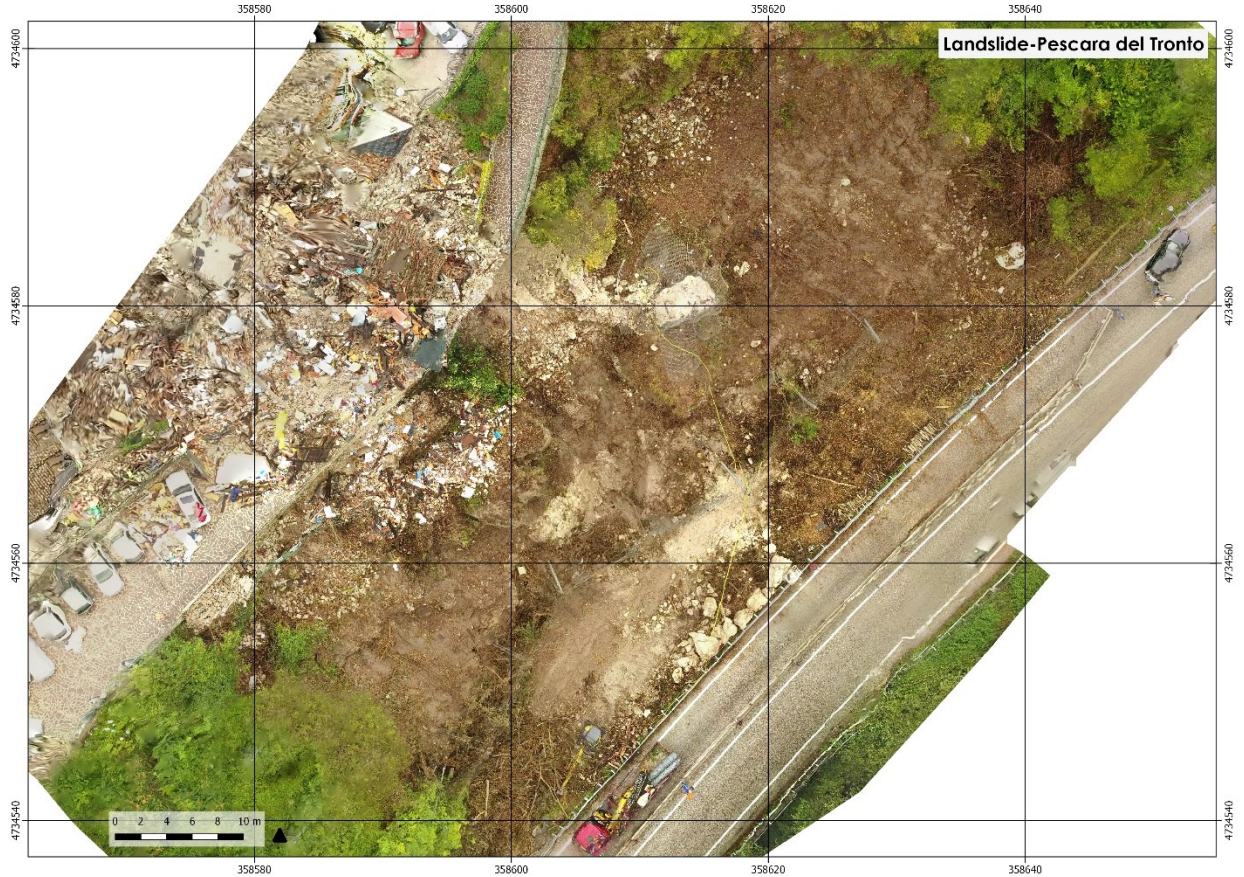
Figure 4.28. Orthophoto of the large landslide below Pescara del Tronto (42.75057 N 13.27223 E)

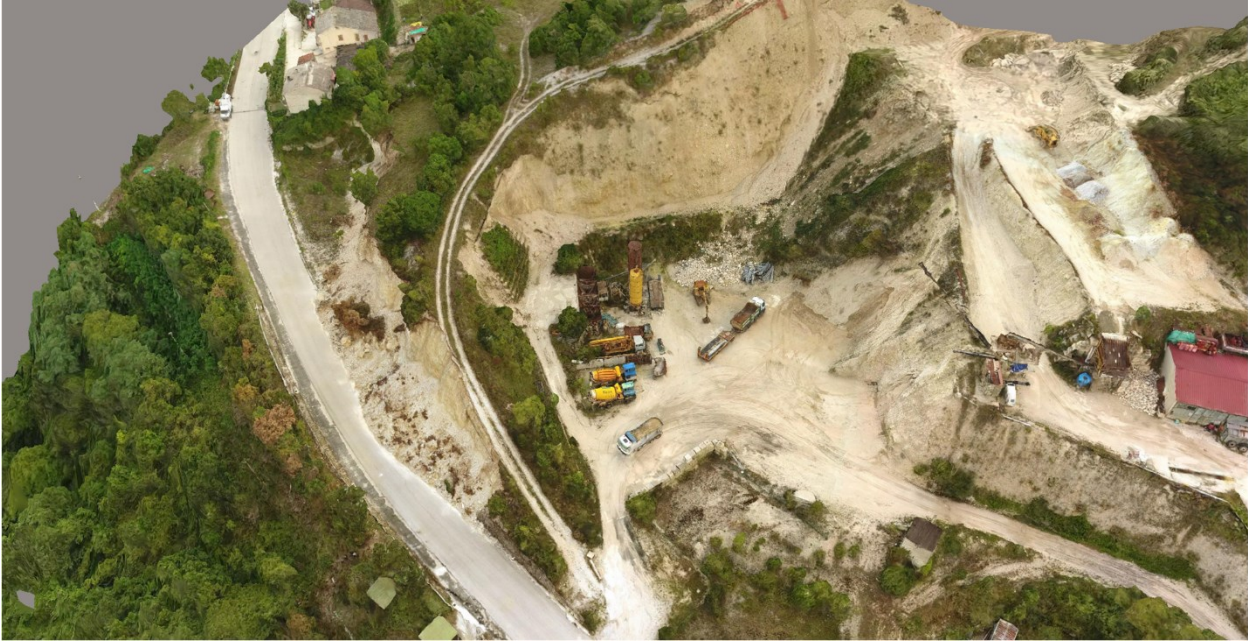
Another set of interesting landslide features in Pescara del Tronto is located near the gravel pit on the southern upper portion of the town (marked as #7 in Figure 4.24; 42.74985 N 13.26893 E). An overview image of the gravel pit taken from the UAV-based 3D model is presented in Figure 4.35. The gravel pit is approximately 70 meters by 90 meters, and has 2.4V:1H side slopes comprised of slightly cemented cartaclasized limestone blocks interspersed in a gravelly-sandy matrix comprised of angular limestone clasts. A dirt haul road traveling up and along the edge of the slope is located on the south side of the gravel pit. At the time of the GEER reconnaissance, a significant amount of debris was observed on Road SP129, which passes directly adjacent to the gravel pit on the east and south. A landslide had obviously occurred, and had exposed about 15 meters of a 50 cm-diameter pipeline that was shallowly buried beneath the dirt haul road (Figure 4.36). Comparisons with Google Street View images from May 2011 showed that the pipeline had not been exposed prior to the earthquake, as shown in Figure 4.37. Also shown in Figure 4.37 is a tree that appears to have moved 9.3 meters downslope (circled in yellow). On the other side of the slope (inside the gravel pit), a portion of another pipe (...possibly the same pipe) was visible in the Google Street View images in May 2011, but the 3D model suggests that an additional 10 meters of pipeline became exposed from landslides inside the gravel pit following the August 24 earthquake (Figure 4.38). A final view of both exposed pipelines and the failed slopes is presented in Figure 4.39. From this image,

sections of the slope up to 5 meters wide broke loose and slid downslope due to the earthquake.

Figure 4.35. Overview model image of the gravel pit in Pescara del Tronto (42.74985 N 13.26893 E).

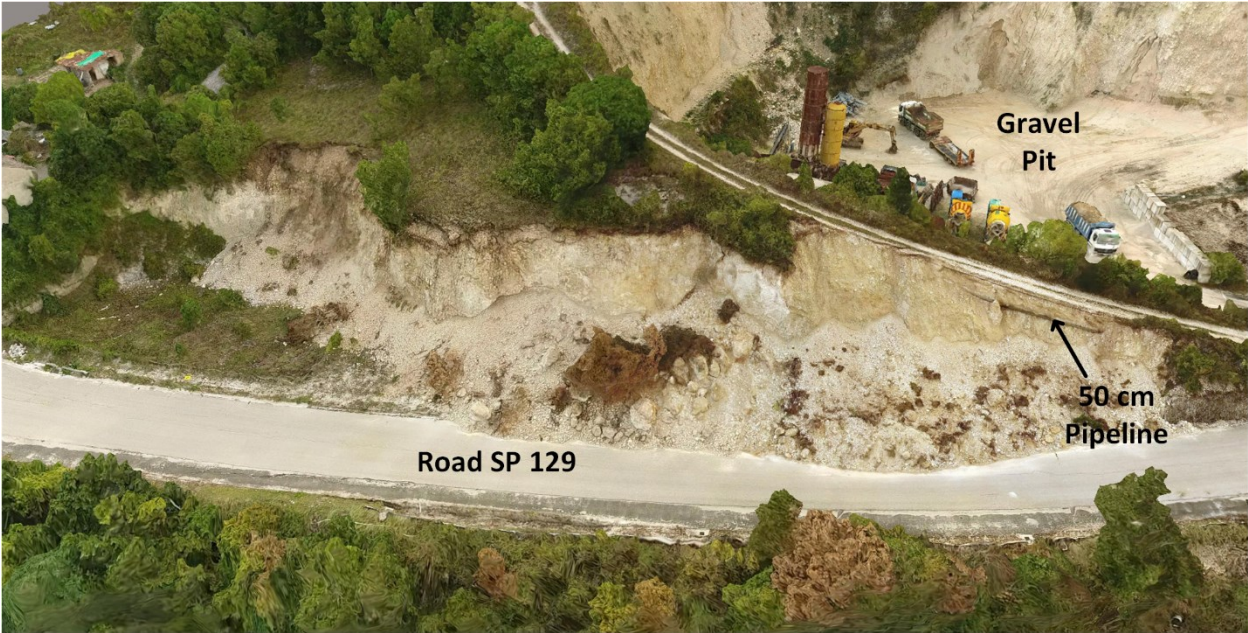
Figure 4.36. Model image of landslide near gravel pit and Road SP 129 that exposed a 50 cm-diameter pipeline (42.74950 N 13.26958 E).

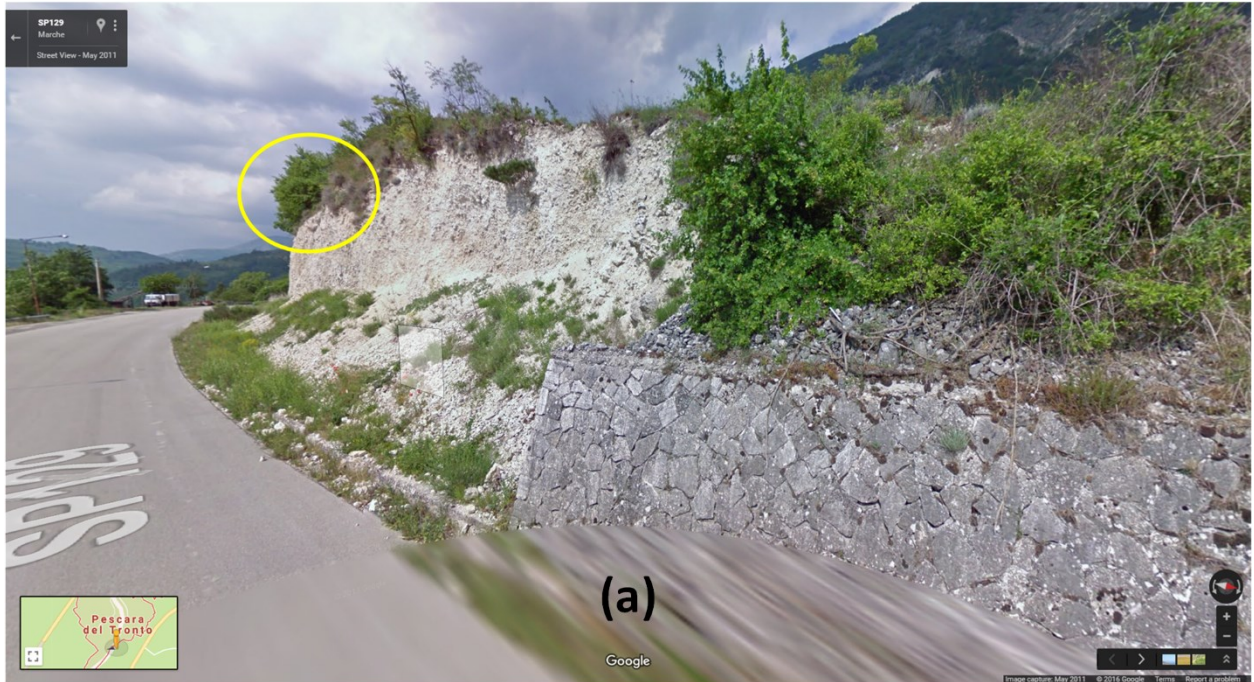
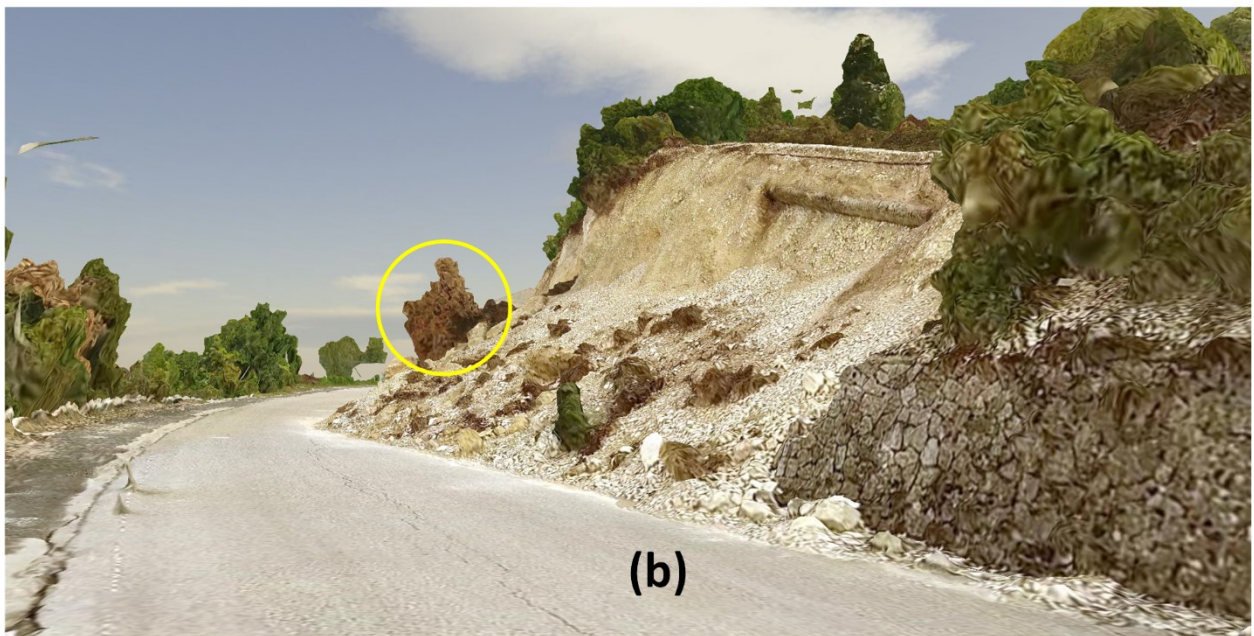
Figure 4.37. Both pre-earthquake (a) and post-earthquake (b) images of the slope near the gravel pit where a landslide exposed a pipeline. Pre-earthquake imagery courtesy of Google.

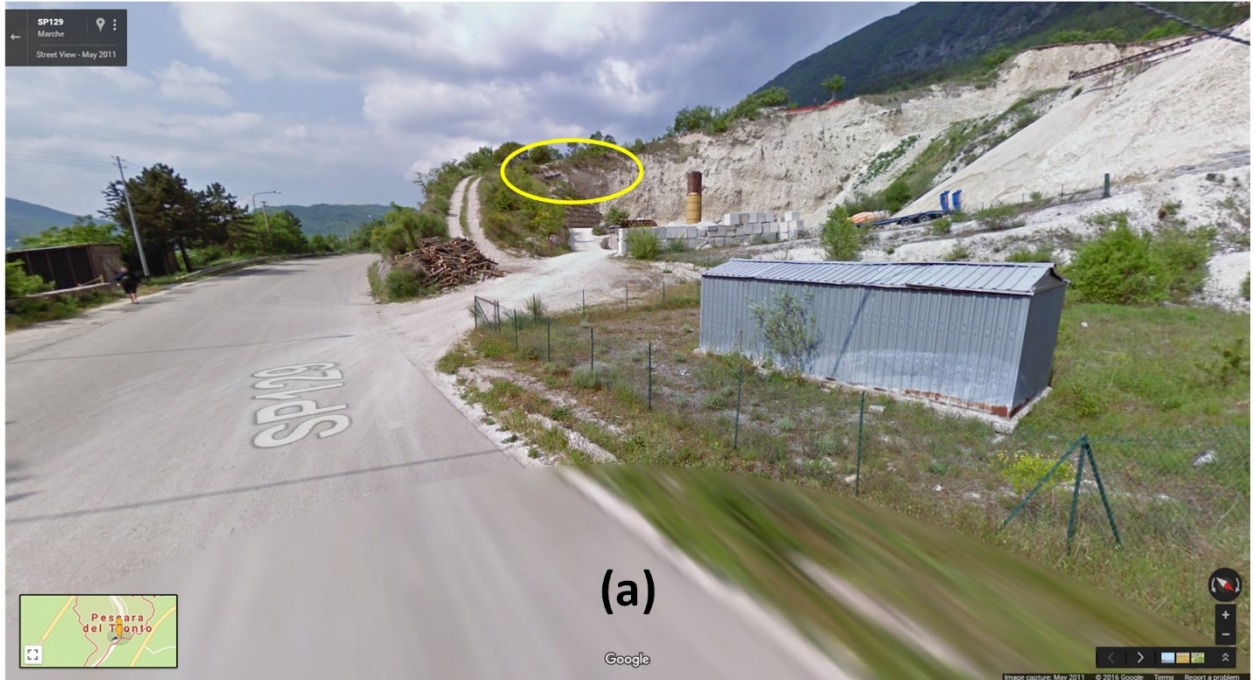
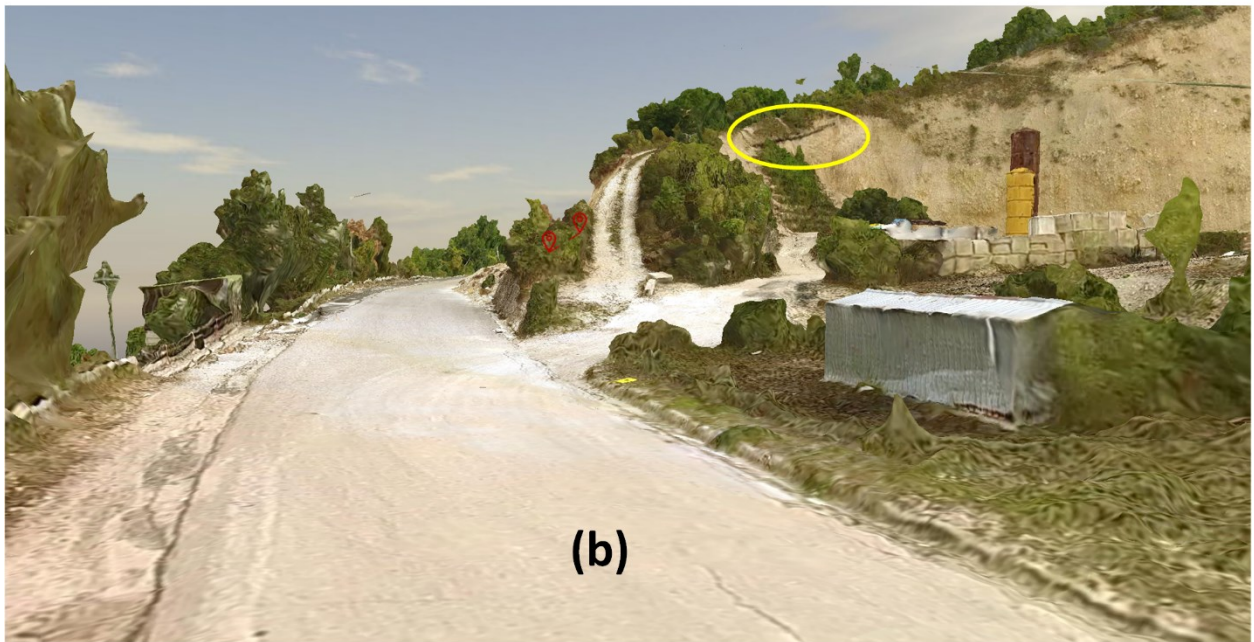
Figure 4.38. Pre-earthquake (a) and post-earthquake (b) images of the haul road slope inside the gravel pit, with exposed pipeline. Pre-earthquake imagery courtesy of Google. From these images, it appears that the earthquake and subsequent landslide into the gravel exposed 10 meters more of the pipeline.

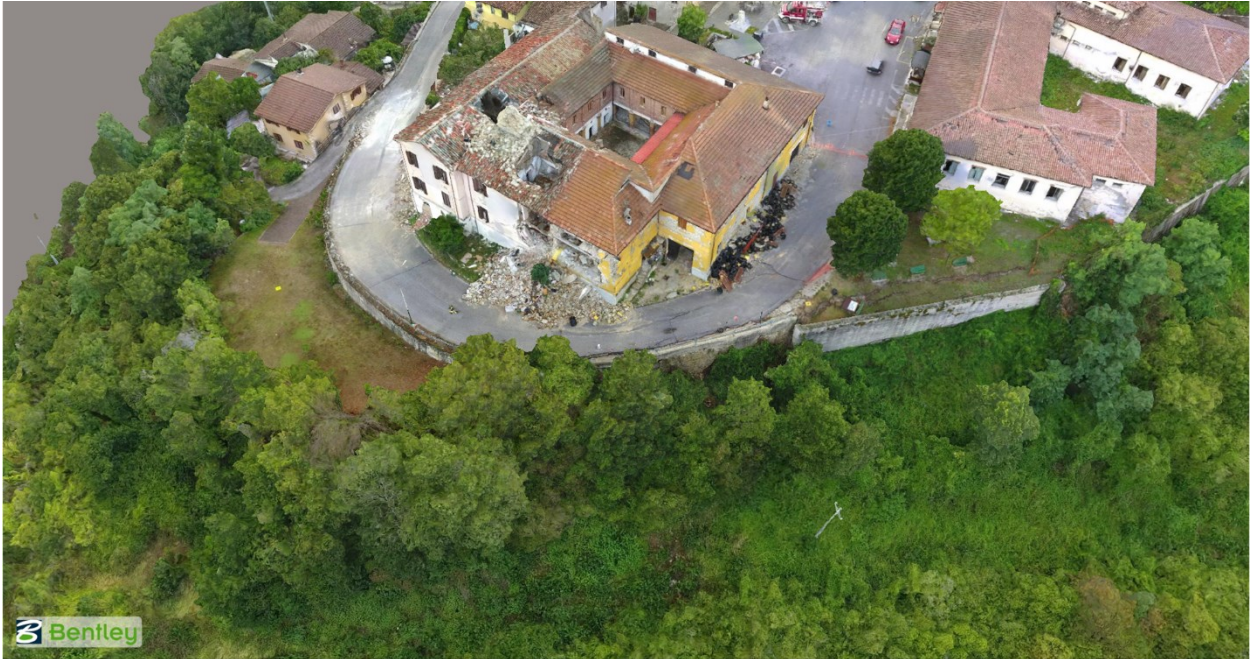
Figure 4.41. 3D Model overview image of the eastern portion of Accumoli

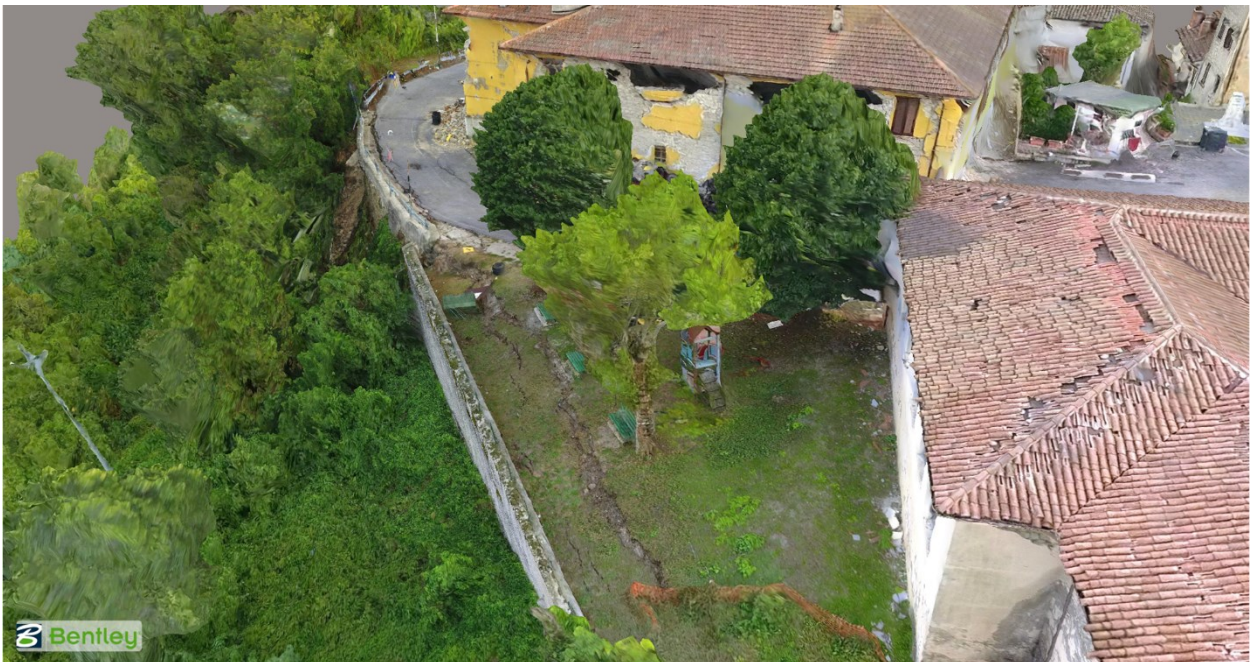
Figure 4.42. Model image of a rotated retaining wall (3.5-degrees) and the subsequent soil graben behind the wall (42.69446 N 13.24980 E).

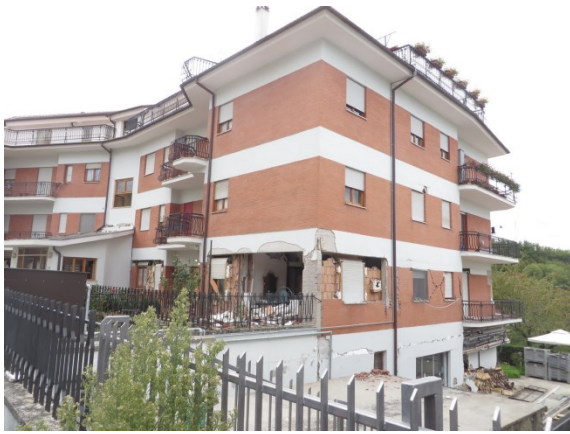
P19

Major damage was observed in critical buildings, such as police stations (the one of the *Carabinieri* corps, which is a three-story masonry structure strengthened with steel ties, P15 and P16 in Figure 5.9, and the one of the Highway Patrols, P11) and a school that, despite previous interventions, collapsed partially (P17). Also evident are structural members that were individually strengthened (P18). Multi-story reinforced concrete buildings behaved relatively well, mainly exhibiting in-plane shear failure of infill panels (P19) and minor to moderate damage at their beam-column joints (P20).

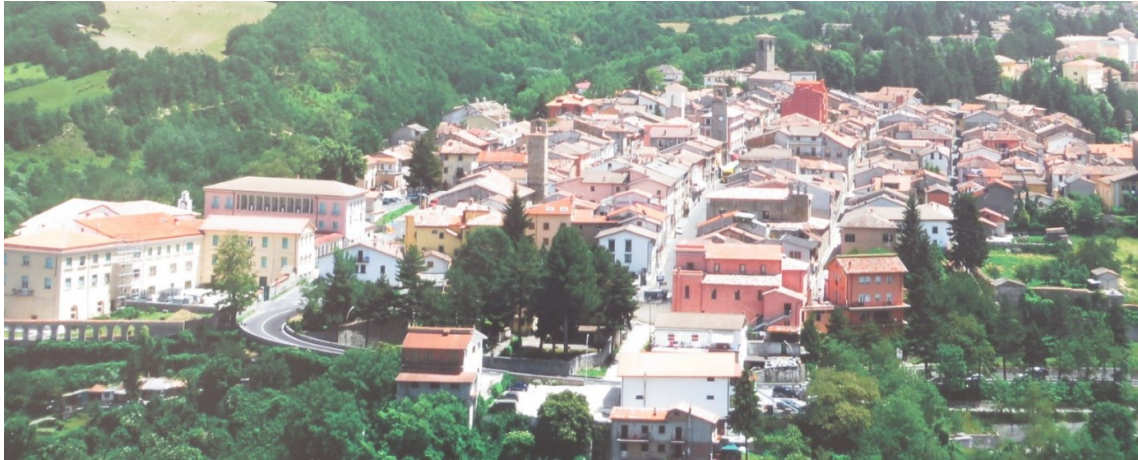
Figure 5.11. Overview of Amatrice Red Zone before and after the 24 August event.

During the second phase of the reconnaissance field mission detailed building-by-building inspections were performed within the Amatrice Red Zone (as shown in Figure 5.11 along with a pre-event aerial photo). It is noted that for safety purposes, access to the Red Zone was permitted to specific streets only, e.g., the main Amatrice market street, a number of perpendicular streets, as well as streets around the inner perimeter of the Red Zone. The steps of the detailed visual inspection of Amatrice were also followed in all other areas inspected by the group and are briefly summarized as follows: (a) Initialization of the field mission based on Copernicus aerial imaging, (b) geo-localization of the photoshoots, (c) identification of the structural typologies and translation of the Italian quick inspection sheet as described in the Field Manual for the Post-earthquake damage and short-term counter measures (AeDES form), (d) transformation of the AeDes form into an Access database for archiving and statistical post-processing, (e) completion of hardcopy AeDes forms in the field for reliability purposes, (f) correlation of the damage observed for each building with pre-event Google Street View photos, (g) definition of a quantitative weighting procedure to derive the global building damage at a scale of D0 to D5 based on the local damage identified according to the Italian quick inspection sheet, (h) generation of the spatial distribution of damage in the form of shape and KMZ files.

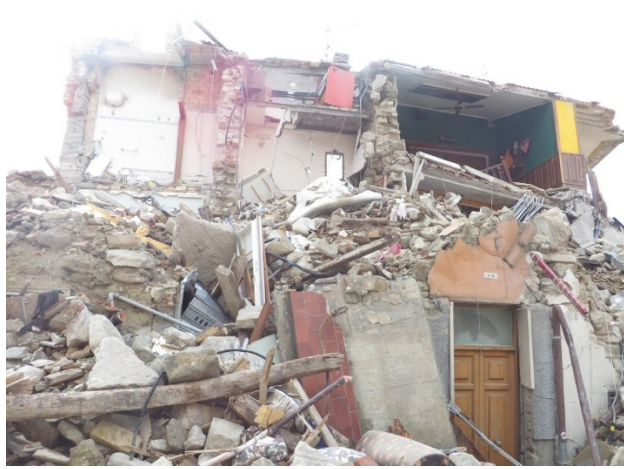
P22

Figure 5.13. Photos of extensive building collapse within Amatrice Red Zone after the 24 August event.

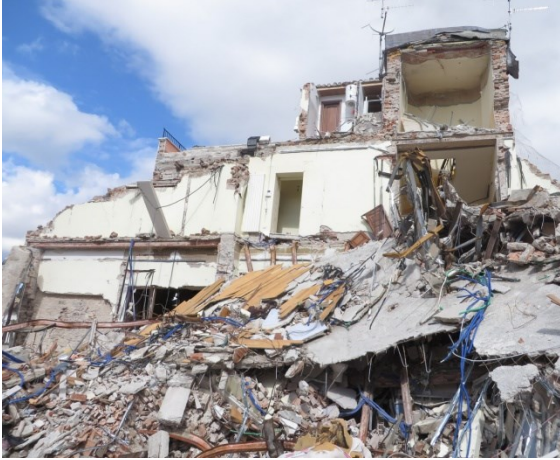
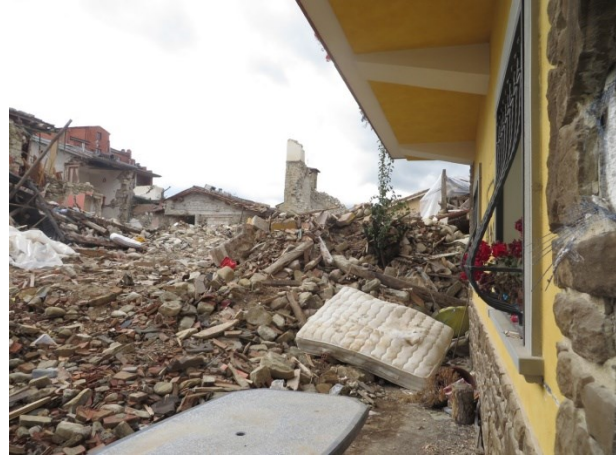
Figure 5.14. Photos of building collapse (P27, P28) but also mahor (P29 and P30) and minor (P31 and P32) damage along the main market street of Amatrice.

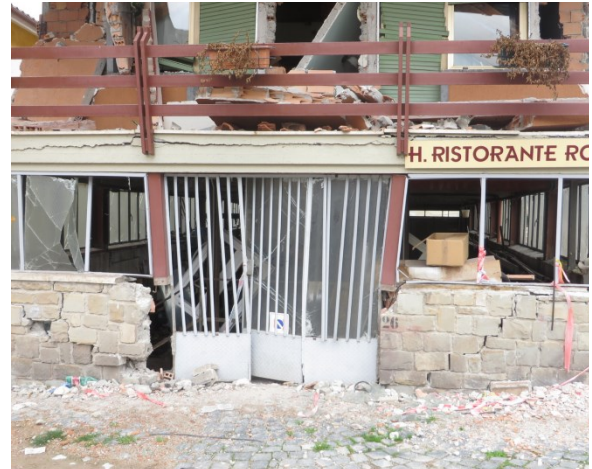
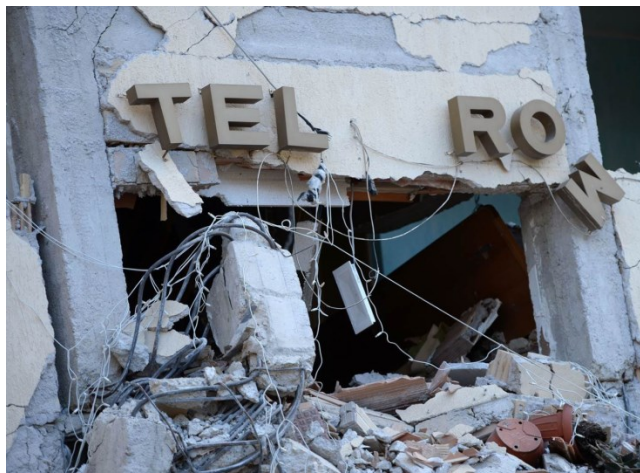
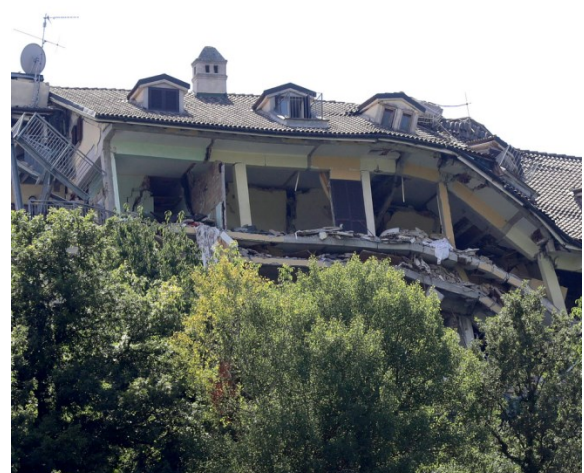
Figure 5.12 (top photograph) illustrates the extent of structural damage while the distribution of global damage is portrayed in lower figures (it is noted that the building sample is still being processed). Characteristic images of building collapses are shown in Figure 5.13 and Figure 5.14 (P21-P28) while corresponding coordinates are reported in Table 5.5. Of particular interest was the five story R/C building of P29-P30 in Figure 5.14 along the main market street, which exhibited major damage but did not collapse during the **M6.1** main shock nor subsequent aftershocks. Unfortunately, it subsequently collapsed during the 26 October 2016 **M6.1** event. A few buildings, recently restored, remained undamaged or suffered only minor damage, two of which are depicted in P31-P32. The same applies to the three-story steel building of P33-P34 (Figure 5.15) that experienced minor damage (i.e., shear failure of the infill panels and only minor buckling to one of its columns). The latter building was located very close to the R/C building of Hotel Roma, the town's main hotel, which collapsed (P35-P36 in Figure 5.15).

Figure 5.15. Photos of a characteristic steel building with minor-to-moderate damage (DS2, P33-P34) next to Hotel Roma, a collapsed R/C building (P35, P36).
