Engineering Reconnaissance of the 24 August 2016 Central Italy Earthquake. Version 2

Geotechnical Extreme Events Reconnaissance Association

Report No. GEER-050

22 November 2016

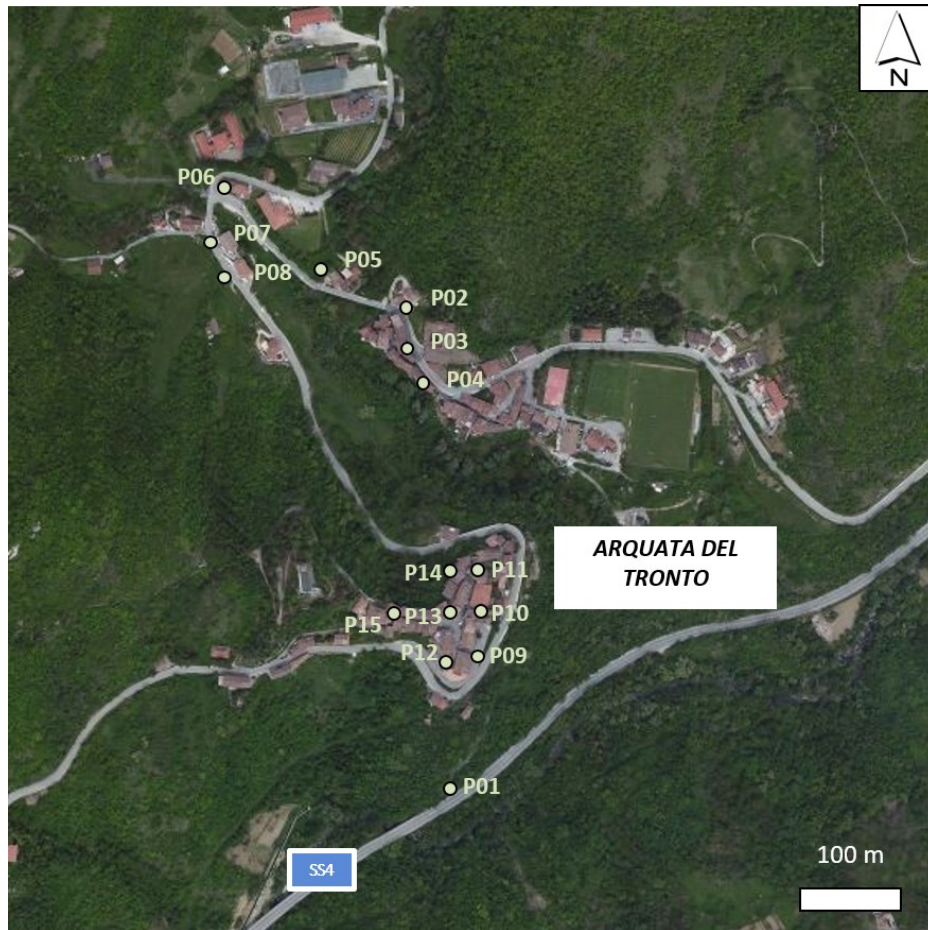
Figure 5.17. Locations of representative structures inspected in the village (see Table 5.6 for details).

Locations of representative structures inspected in Arquata and Borgo by the GEER team are reported in Figure 5.17, while details (WGS-84 coordinates, damage level of buildings, other notes) are given in Table 5.6. The pictures are presented in Figure 5.18. The area around P15 (especially the zone NE of this point) had limited access on the date of the survey. The village consisted mainly of un-reinforced masonry structures, 2-3 stories in height. Very few of the structures were retrofitted with through-going iron bars (for instance P4). Isolated relatively modern reinforced concrete structures were found (see P08) showing negligible or low damage.

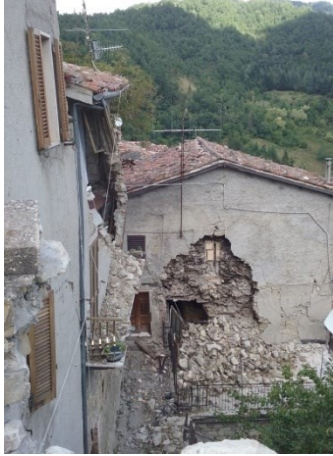
P11

Damage patterns evaluated from aerial image analysis of Arquata are presented in Figure 5.20. No information is provided for Borgo. The higher degree of damage in Arquata, located near the top of the ridge, relative to Borgo was captured on average. Again, a decreasing degree of damage was observed away from the edge. The cases of full collapse were generally captured by the aerial image analysis (P13 and P14 were reproduced, while P12 was reported as highly damaged). The degree of damage to highly damaged and partially collapsed buildings was sometimes underestimated and identified as “negligible to slight damage” (e.g., P11).

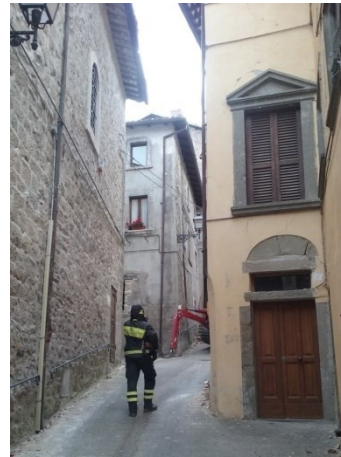
P15

The village was significantly damaged by the mainshock. However, the degree of damage to buildings is quite variable in space. A tentative damage zonation is reported in Figure 5.19. The hamlet of Borgo suffered minor damage (mainly cracking of non-structural elements) and no collapses were observed. The level of damage slightly increased from D1-D2 to D2-D3 moving in the NW direction. Arquata, founded on top of the ridge, was highly damaged. Several unreinforced masonry structures were partially or fully collapsed (P10-P14). A few cases of retaining wall failures along the road leading to the village were observed, which consisted of permanent deformation of the wall as a whole and collapse of the upper part of the wall. Some buildings survived the event but appeared to have approached the point of collapse or severe damage (see P11 for instance). The level of damage decreased away from the edge of the cliff (P15), although this area was not fully accessible on the date of our survey.

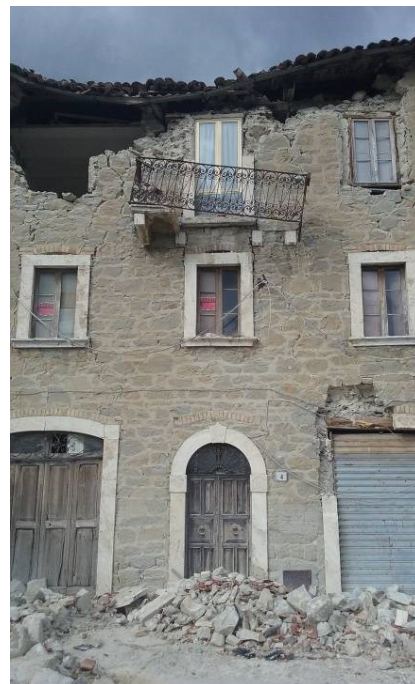
P02

Buildings in the village mainly consisted of un-reinforced masonry structures 2-3 stories in height. Very few of the structures were retrofitted (see for instance P11). Isolated, relatively modern reinforced concrete structures can be found along the road to access to the village and were subjected to relevant damage (P01).

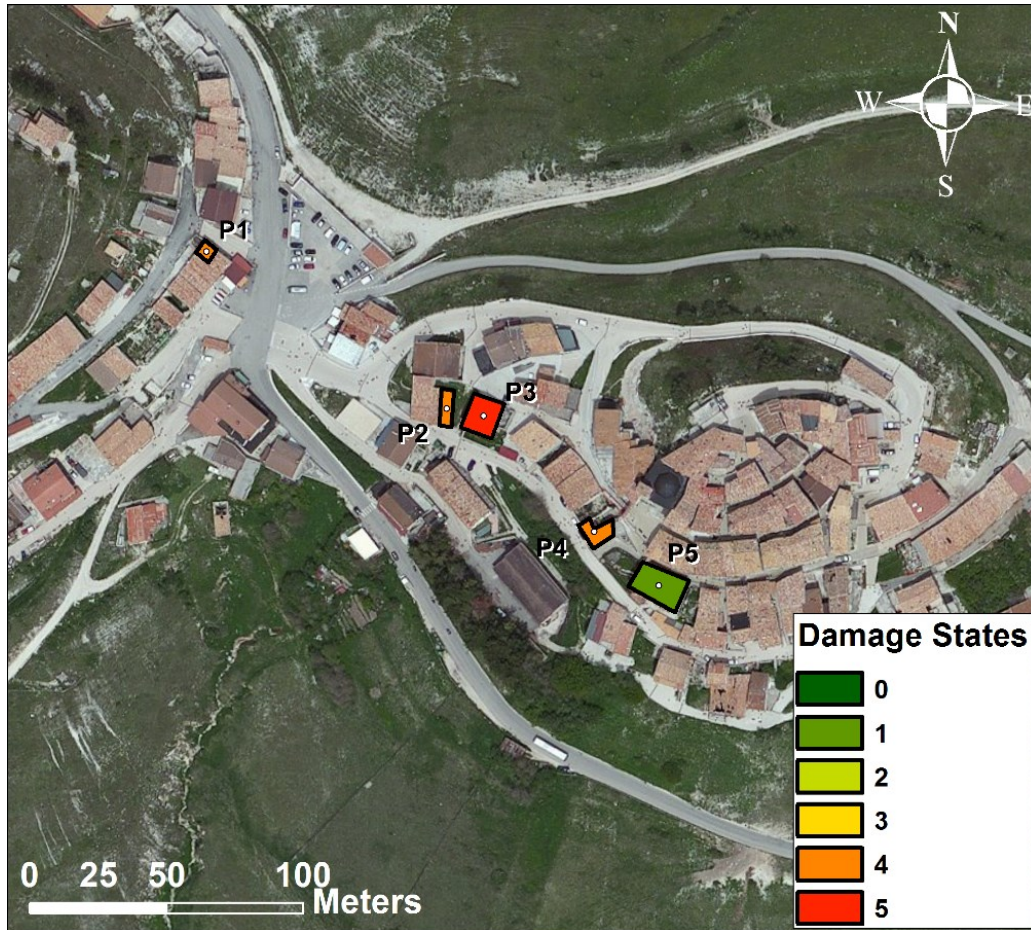
We documented the performance of five buildings according to the Italian inspection sheet, with the results in Table 5.9. The location of the surveyed buildings and the graphical representation of their damage state as well as representative photographs of damage are shown in Figure 5.40 and Figure 5.41.

Figure 5.40. Location of surveyed buildings and their damage state.

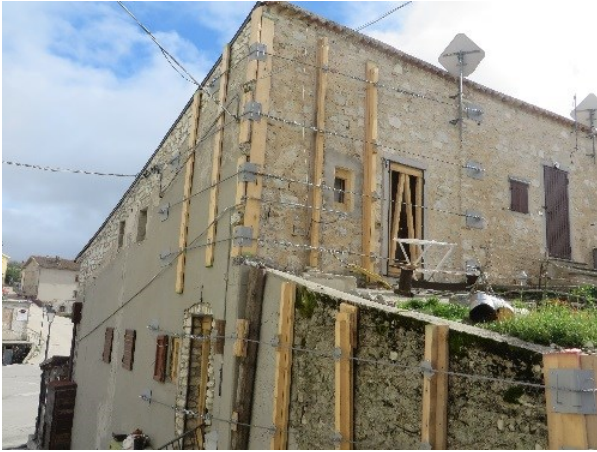
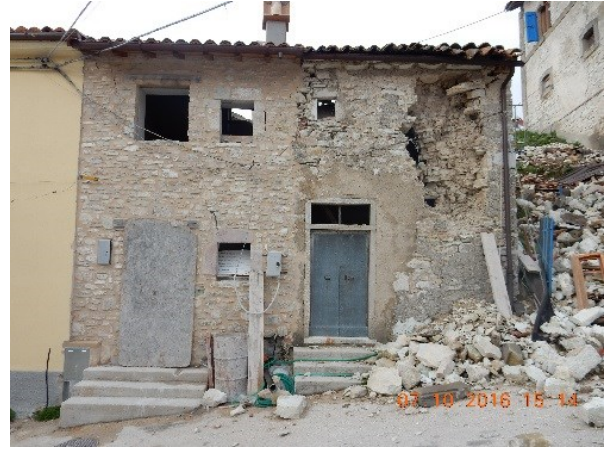
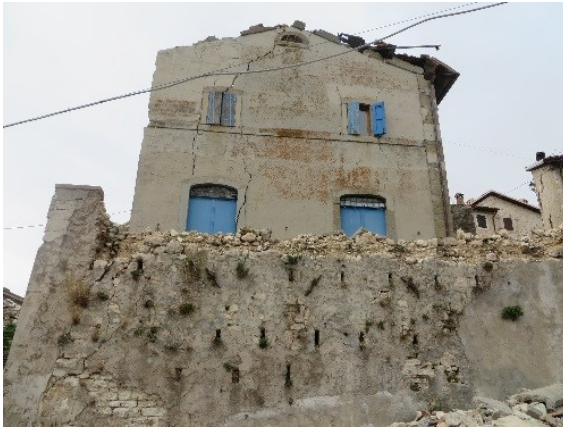
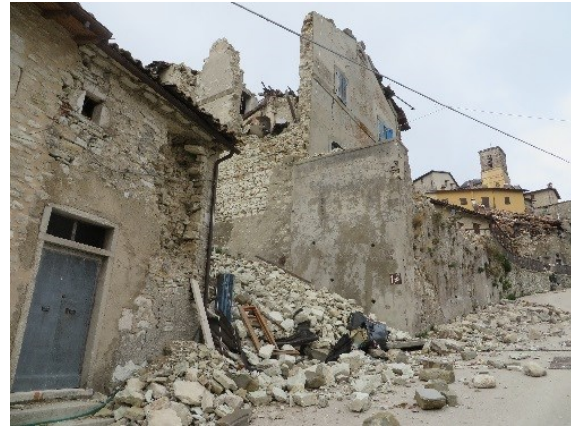
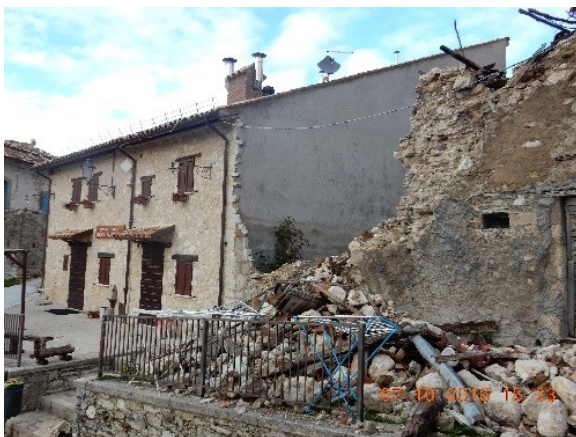
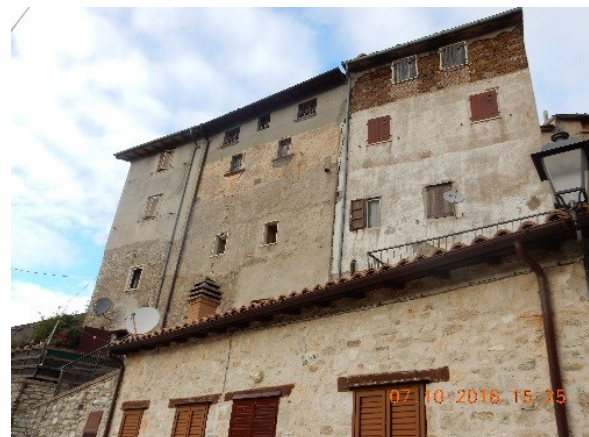
Figure 5.41. Representative pictures taken in Castelluccio during the survey.

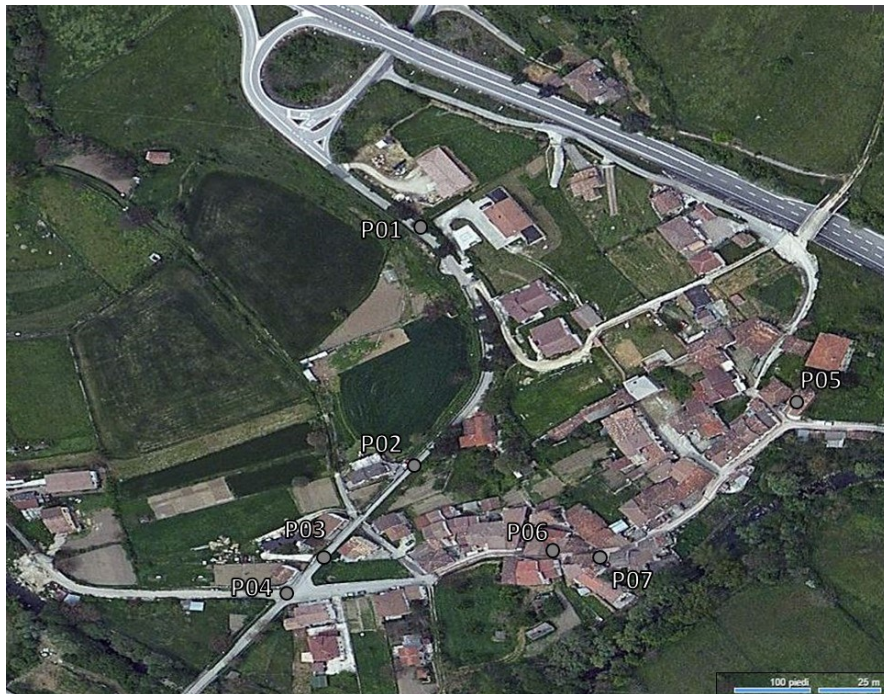
As reported in Figure 5.48 to Figure 5.51 and Table 5.11, masonry buildings were the most highly damaged structures in the area. Two zones have been drawn based on the distribution of the damage: the most ancient part of the village characterized by damage levels D4-D5, and the more recently built surrounding zones characterized by a damage levels not exceeding D3. The same damage pattern was reported on the Copernicus map (Figure 5.51).

Figure 5.48. Locations of representative structures inspected in the hamlet (see Table 5.11 for details)

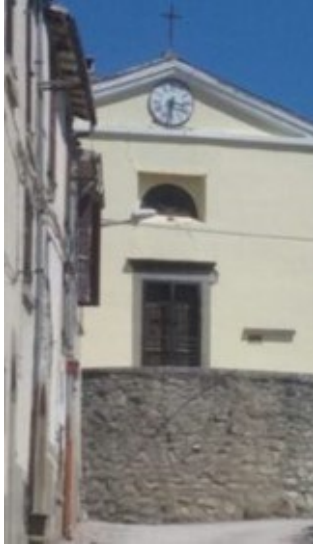
P05

Picture	DATUM	longitude	latitude	Damage level	Note
P01.jpg	WGS- 84	13.255	42.69528	D3	
P02.jpg	WGS- 84	13.255	42.69417	D4	View of several buildings
P03.jpg	WGS- 84	13.255	42.69528	D3	View of several buildings
P04.jpg	WGS- 84	13.255	42.69528	D3	
P05.jpg				D3	Downloaded from http://www.fontedelcampo.it/foto/foto-terremoto/
P06.jpg				D5	Downloaded from http://www.fontedelcampo.it/foto/foto-terremoto/
P07.jpg				D3	Downloaded from http://www.fontedelcampo.it/foto/foto-terremoto/

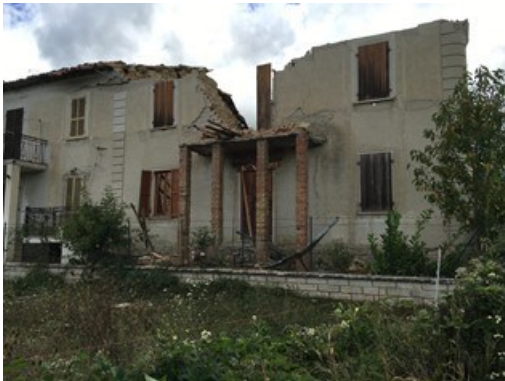
P01

Picture	DATUM	longitude	latitude	Damage level	Note
P01.jpg	WGS- 84	13.3084861	42.6349806	D4	Roof and inner walls collapsed
P02.jpg	WGS- 84	13.3101861	42.6350861	D4	Collapsed roof
P03.jpg	WGS- 84	13.3101972	42.6350861	D1	Only few cracks
P04.jpg	WGS- 84	13.3101972	42.635075	D0	Almost undamaged
P05.jpg	WGS- 84	13.3098639	42.6349722	D4	Collapsed roof showing poor masonry brickwork (adjacent to P04)
P06.jpg	WGS- 84	13.3099917	42.6349333	D3	Center - breached wall
P07.jpg	WGS- 84	13.3098361	42.6349333	D1	Effective tie rods
P08.jpg	WGS- 84	13.3098194	42.6349361	D4-D1	Collapsed unreinforced part (left) - Effective tie rods (right)
P09.jpg	WGS- 84	13.3098028	42.6349528	D3-D2	Diagonal cracks (left) – Almost effective tie rods (right)
P10.jpg	WGS- 84	13.3094667	42.6349056	D3	Diagonal cracks at the ground floor
P11.jpg	WGS- 84	13.3102028	42.6351083	D0	Undamaged recent (r.c.?) building
P12.jpg	WGS- 84	13.3098	42.6349	D1	Effective tie rods (installed also at the intermediate floor)

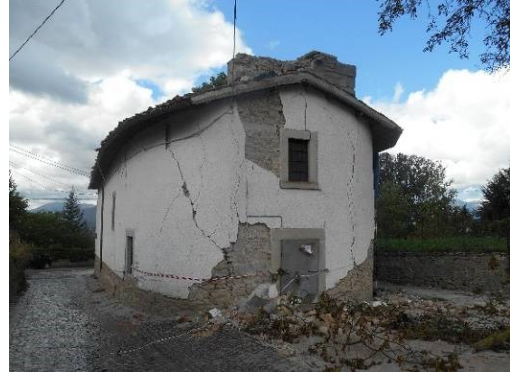
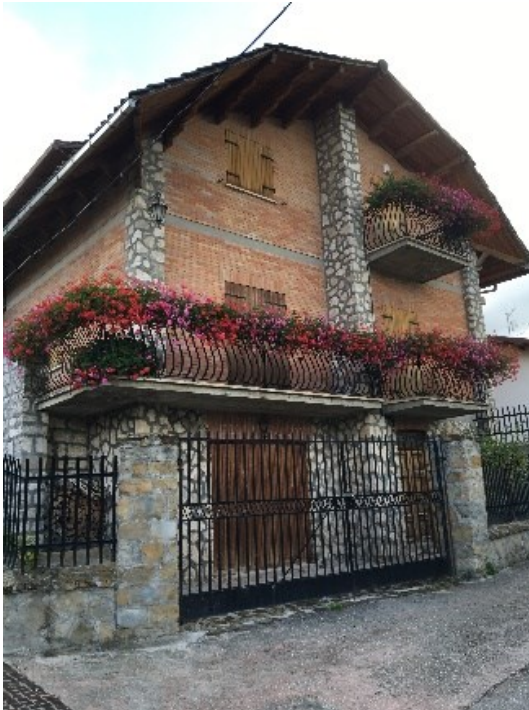
Picture	DATUM	longitude	latitude	Damage level	Note
P01	WGS- 84	13.324171	42.634639	D3	Old chapel, façade and absidal walls very deformed and x-cracked
P02	WGS- 84	13.324385	42.634543	D0	Almost undamaged new building in front of the chapel
P03	WGS- 84	13.324870	42.634559	D3	Intensely cracked building with a singular breach at the toe
P04	WGS- 84	13.325142	42.634781	D2 - D3	Small houses unevenly damaged
P05	WGS- 84	13.325969	42.634808	D3	Court house with dominating inter-openings cracks
P06	WGS- 84	13.325967	42.634803	D3-D4	Poor brickwork cracked (left) and breached (right)
P07	WGS- 84	13.325984	42.634731	D0	Undamaged restored building nearby
P08	WGS- 84	13.326309	42.634897	D0 – D1	Undamaged houses, one recently reinforced (see bottom picture, dated 2011) with tie rods with elliptical plates
P09	WGS- 84	13.326246	42.634884	D0	Recent low constructions uphill, almost undamaged
P10	WGS- 84	13.324369	42.634103	D3 - D4	Upper walls often breached

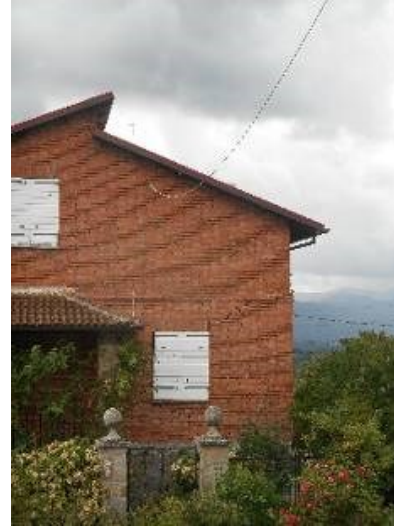
P11	WGS- 84	13.324422	42.633758	D3	Recent brickwork cracked and displaced
P12	WGS- 84	13.324433	42.633853	D3	Bulged and cracked poor masonry wall
P13	WGS- 84	13.324433	42.634000	D2	Partial damage even with tie rods

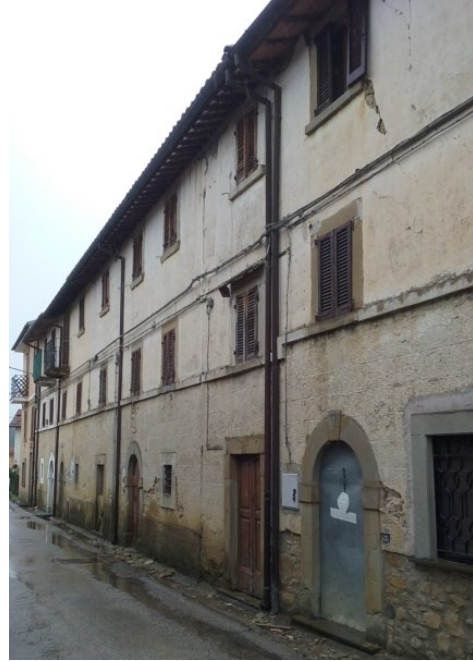
Picture	DATUM	Location		Damage Level	Notes
		Lat.	Long.		
P01	WGS-84	42.622807°	13.279402°	D0-D1	
P02	WGS-84	42.623130°	13.279552°	D1-D2	
P03	WGS-84	42.623654°	13.279299°	D2-D3	
P04	WGS-84	42.623777°	13.279313°	D4	<i>Partial collapse of the roof</i>

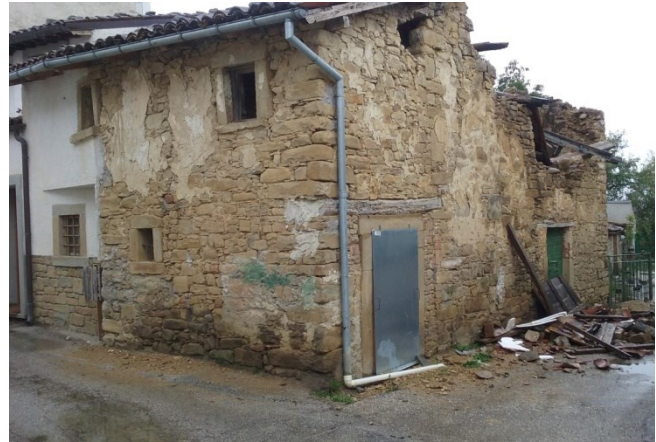
P04

Photos of representative structures inspected in Mosicchio are shown in Figure 5.60, with further details provided in Table 5.15 (WGS-84 coordinates, damage level of buildings, other notes). The hamlet consists mainly of unreinforced masonry structures, 2-3 stories in height. The damage was quite low, on average classified as D2. Only one case of partial collapse (D4) was observed in a poorly constructed, unreinforced masonry building (see P4).

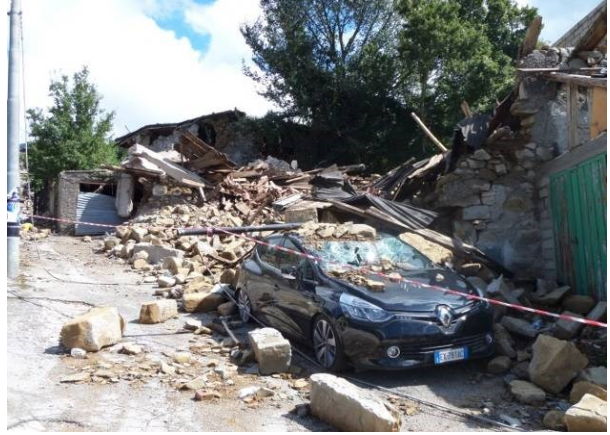
Figure 5.63 and Table 5.16 show locations and details of representative buildings inspected in Casale. Figure 5.64 shows representative structures. There were a significant number of partial (e.g. P03, P05, P07) or total (P01, P02, P08, P11) collapses of masonry buildings in Casale with an average damage level between D4 and D5, which is consistent with local $I_{MCS} = 10$ (Galli et al. 2016).

Picture	DATUM	Location		Damage Level	Notes
		Lat.	Long.		
P01	WBG-84	42.670069	13.286015	D5	
P02	WBG-84	42.669812	13.285955	D5	
P03	WBG-84	42.669689	13.285857	D4	
P04	WBG-84	42.669553	13.285667	D3	
P05	WBG-84	42.669553	13.285667	D4	
P06	WBG-84	42.669596	13.285710	D0	
P07	WBG-84	42.669514	13.285550	D4	
P08	WBG-84	42.669473	13.285491	D5	
P09	WBG-84	42.669293	13.285254	D3	
P10	WBG-84	42.669330	13.285297	D3	
P11	WBG-84	42.669293	13.285254	D5

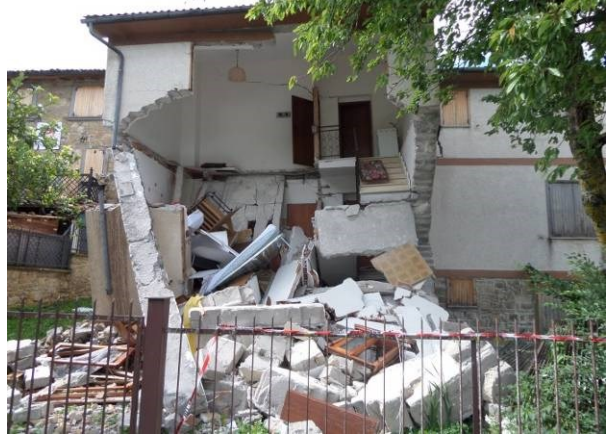
P02

The buildings surveyed along the main road (Figure 5.66 and Table 5.17) showed a significant number of partial (e.g. P02, P06, P15 to P17) or total (P01, P03 to P05, P13, P18) collapse of the masonry buildings (Figure 5.67). The hamlet of Saletta had an average damage level between D4 and D5 for a local IMCS = 10 (Galli et al. 2016).

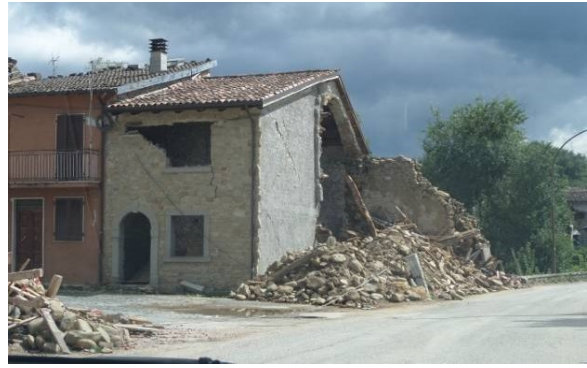
P02

Only a small part of the village was accessible in the days of the reconnaissance, which was surveyed as shown in Figure 5.69 and Table 5.18. The few buildings inspected (Figure 5.70) in some cases were partially or totally collapsed (P02, P03, P07), but most frequently had diffuse cracking (P04, P05, P06). Sommati had an average damage level in the order of D3-D4 with a local IMCS = 9 (Galli et al. 2016).

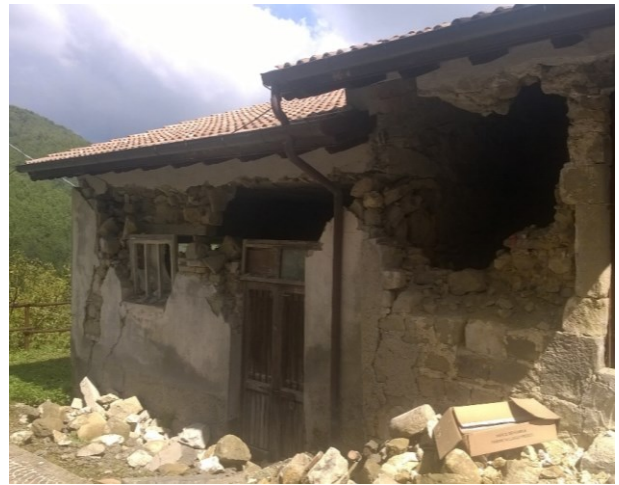
P15 (Castro)

Castro is located at an elevation of 827 m ASL, 2 km north of the county town of Balzo. This hamlet is built on a ridge constituted by the Laga Flysch Formation in arenaceous-pelitic facies. According to Galli et al. (2016), a local $I_{MCS} = 7.0$ was attributed to this village, which is the maximum macroseismic intensity in the Montegalloy districts. The more vulnerable 1-2 story masonry buildings showed moderate to severe damage (P17-P18) to partial collapse (e.g. P15-

P16). The village had an average damage level between D3 and D4. More recently constructed buildings did not suffer noticeable damage.

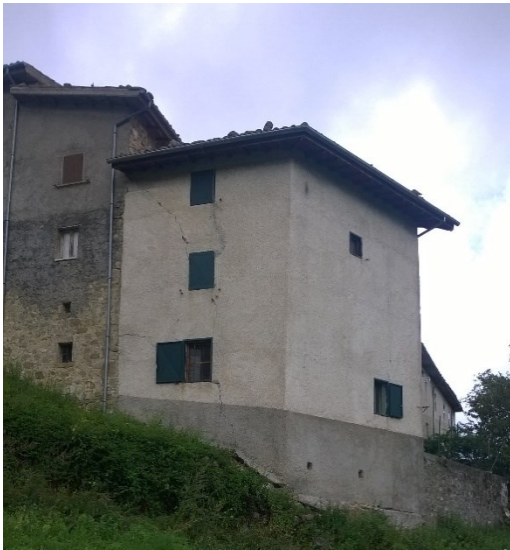
P21 (Colleluce)

Figure 5.82. Representative pictures in Montegallo (location listed in Table 5.22).

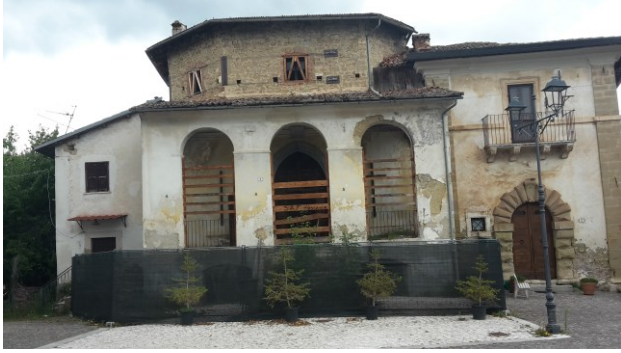
Some representative structures are shown in Figure 5.84 together with the corresponding coordinates. In particular, P01 shows damage from the 2009 Earthquake, whereas P02 shows an example of limited external damage as observed after the 2016 event. A temporary accelerometer network was placed by INGV in Montereale and Capitignano soon after the 24 August 2016 Earthquake to monitor aftershocks (Table 3.1, Figure 3.4).

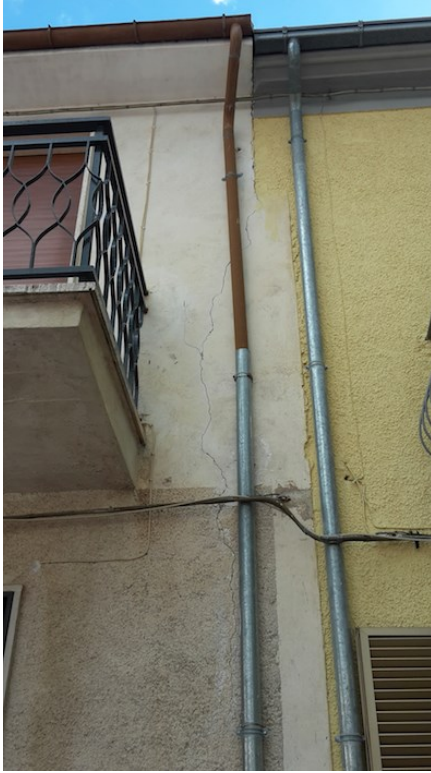
P01

Figure 5.85. Representative pictures of damage in Capitignano.

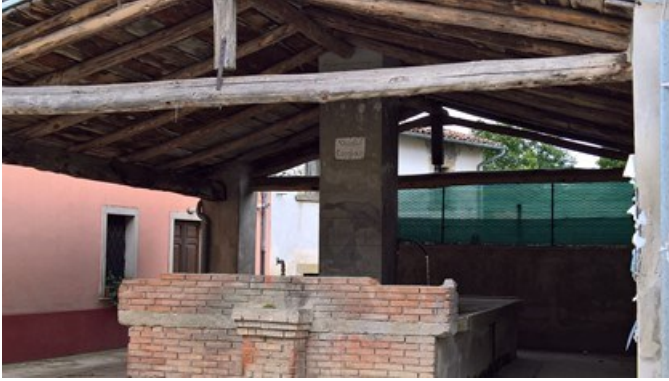
P01

Figure 5.87. Representative structures in Aringo (Montereale).

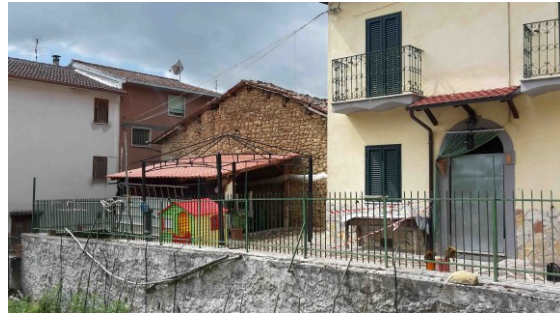
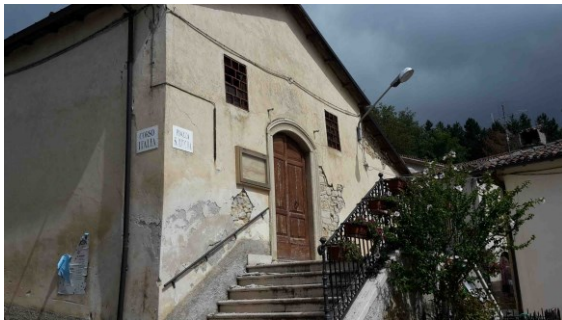
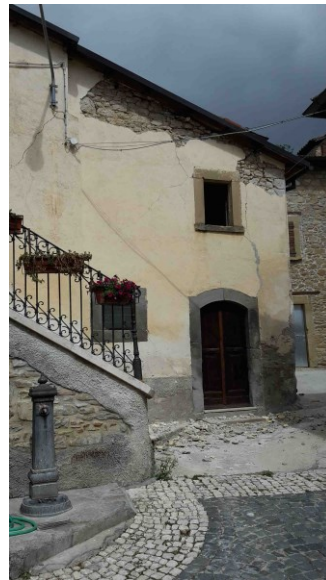
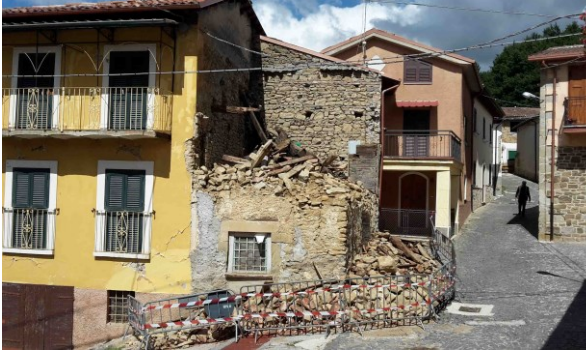
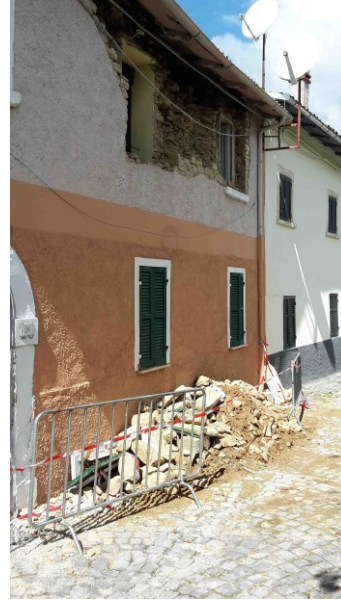
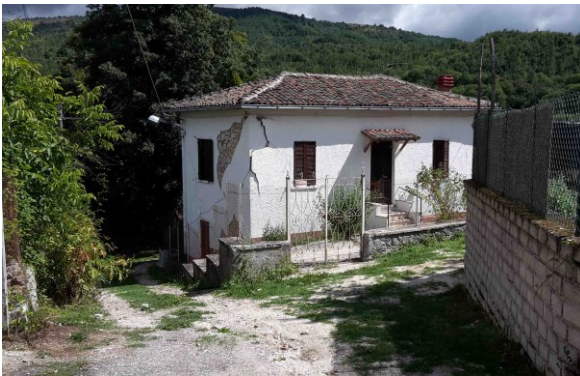
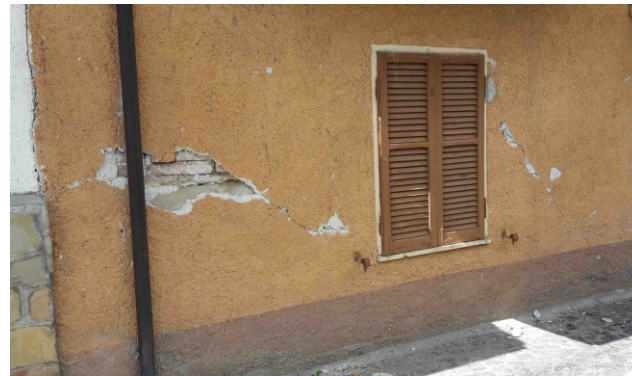
Picture	DATUM	Location		Damage Level
		Lat.	Long.	
P01	WGS-84	42° 34' 18" N	13° 15' 42" E	D1
P02	WGS-85	42° 34' 18" N	13° 15' 43,998" E	D0
P03	WGS-86	42° 34' 18" N	13° 15' 43,998" E	D1
P04	WGS-87	42° 34' 18" N	13° 15' 42" E	D1
P05	WGS-88	42° 34' 16,998" N	13° 15' 43,002" E	D5
P06	WGS-89	42° 34' 16,998" N	13° 15' 43,002" E	D2
P07	WGS-90	42° 34' 15" N	13° 15' 46,002" E	D3
P08	WGS-91	42° 34' 16,002" N	13° 15' 43,002" E	D2

Figure 5.89. Representative pictures in Santa Lucia (Montereale) (see Table 5.24 for details).

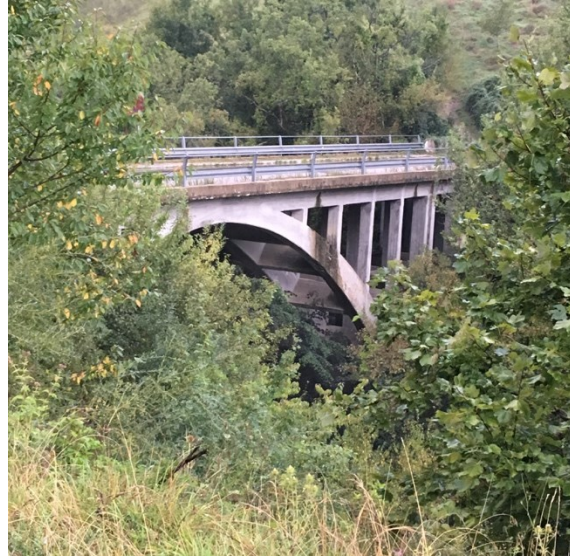
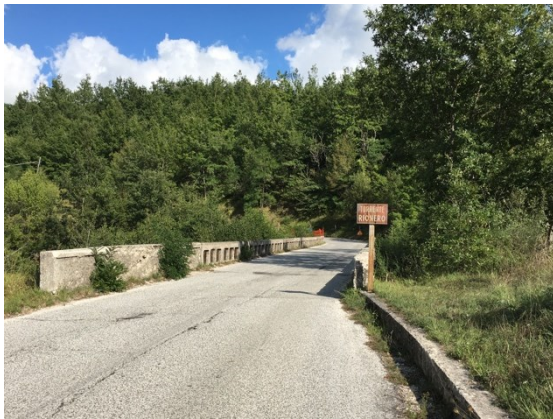
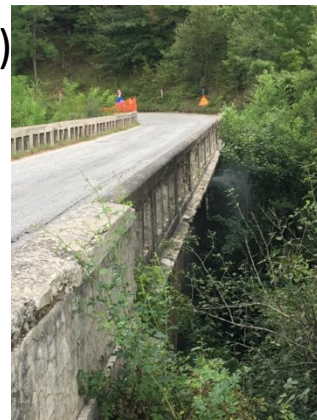
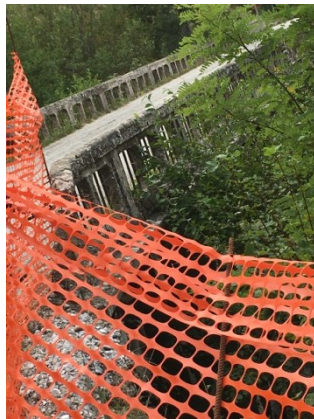
Most of the inspected contemporary bridges do not show evidence of seismic induced damage (Figures from 6.2 to 6.4) that, if present, would have required a limitation in bridge utilization.

Figure 6.3. RC bridge along the SP7 in Boscomartese (42.7241 deg, 13.4405 deg).

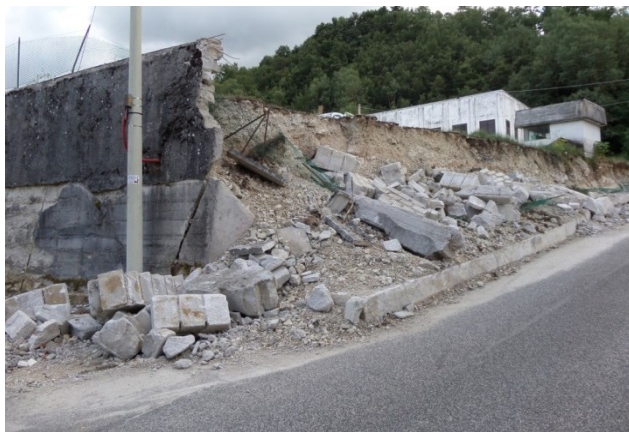
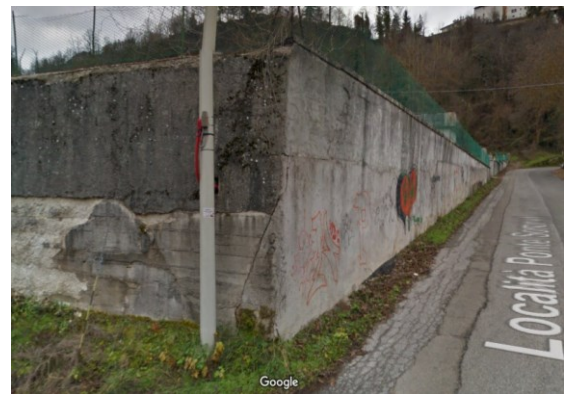
Figure 7.3a shows a collapsed retaining wall supporting a parking lot in the hamlet called “Ponte Sommati”, near Amatrice. The lower part of the wall was made of poorly reinforced concrete and the upper part was built with concrete blocks. The images in Figure 7.3b-c indicate the poor quality of the wall, including poor connections between the upper and lower parts.

Figure 7.3. Retaining wall at Ponte Sommati, in the surroundings of Amatrice (42.630662N, 13.291511E): (a) global view of the collapsed wall, (b) side of the wall not collapsed during the earthquake, (c) pre-earthquake image of the retaining structure (Google Earth, July 2011).

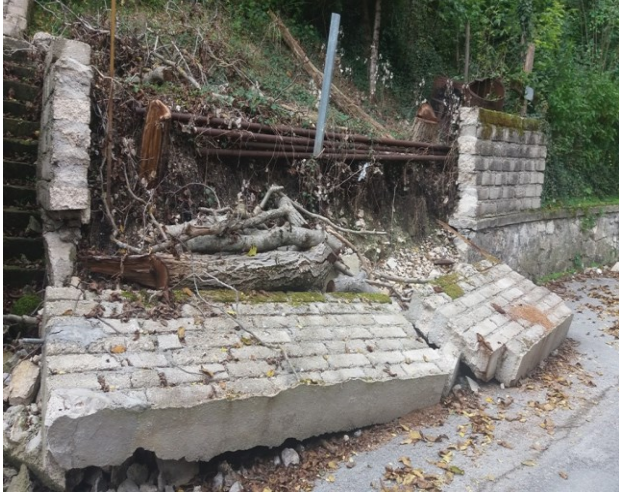
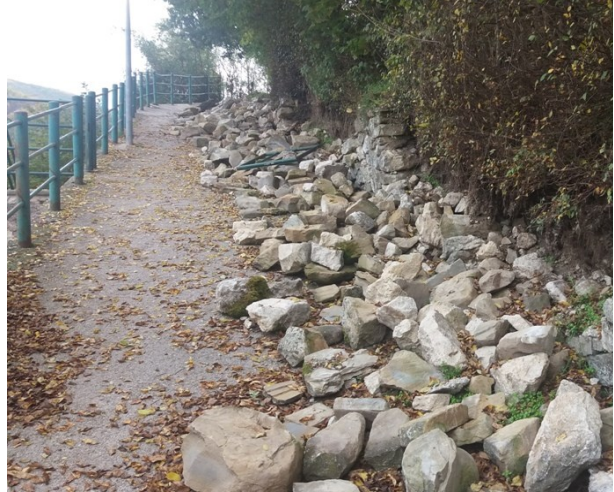
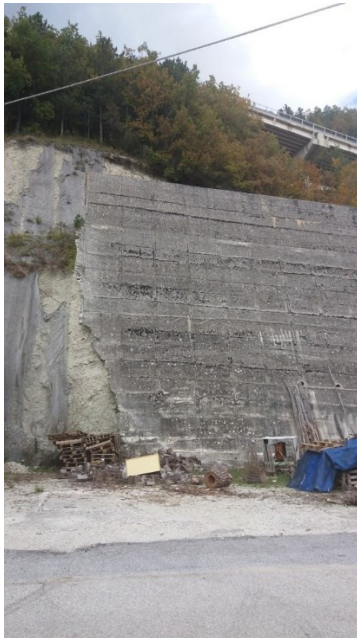
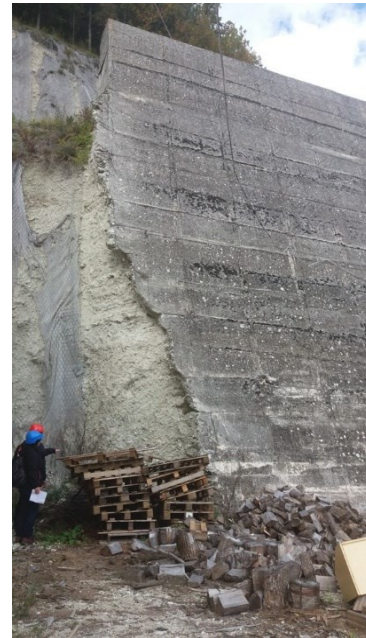
Figure 7.5 shows three cases of retaining walls damaged in Pescara del Tronto. In each case, the observed damage may be attributed in part to the poor quality of the retaining structures. Figures 7.5a-b show the collapse of two relatively low masonry walls. The wall in Figure 7.5a is made of concrete blocks connected by mortar, with no evidence of drainage measures having

been installed in the backfill. The wall in Figure 7.5b was erected with a typical dry-stone masonry technique (no mortar between stones) with no foundation. Figure 7.5c-d illustrate the damage to a fence drapery breached by calcarenite rock blocks falling from a slope as high as 8m. No significant damage was observed in the adjacent high concrete wall.

Figure 7.5. Retaining walls in Pescara del Tronto: (a) collapse of a concrete block masonry wall (42.751705N, 13.270562E), (b) collapse of a dry-stone masonry wall (42.751141N, 13.270889), (c) fence drapery breached by calcarenite rock blocks, (d) performance of the adjacent concrete wall (42.752331, 13.270207E).

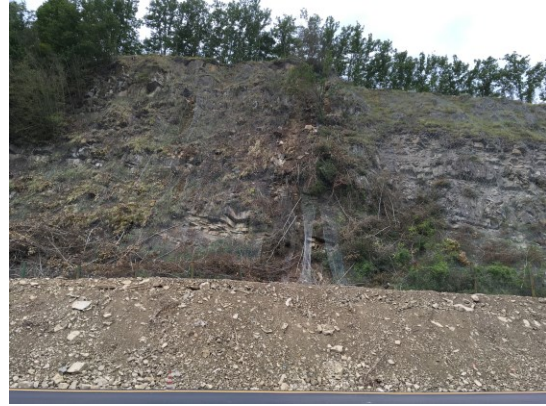
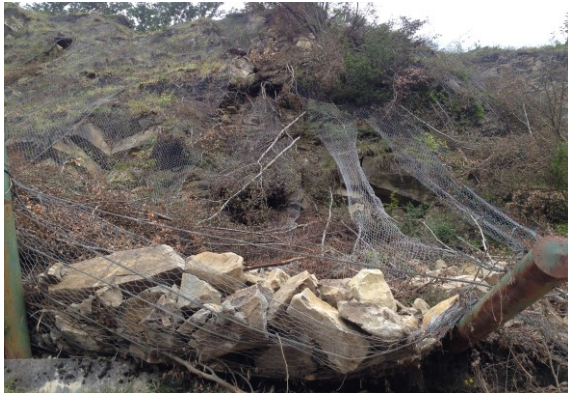
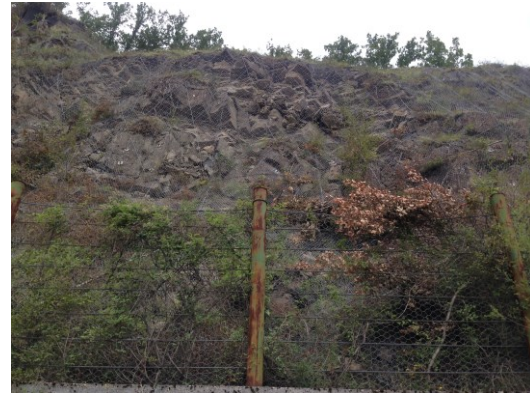
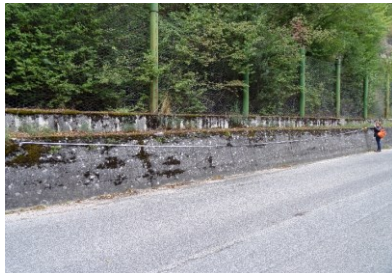
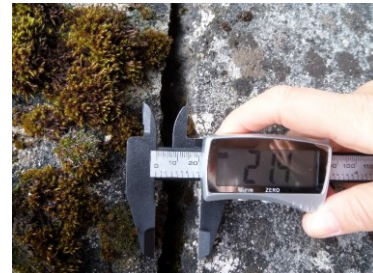
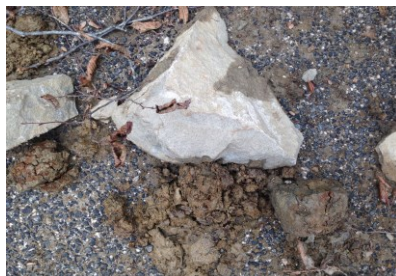
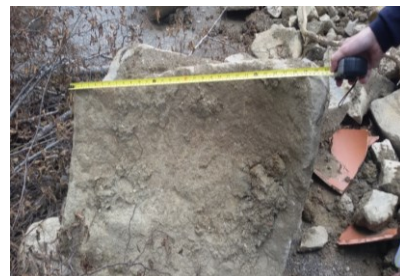
Figure 7.6a shows damage to a rockfall barrier along the SS260 road branch that connects Amatrice to the main road SS4 (Salaria). At the time of the reconnaissance, a protection embankment was placed at the toe of the slope (Figure 7.6b). The slope behind the barrier is covered with a hexagonal mesh, which along the failed slope is simply draped with no evidence of reinforcement (Figure 7.6c), while along the stable slope it appears connected to the arenaceous flysch formation by ropes and nails (Figure 7.6d).

Figure 7.6. Damage to a rockfall protection system along the SS260 road (42.648203N, 13.274285E) in Amatrice municipality: (a) collapsed zone; (b) failed (left) and stable (right) parts of the slope with protection embankment in the foreground; bottom view of the failed (c) vs. stable (d) slope and barrier; concrete wall supporting the barrier (e) and previous crack (f) denoting the absence of reinforcement; (g) arenaceous block with silty matrix and (h) maximum size of the rock blocks fallen.

The rockfall barrier is comprised of a fence with steel horizontal cables connected to vertical cantilever tubular piles anchored to a concrete beam placed upon a 1.4 m tall retaining wall (Figure 7.6e). The concrete wall appears to be unreinforced (Figure 7.6f).

Collapse of the system may be attributed to several factors, among which the lack of anchorage of the mesh panels to the slope and between adjacent panels too, inadequacy of the rockfall barrier with reference to the foundation of the tubular elements, the absence of any retaining cable on the top of the barrier, and the limited strength of both the fence and the horizontal cables. The rockfall barrier was not able to intercept arenaceous blocks up to approximately 30-40 cm in size (Figure 7.6f-g), sliding or falling from a maximum height of about 12 m.

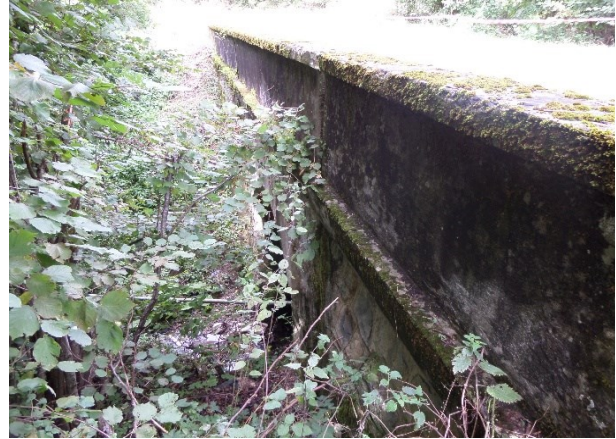
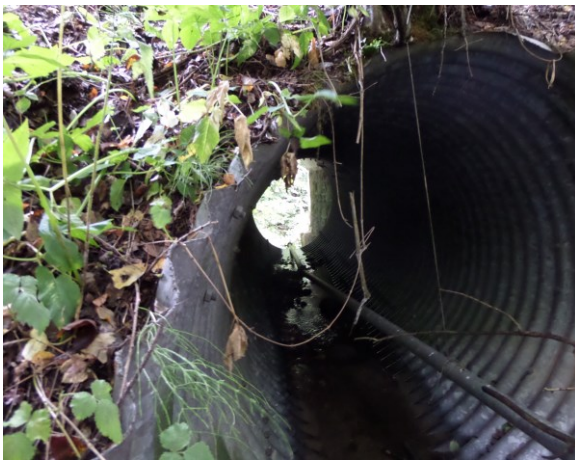
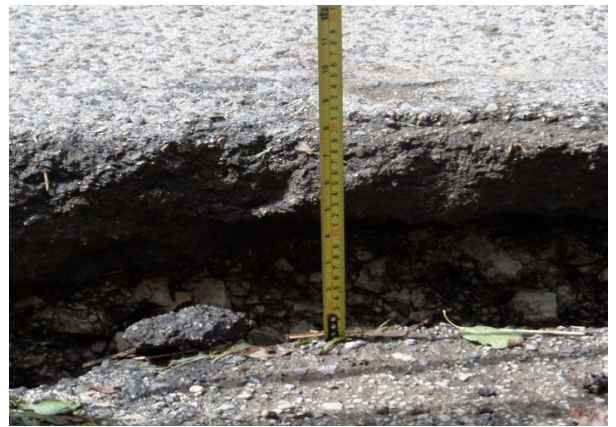
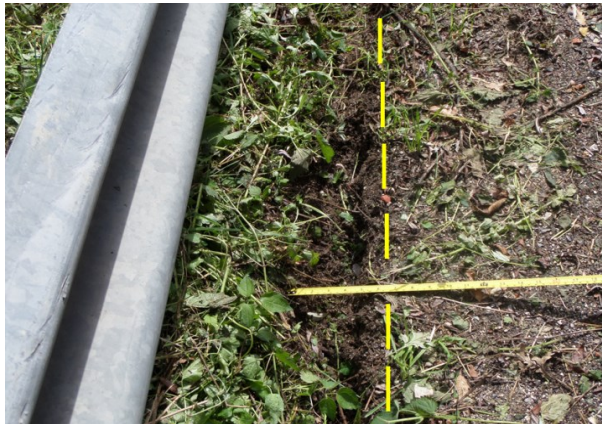
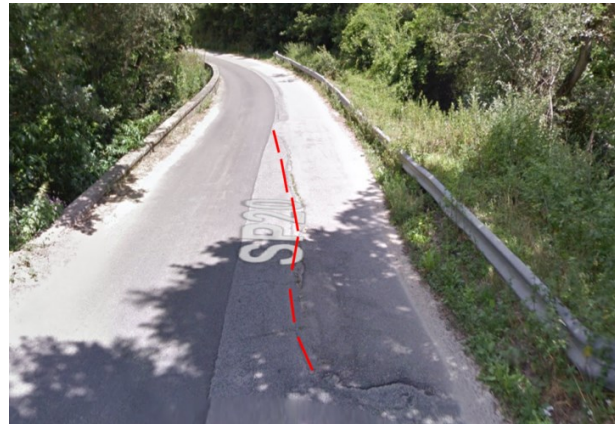
Longitudinal cracks (Figure 7.7a) were observed in two locations (42.660061N - 13.293697E; 42.657023N - 13.295309E) along SP20 road between Amatrice hamlets San Lorenzo e Flaviano and Sommati. In both cases (RE1a and RE1b in Figure 7.1), differential settlement occurred between a masonry bridge (Figure 7.7b) and an adjacent road embankment. In both locations, the road embankment was probably built after the construction of the small masonry bridges, in order to enlarge the SP20 roadway. A stainless Armco[®] tube (Figure 7.7c) lies underneath the embankment and the small bridge, apparently acting as a culvert.

Figure 7.7. Embankment instability along the SP20 road between the villages of San Lorenzo e Flaviano and Sommati (42.660061N, 13.293697E): (a) longitudinal crack along the road surface after the earthquake;(b) downstream view of the crossing section; (c) view of the Armco tube underneath the embankment; (d) maximum vertical settlement at the bridge-embankment connection; (e) longitudinal crack at the border of the pavement surface; (f) previous conditions of the road branch before the earthquake (Google image dated July 2011).

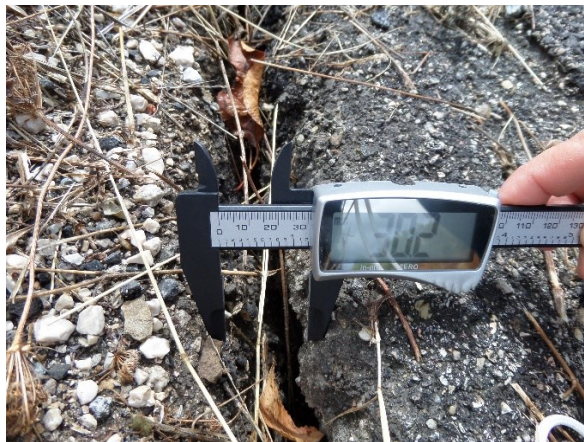
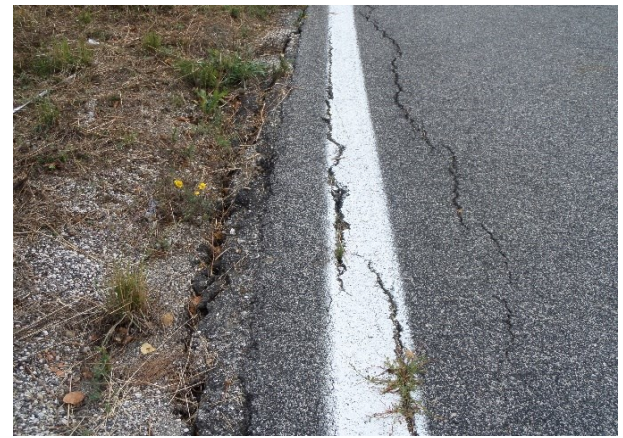
Figure 7.8. Embankment instability along the SS4 road at km 133 (42.650533N - 13.270442E): (a) longitudinal cracks along the whole rest area, (b) identification of the site location by road sign, (c) maximum horizontal opening of the longitudinal crack, (d) disconnection between the lateral slope and the road surface.

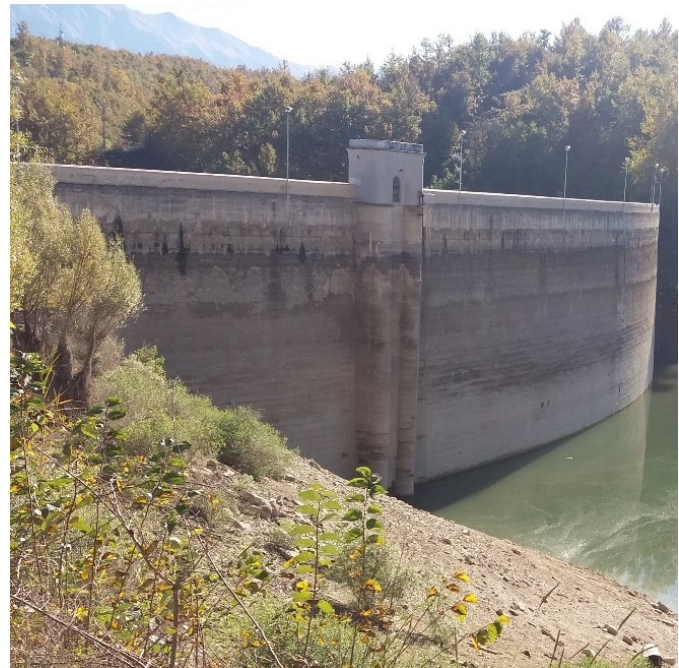
Inspections carried out by ENEL staff after the earthquake revealed no damage to Scandarello dam, which we confirmed on October 19, 2016 (Figure 7.12). Furthermore, ENEL staff stated that

Figure 7.13. Scandarello dam: (a) cross-section (ANIDEL, 1951); (b) photo of the upstream face taken on October 19, 2016 (42.641560°N, 13.269000°E).

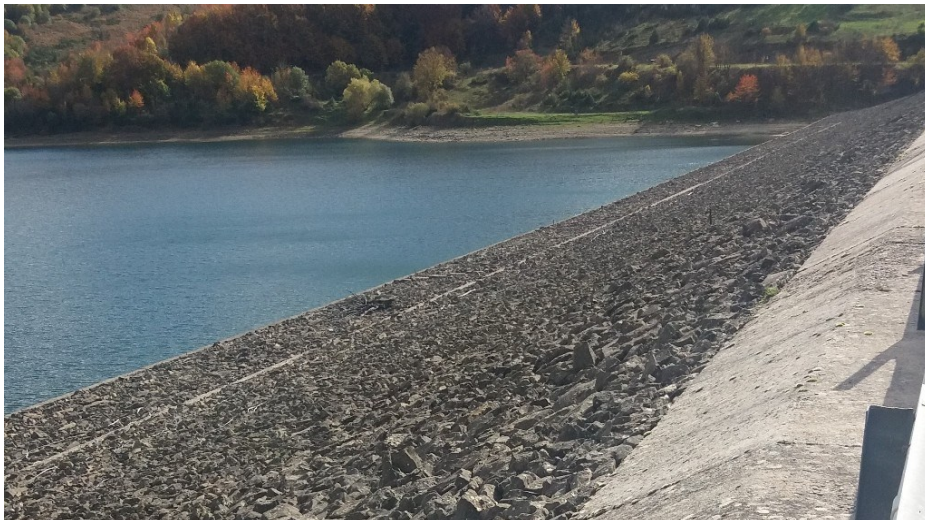
Settlements and interior pore pressures of the Poggio Cancelli dam are monitored by a complex system which includes several control points, located at the crest, within the core, vertically beneath the toe of the dam, and downstream of the toe of the dam. By combining the measurements provided by settlement gauges and from differential leveling surveys, the system allows to obtain separately the settlements of the core and in the underlying foundation. In the immediate aftermath of the August 24 mainshock, only a few millimeters of settlements of the crest were measured. More detailed information was not available at the time of the survey. The Poggio Cancelli dam hosts the PCB station (Figure 7.15), which, during the August 24 earthquake, recorded a horizontal peak ground acceleration as high as 0.31 g (Figure 7.10). The installation date is September 28, 1994 according to ITACA (ITalian ACcelerometric Archive, V2.1; <http://itaca.mi.ingv.it>). Despite the severity of ground motion, the seismic response of Poggio Cancelli dam was satisfactory.

Figure 7.15. Poggio Cancelli embankment dam on the Campotosto reservoir (L'Aquila): photo of the upstream face taken on October 19, 2016 (42.557106°N, 13.338342°E).

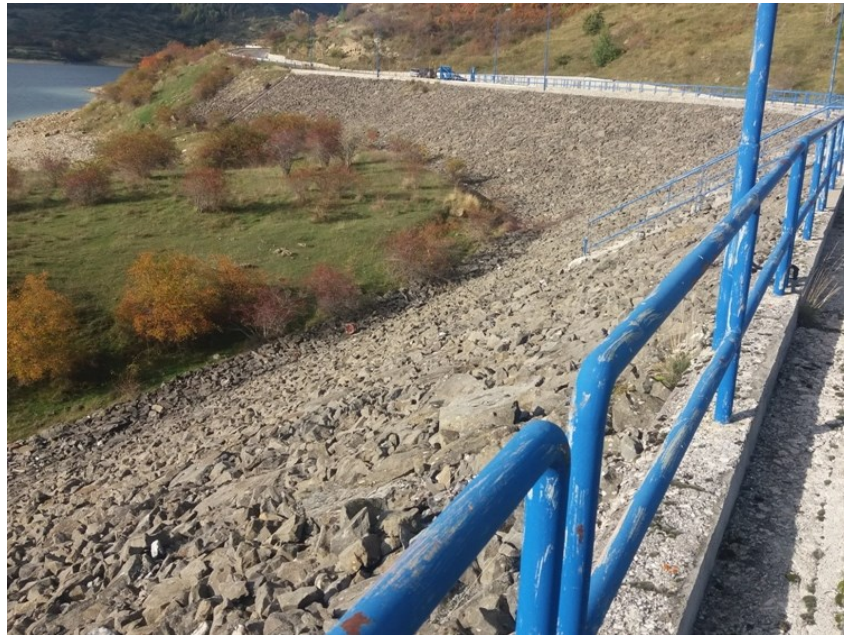
(b)

Figure 7.18. Photos taken on October 19, 2016 of the upstream face of Sella Pedicate concrete dam (a) and of one of its extremities (b), which is an embankment dam (42.514468°N, 13.370155°E).

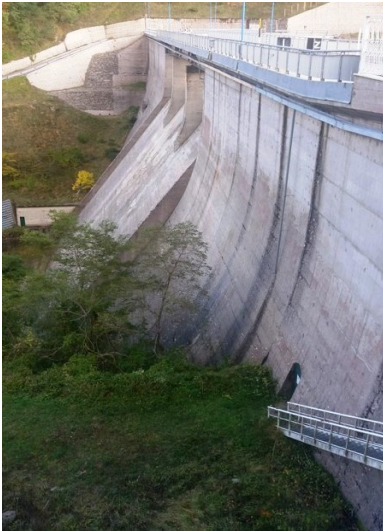
(a)

Figure 7.19. Photo of downstream face taken on October 19, 2016 (42.535681°N, 13.409286°E) and a cross-section (b) of the dam (from FCEM, 1998).

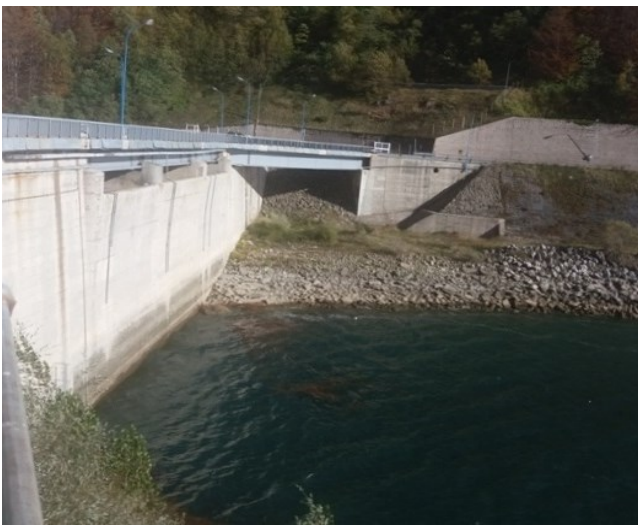
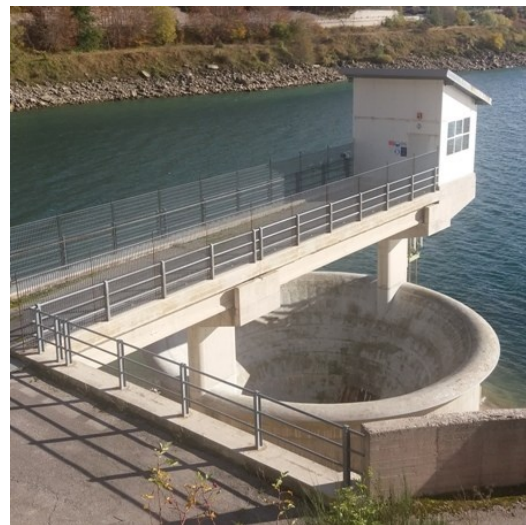
The inspections carried out by ENEL staff after the August 24, 2016 earthquake revealed that no damage to Rio Fucino dam was observed.

Figure 7.20. Photo of upstream face (a) and of the bell-mouth spillway (b) of the Rio Fucino dam (October 19, 2016).
