**Italian Joint Reconnaissance Mission**

# Türkiye

**Daily Report**  
**May 10<sup>th</sup> 2023**

## Daily report, May 10th 2023

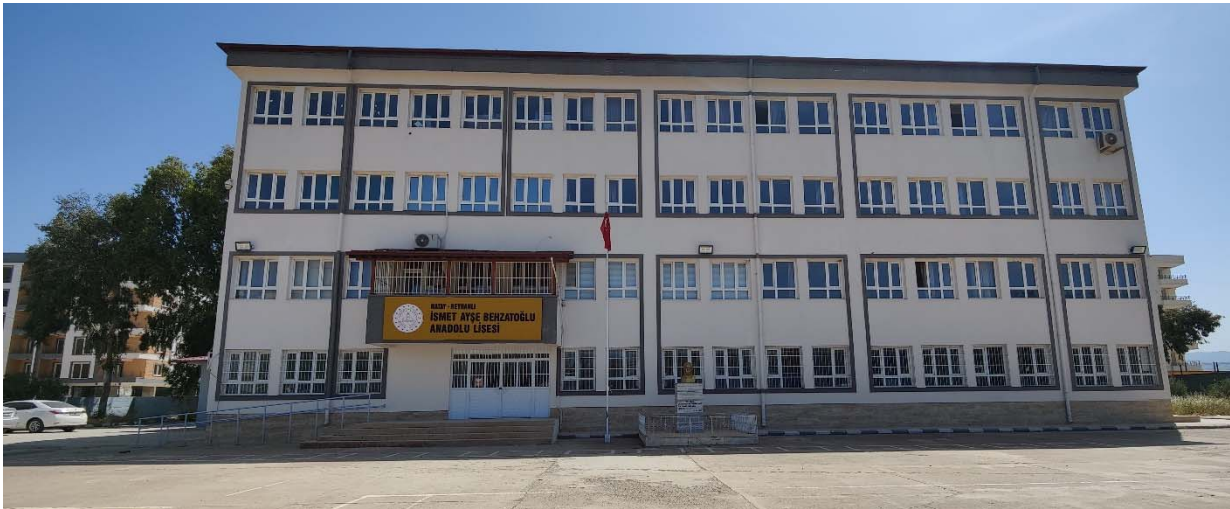
Fig. 2. -. Front view of the building.

The building was classified as moderately damaged, and was temporarily closed to scholastic activities, due to flexural cracks observed on beams of the frames in the longitudinal direction, such as the one shown in Fig. 3 with a crack width of 0.5 millimeters. The building avails of a strengthening system composed by additional RC shear walls, placed near the central part and spanning the entire height of the building

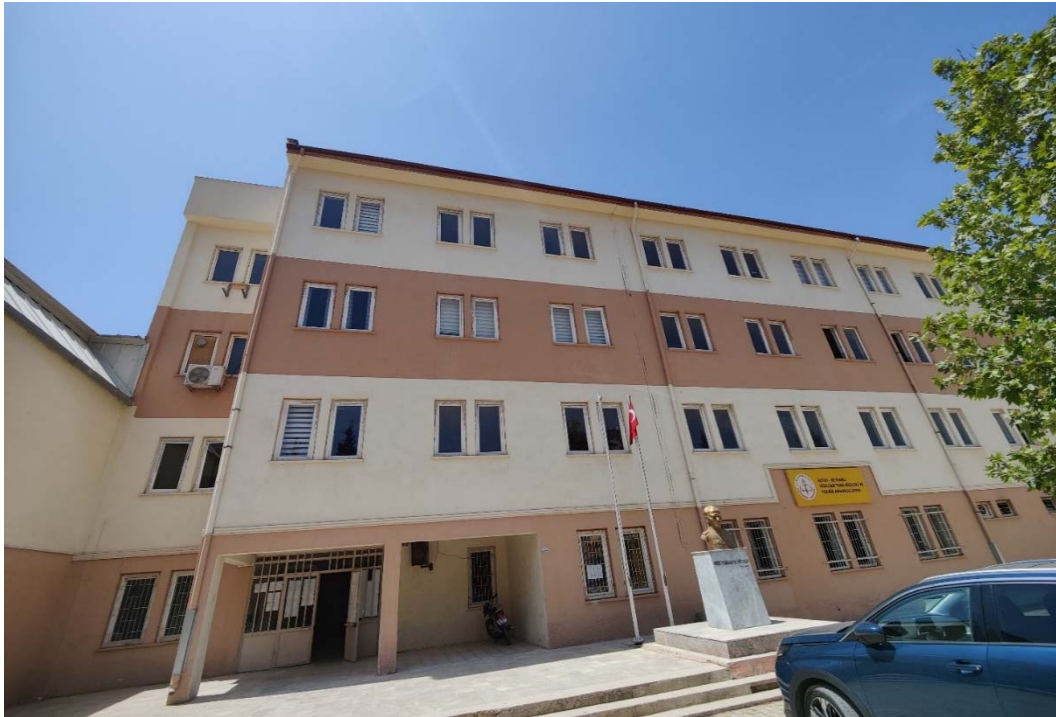
Fig. 4 Front view of the building

This building does not exhibit earthquake damage. All that can be observed is some separation of the masonry infill around the gym area, that was probably cause by some existing case of foundation settlement, as shown in Fig. 5. The building exhibits a strengthening system consisting of RCC shear walls spanning the entire height of the building

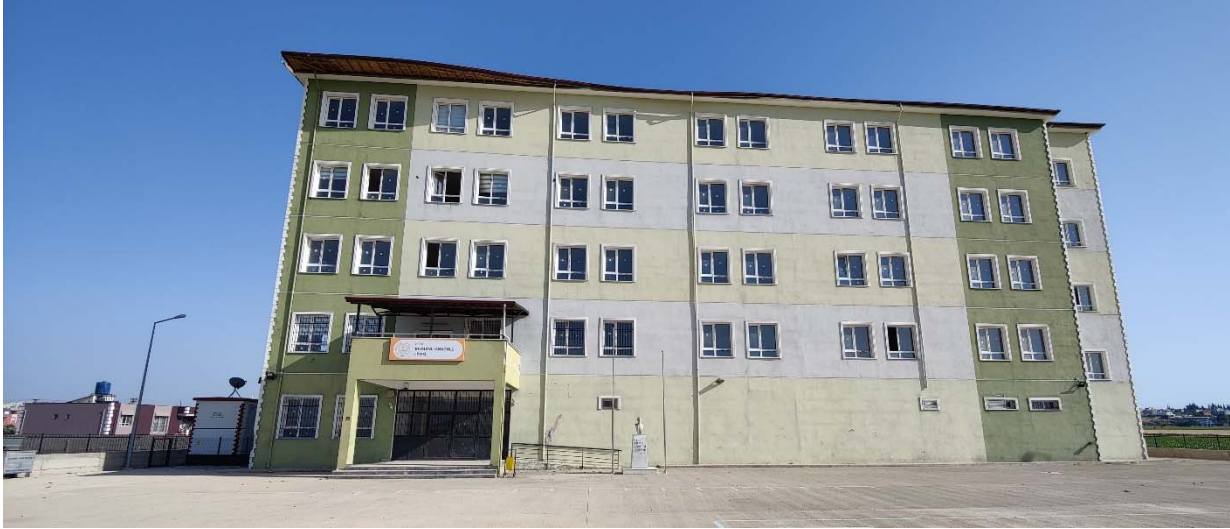
Fig. 6 – Front view of the building.

This building was closed to scholastic activities. It exhibits ubiquitous cracks on all sides, that only seem to concern the finishing mortar. The roof cover has evident damage, with part of it on the front side being displaced with some the roof tiles falling over.
